# **MANAGING THE HIGH ECOLOGICAL VALUE AQUATIC ECOSYSTEMS**

**OF THE COOPER CREEK CATCHMENT  
SOUTH AUSTRALIA**

**Summary of technical findings** *June 2014*

Report to the South Australian Arid Lands Natural Resources Management Board, June 2014

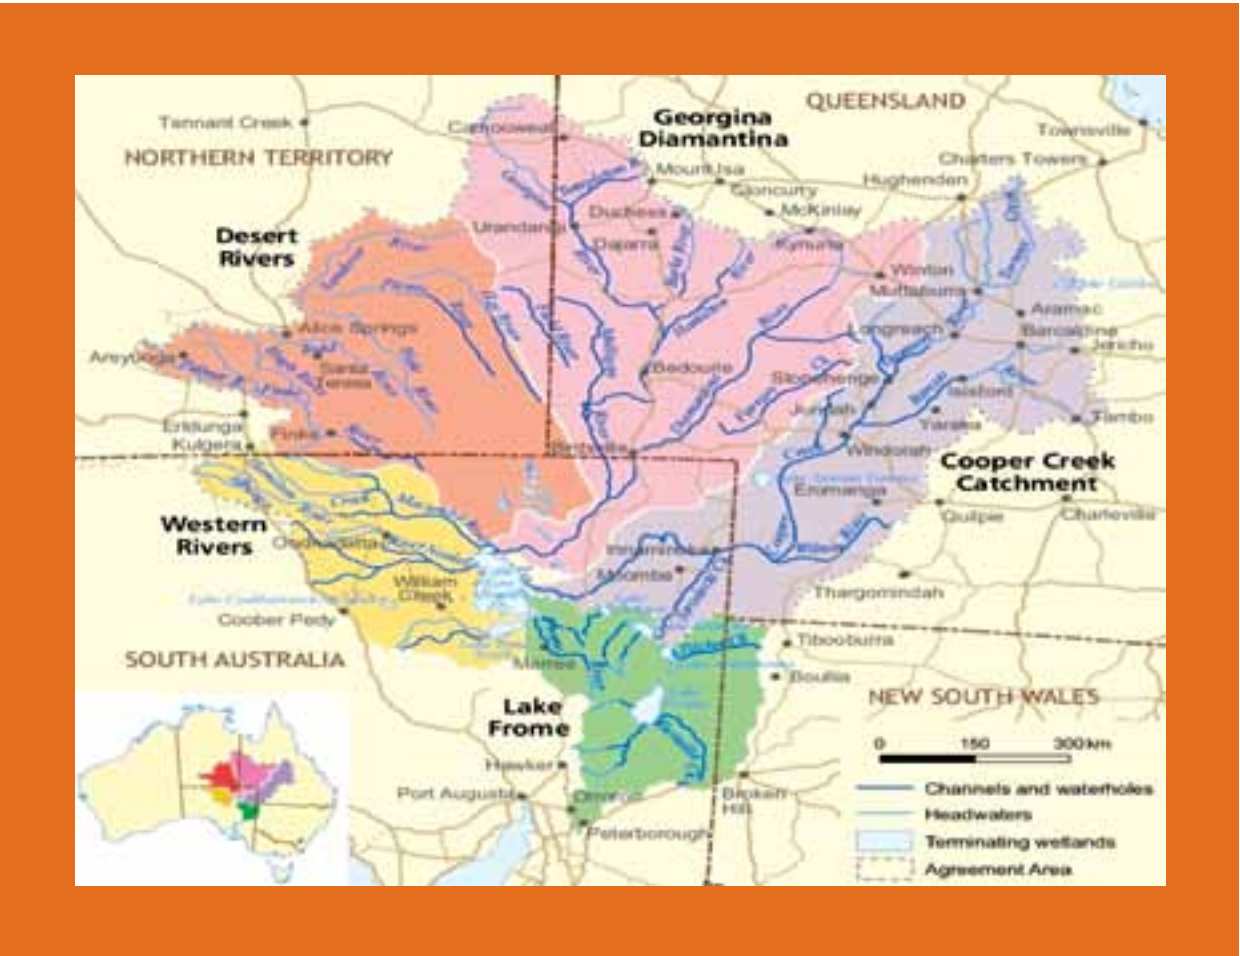
**Figure 1.**  
*Lake Eyre Basin,  
 showing Cooper  
 Creek Catchment*  
 (Map source: *State of  
 the Basin 2008: Rivers  
 Assessment (DEWHA)*)

The Cooper Creek is a significant feature of the Lake Eyre Basin in the centre of the Australian continent (Fig.1). In the South Australian section of the Cooper Creek Catchment annual rainfall is very low and highly variable in timing, duration and intensity. The area receives median annual rainfall of 100-150 mm and mean annual pan evaporation of 3,500 mm. Cooper Creek receives water via the Thomson River from monsoonal rainfall to the north and via the Barcoo River from monsoonal and easterly rain systems in Queensland. There is enormous year-to-year variability in the size of floods in Cooper Creek. Floods large enough to reach Kati Thanda-Lake Eyre occur on average every ten years. In most years flows terminate in the Coongie Lakes system and Embarka Swamp (Main Branch).

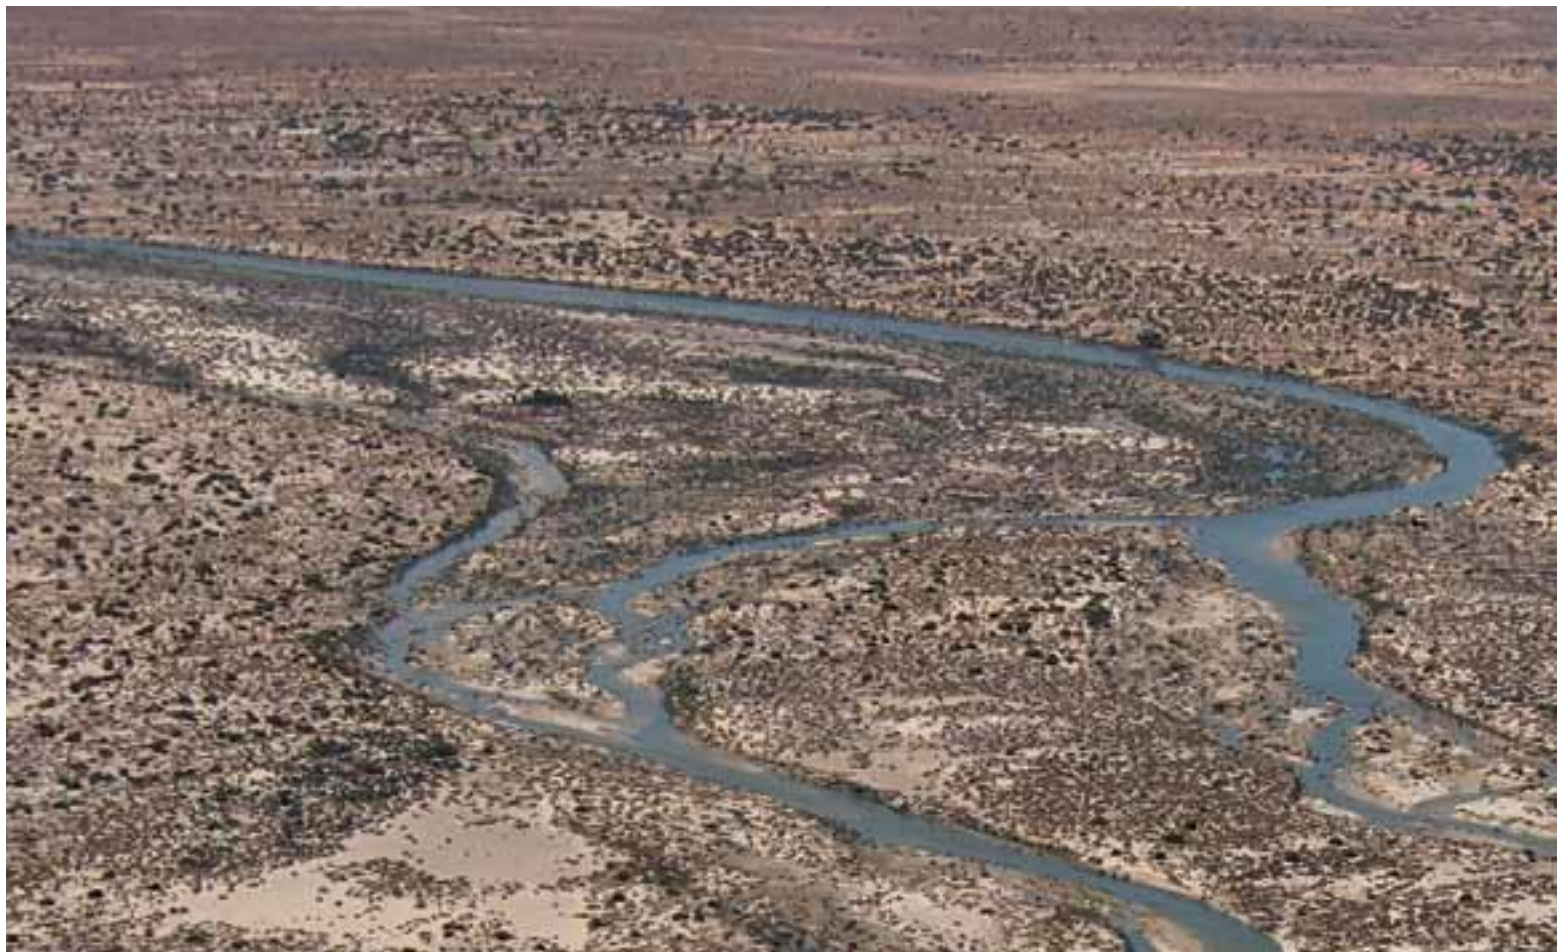
**Figure 1.**

Aerial photograph of Cooper Creek as it flows across the Cooper Creek Fan, from Queerbiddie Waterhole and the Town Common on the right, to the Main Branch – North-west Branch split on the left.

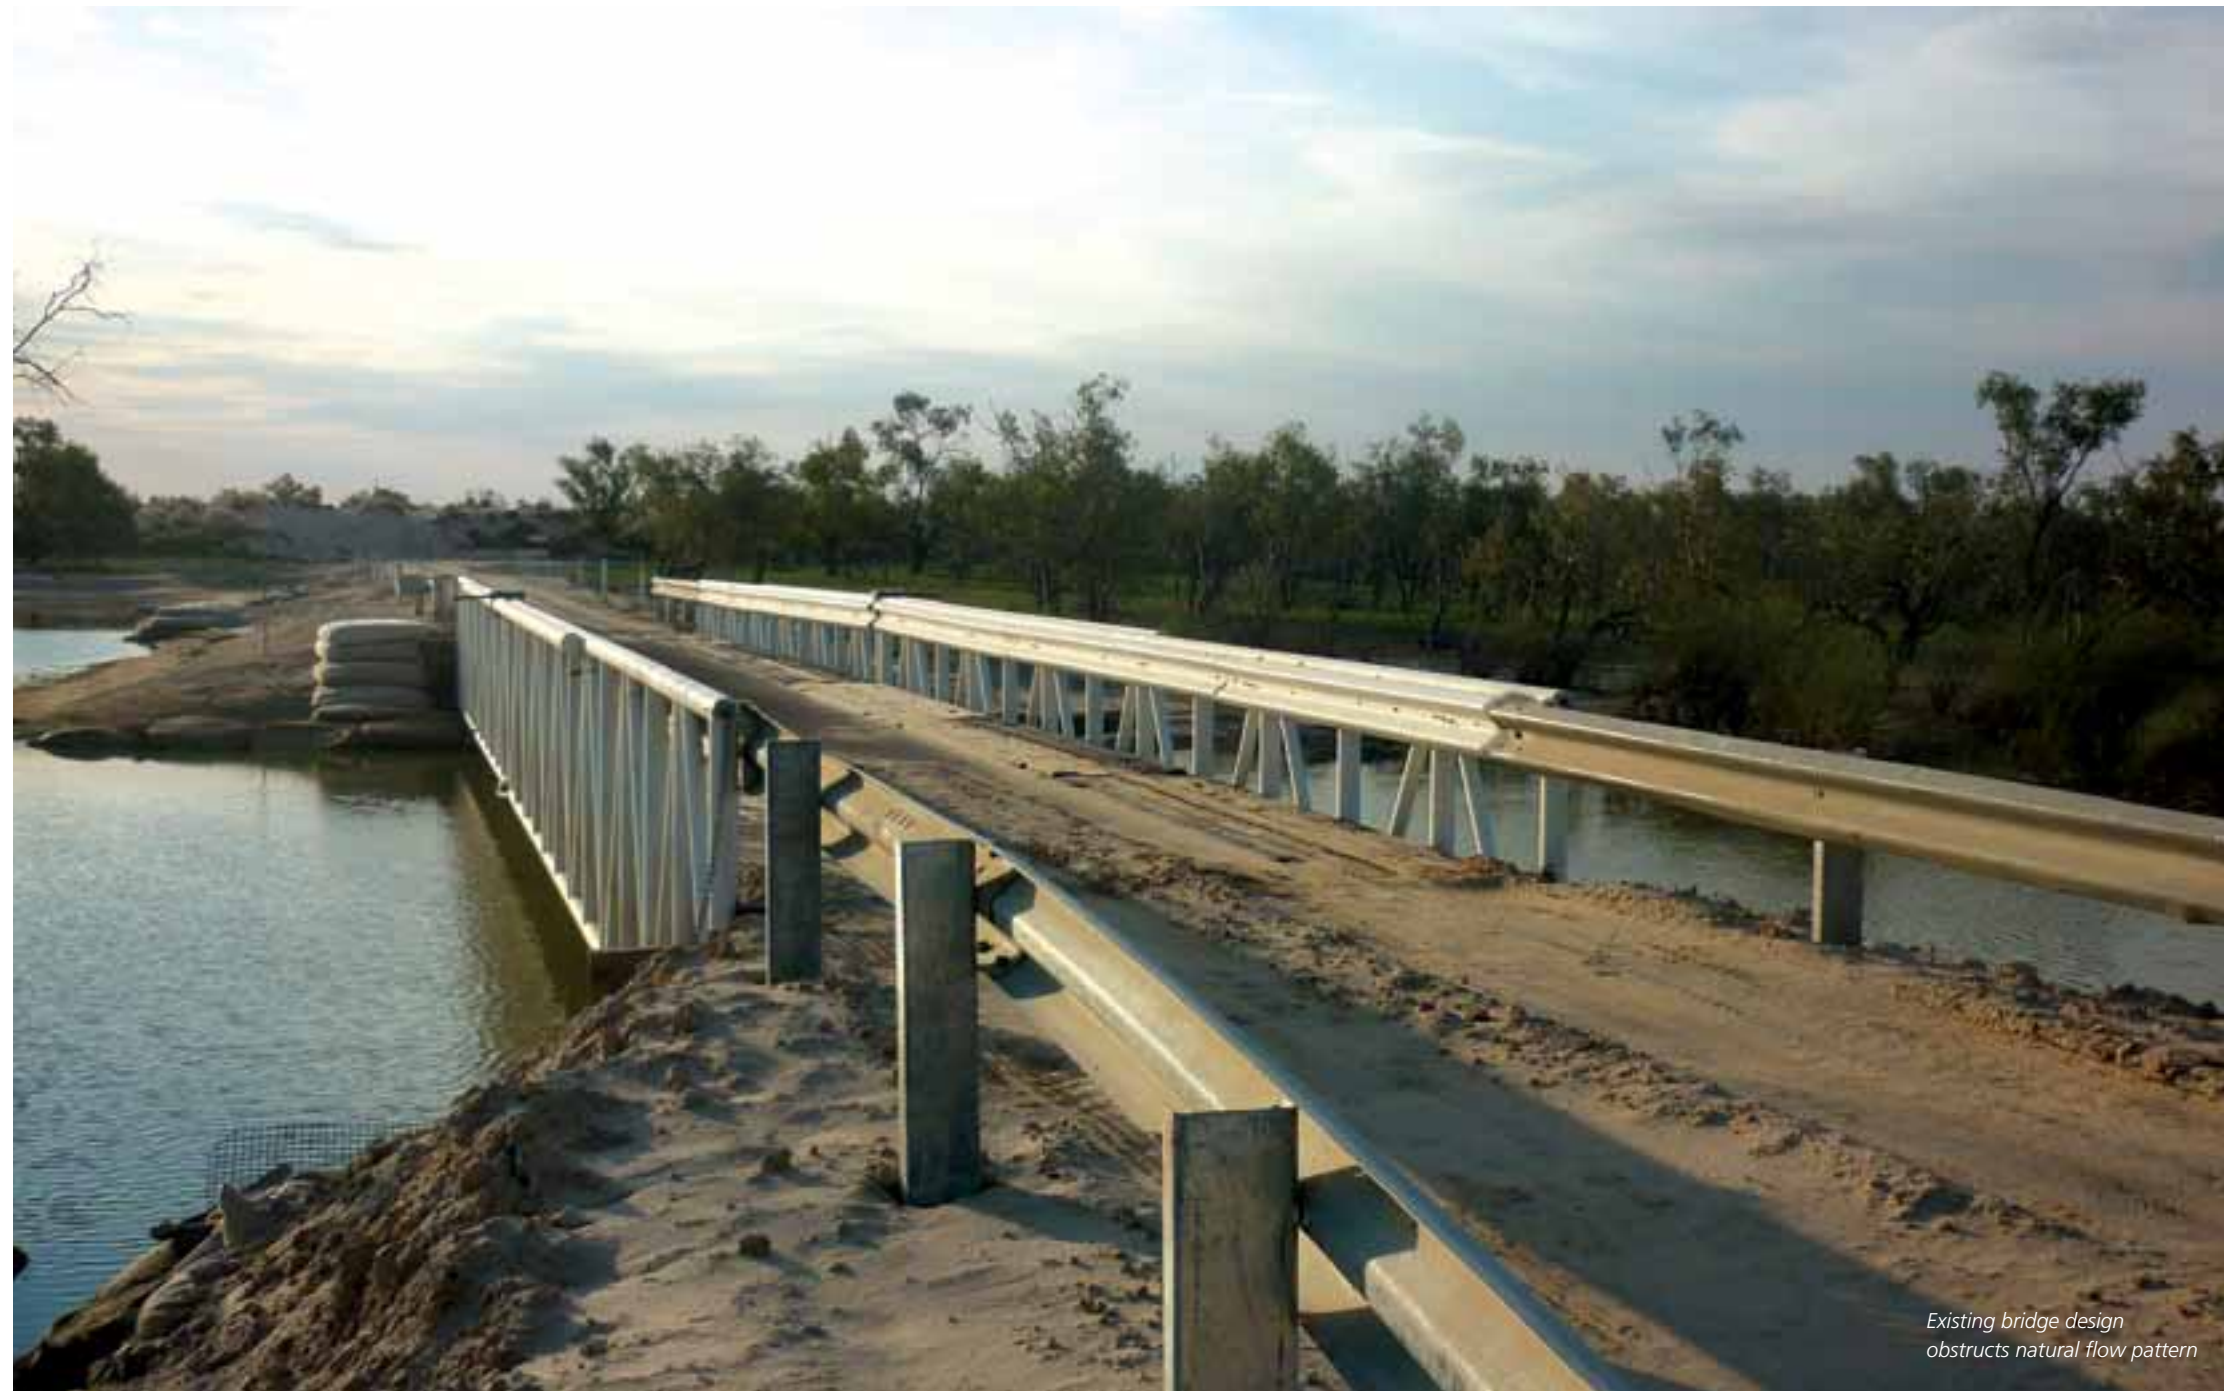
Existing bridge design obstructs natural flow pattern

→ Mining activity has also been generally well managed but there is evidence that some built-up roads and bridges which cross the main flow paths of the Cooper have retarded or changed the flow of high-volume flood peaks.

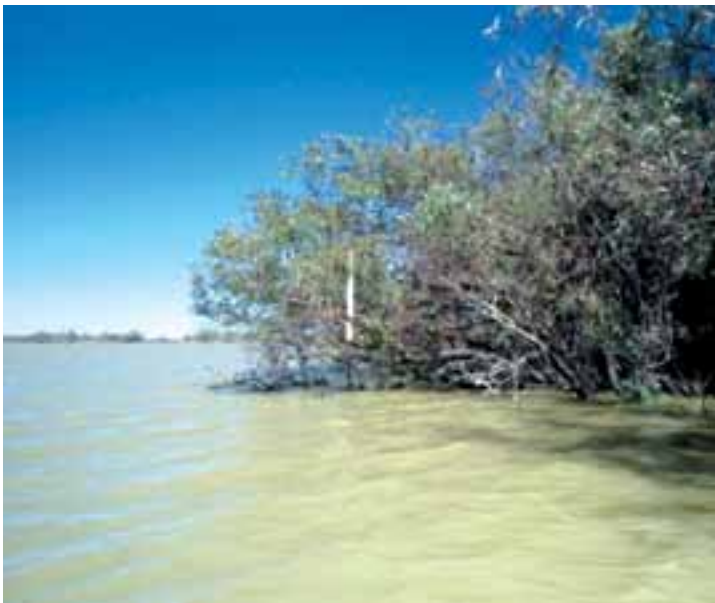
The logger position at the mouth of Ellar Creek and Lake Goyder

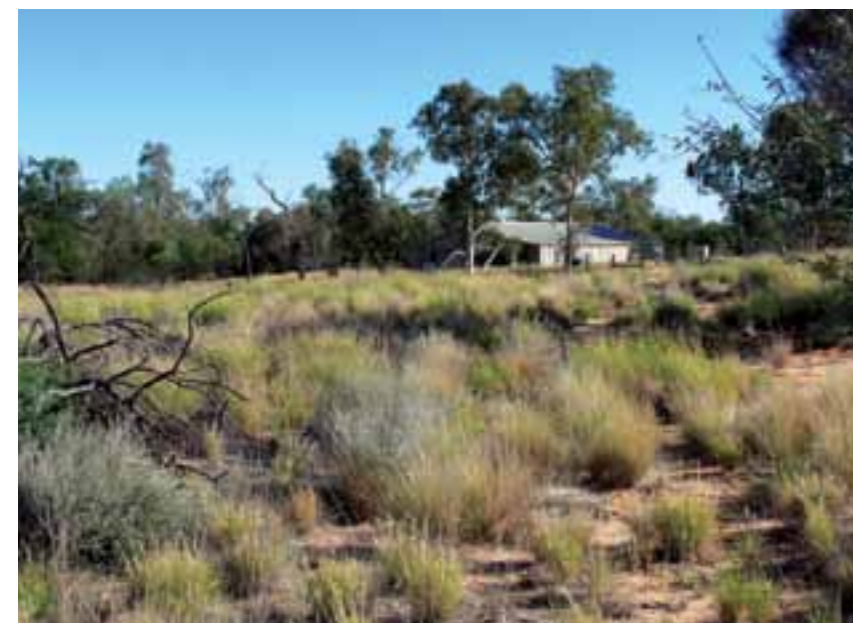
**Left** Buffel grass infestation at Kudriemitchie Outstation

Buffel grass (*Cenchrus ciliaris*) was observed in the early invasion stages near two waterholes. If permitted to spread, this plant has potential to severely alter ecosystems through displacing native species and altering fire regimes.

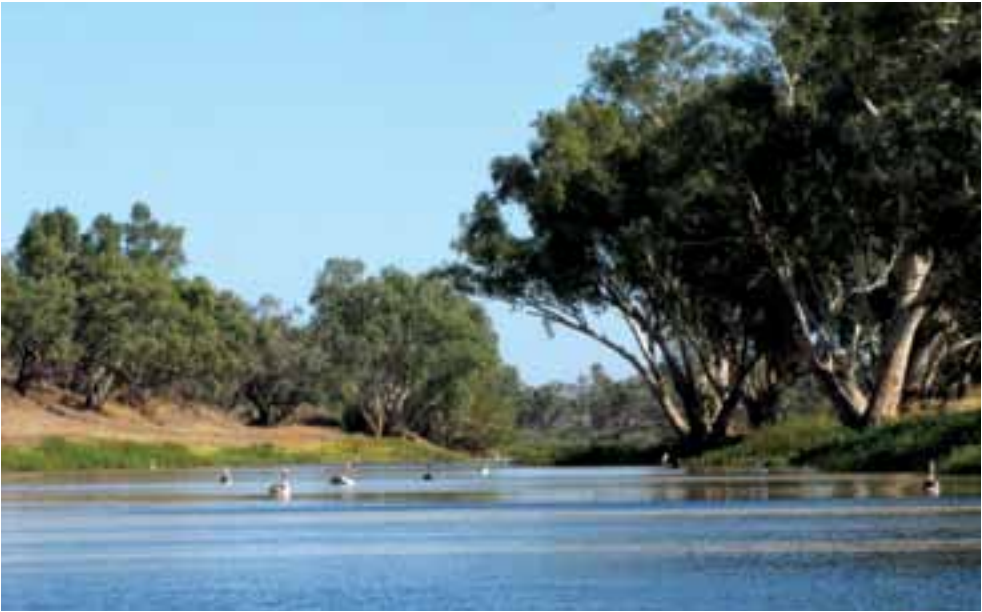
**TABLE 1.**  
**WETLAND SITE**  
**CONDITION SUMMARY**  
(colours reflect investment priority)

Generally vegetation condition was rated as ‘good’ (Table 1). There was impact (moderate stream-bank damage) from tourism activity and grazing pressure at some waterholes and an increase in mining activity and infrastructure development affecting floodplain environments. Recreation and tourist visitation at sites had an impact on the landscape through compaction and soil erosion from vehicles and human use and firewood collection. Feral animal grazing from rabbits was a major threat with impacts likely to increase. Vegetation responses such as extensive regeneration of coolibah seedlings and prolific seed production particularly for native grasses were observed due to the favorable conditions. Presently the system is not greatly impacted by any serious weed infestations. However, buffel grass (*Cenchrus ciliaris*) poses a serious future threat and requires management to contain isolated populations at priority sites (e.g. Kudriemitchie Outstation and Minkie Waterhole).

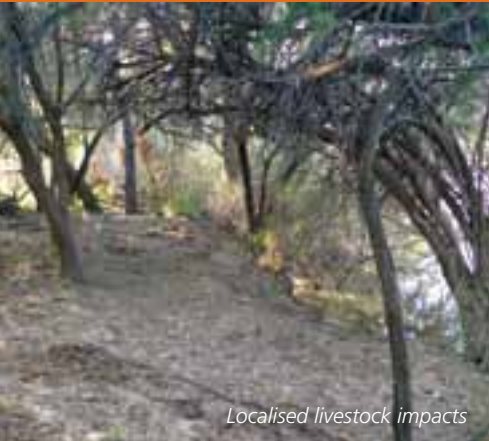
Localised livestock impacts

- Overgrazing causes loss of vegetation cover and habitat diversity and increased erosion in turn adding to siltation of waterholes. Grazing of young seedlings can destroy a generation of new plants, substantially damaging vegetation structure.

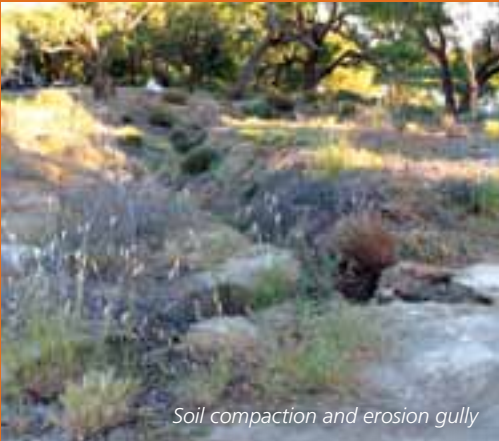
Soil compaction and erosion gully

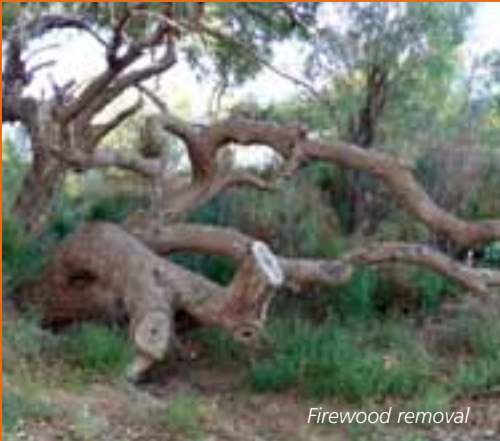
Firewood removal

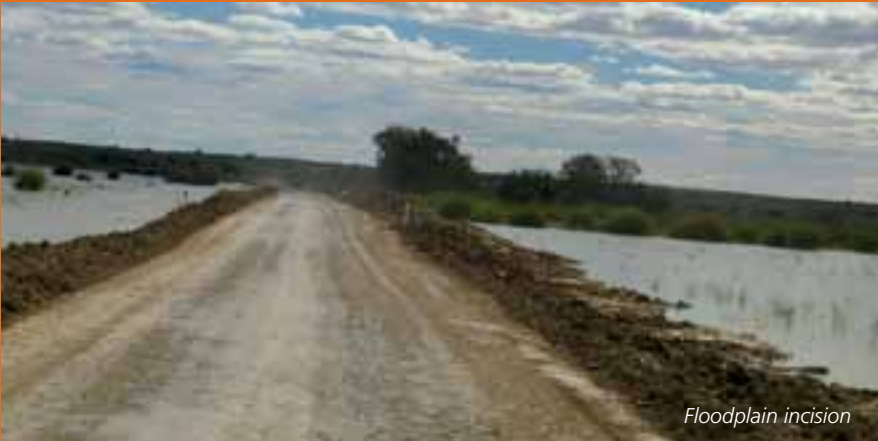
Floodplain incision

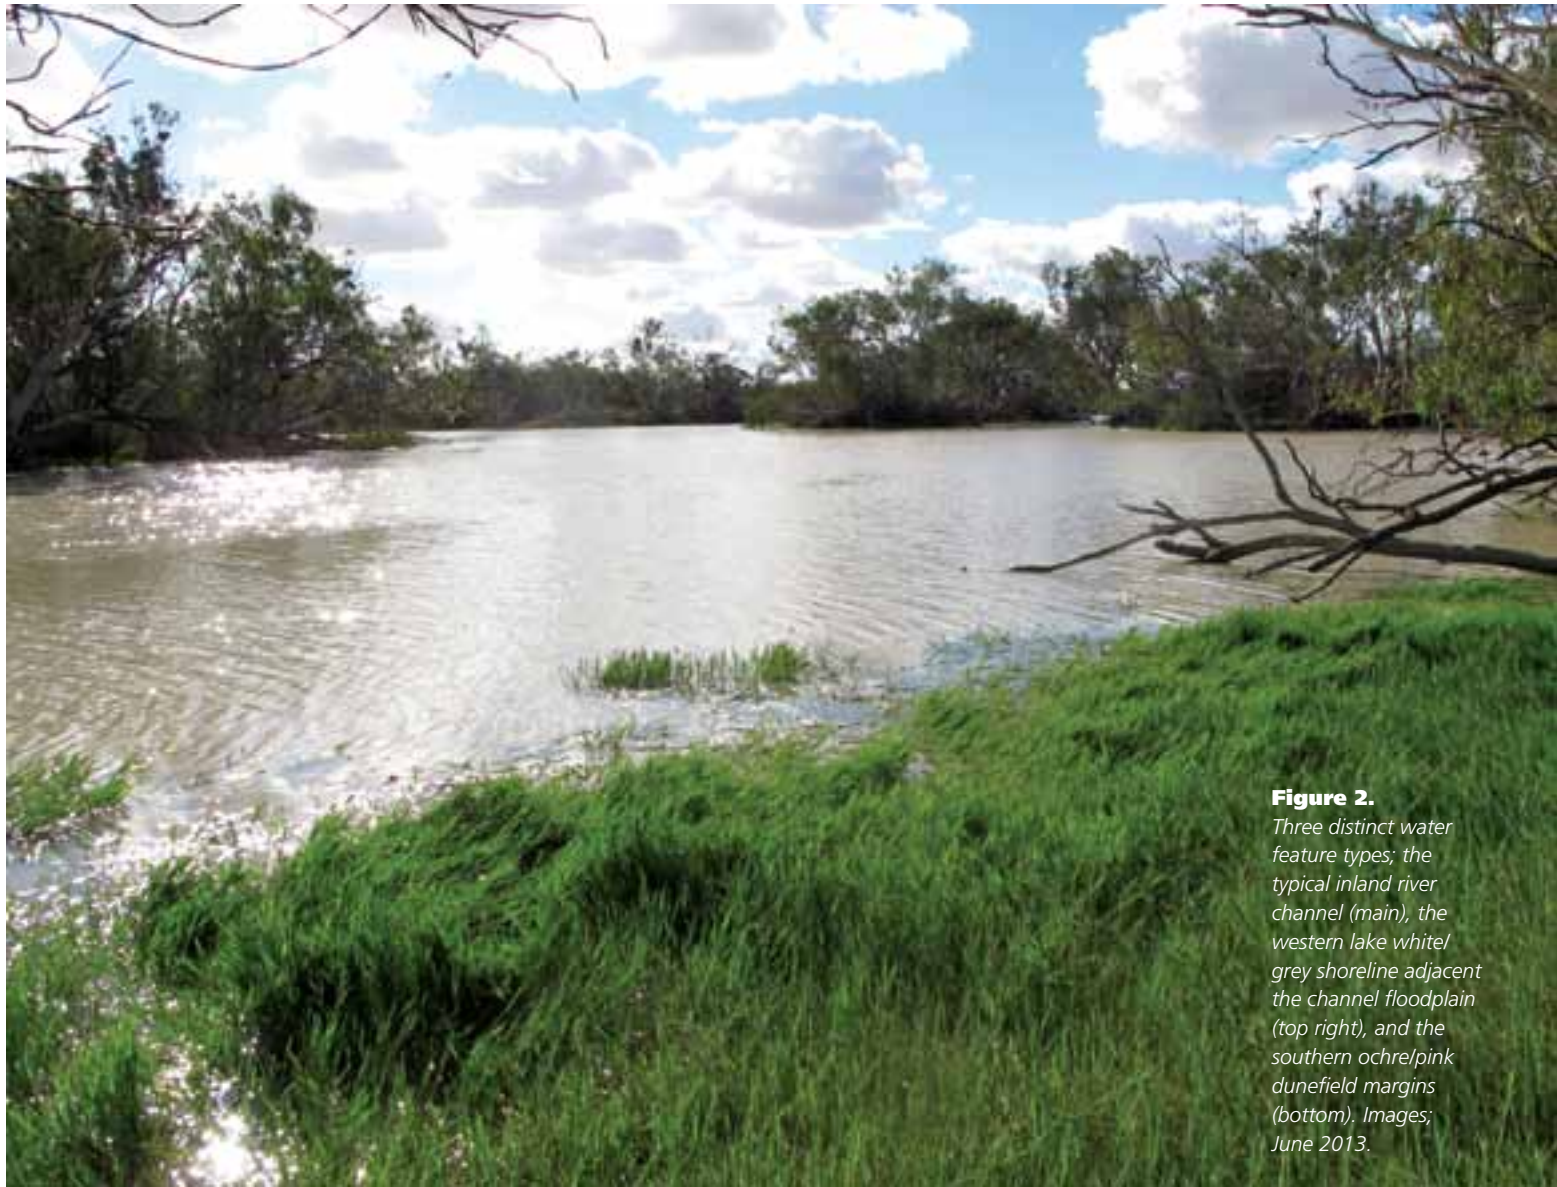
**Figure 2.**  
Three distinct water feature types; the typical inland river channel (main), the western lake whitel/grey shoreline adjacent the channel floodplain (top right), and the southern ochre/pink dunefield margins (bottom). Images; June 2013.

Three distinct water feature characters types provide diversity; the deeper Branch channel flows linearly, the shallow floodplain lake is affected by silting and flooding regimes, and the sandy lake is defined by intersecting dunes and dune plains (Fig. 2).

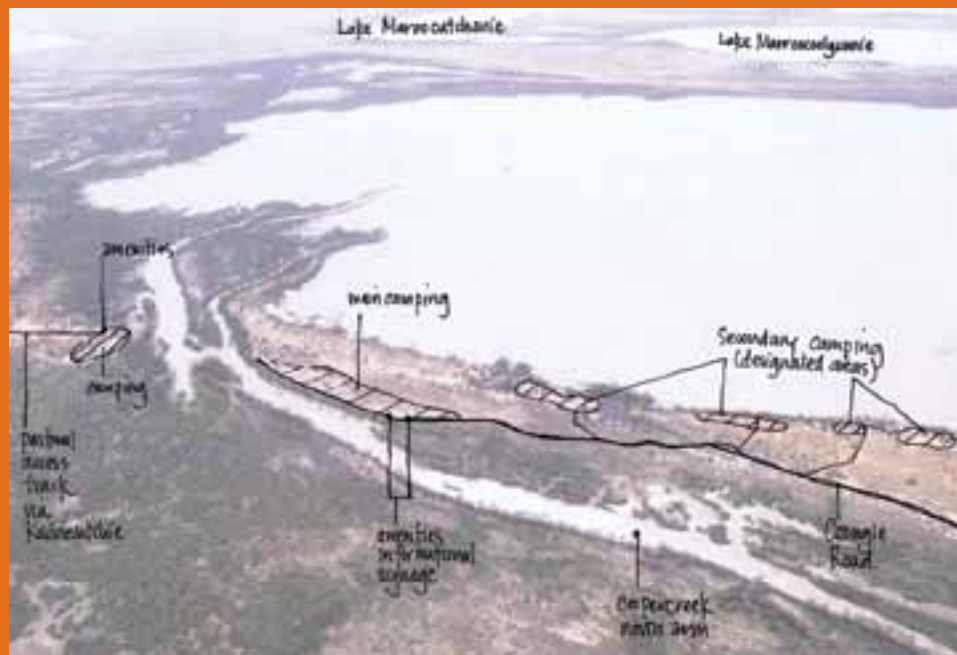
**Figure 3.** The Coongie main eastern campsite area on the channel and lakeside 'wild' campsites. Image: Sep 2012.

The area is designated a National Park and Ramsar Wetland and co-management regimes are applied. A small campground and ablution facilities is located at the confluence of the North-west Branch channel and Lake. Alternative southern campsites line the lakeside in a variety of low white sandy beach and swampy wetland sites (Fig. 3).
