OULNINA

Recovering Eroded Land in SA's Pastoral Lands

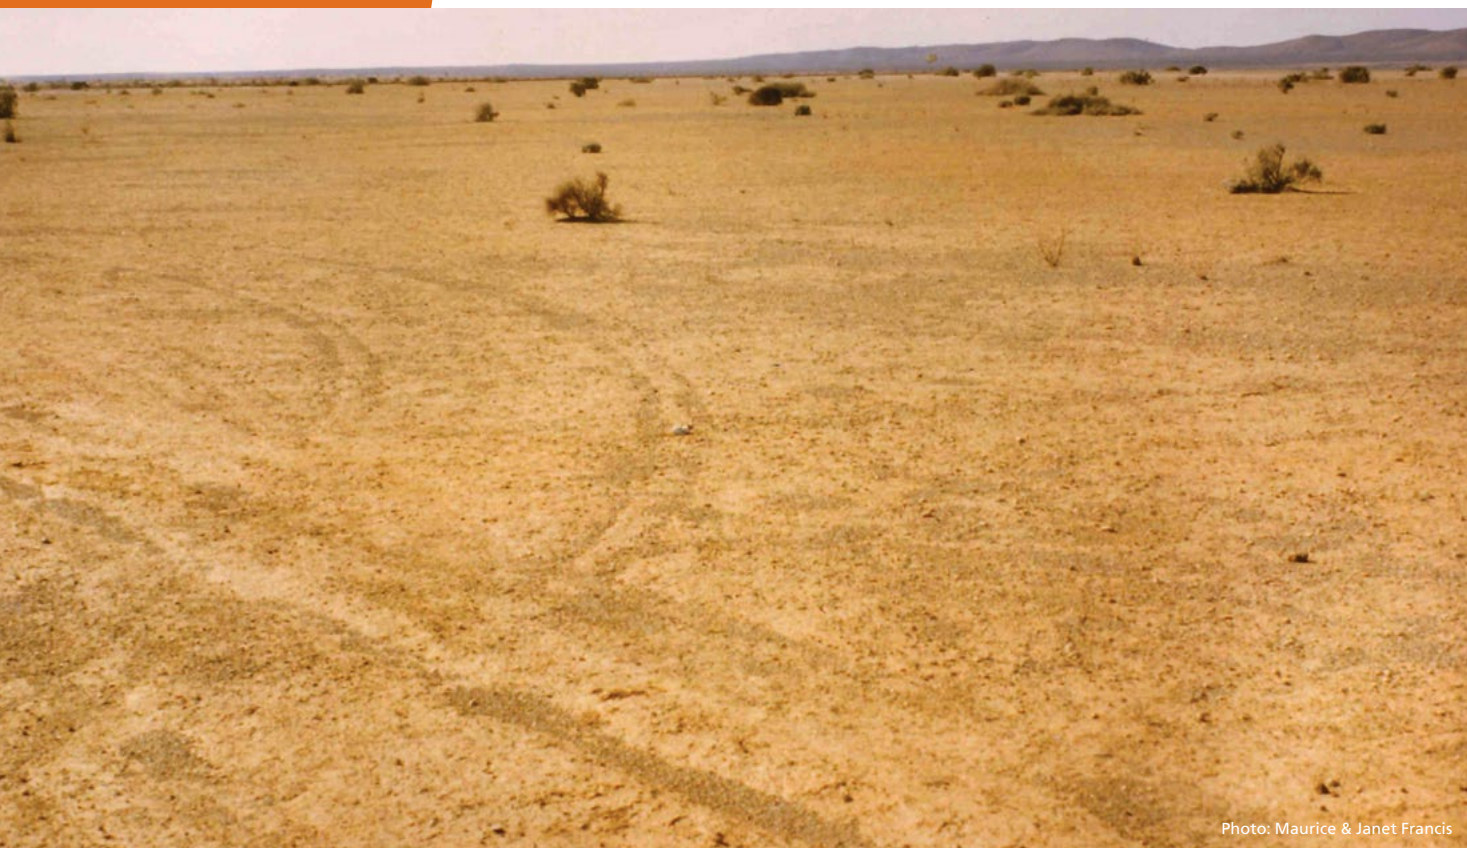
East Jumbuck paddock May 1983. Land was bare and vulnerable to wind sweep.

At the time, the region was again experiencing a severe drought. The East Jumbuck paddock was regarded as one of the property's most productive ones but had become quite bare. The dominant vegetation was *Maireana sedifolia* (Pearl Bluebush) but this had been reduced to a few scattered bushes.

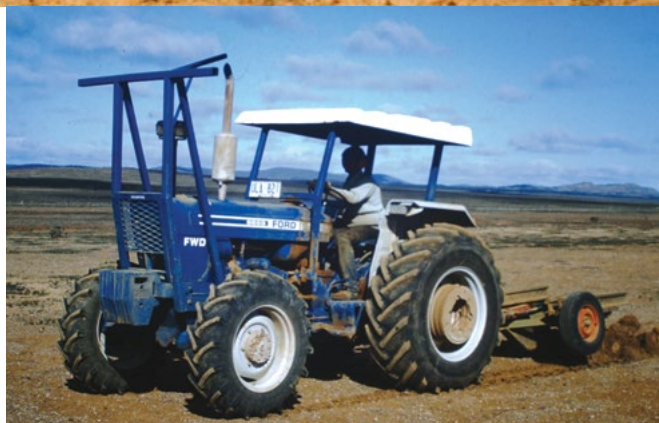
Ripping furrows on Oulnina. The ripper is a single-tined implement with 'wings' on both sides of the tine to throw a mound of soil either side of the furrow.

Key lines were surveyed with a dumpy level to ensure that furrows were ripped on the contour as the land had gentle to moderate slopes of one to four percent. Contour furrows slow runoff and enable it to soak into the soil as well as acting as a barrier to wind sweep. Furrows were ripped to a depth of approximately 45 cm and spaced between five to ten metres apart.

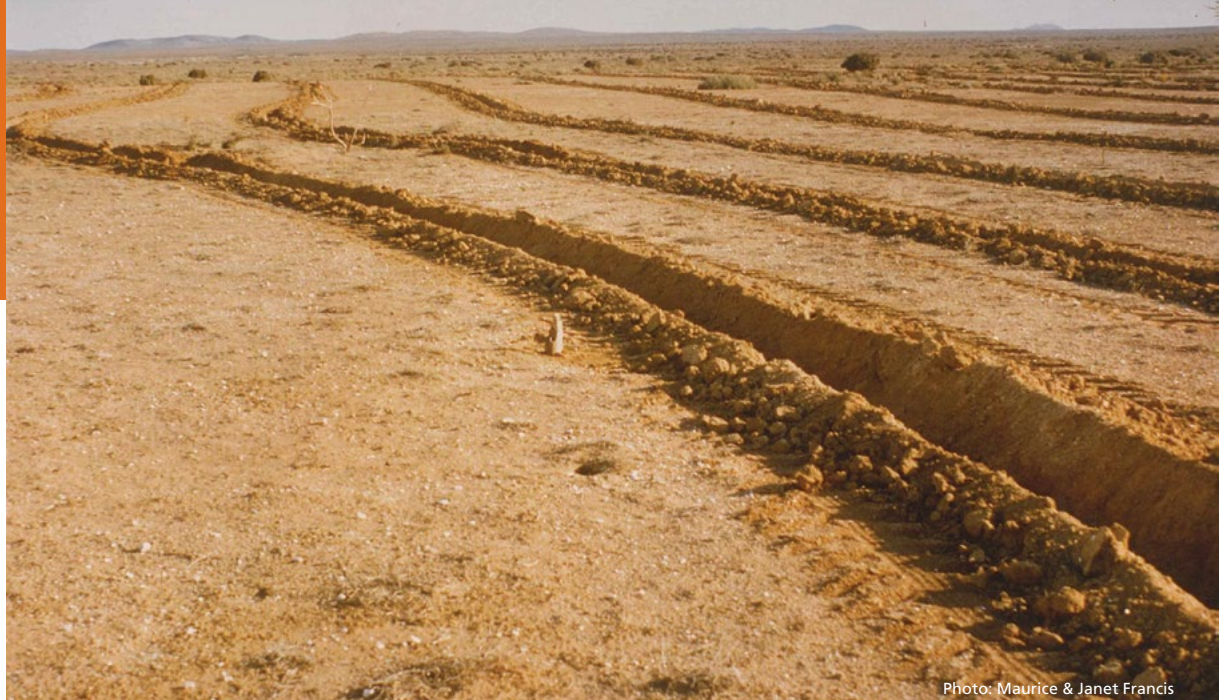
19/05/1983

Land immediately
after ripping.

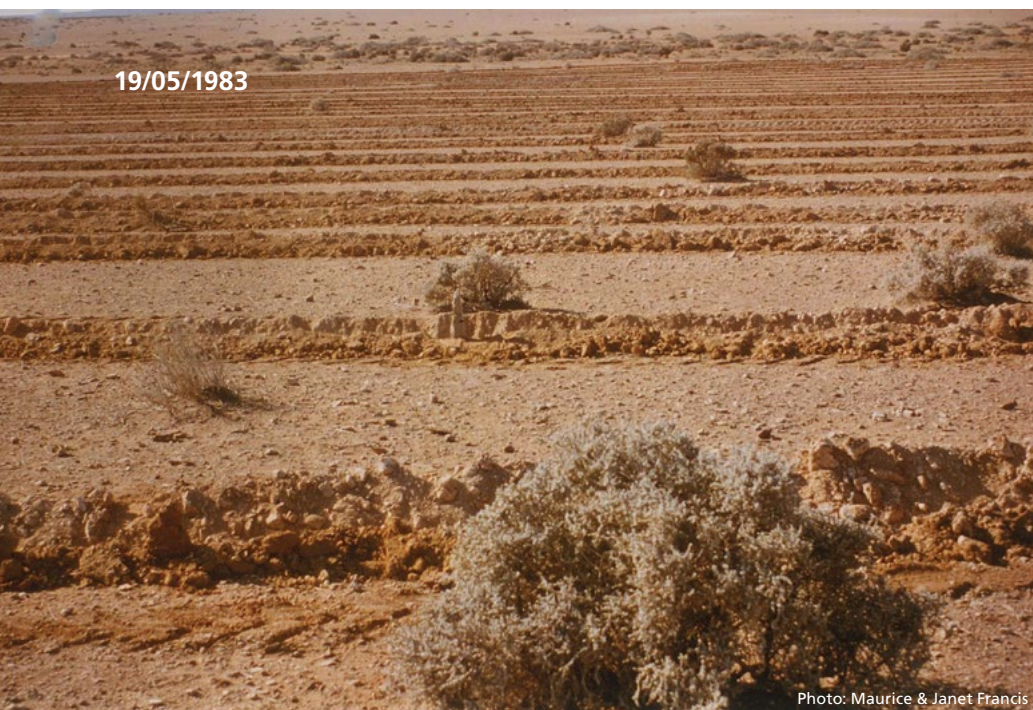
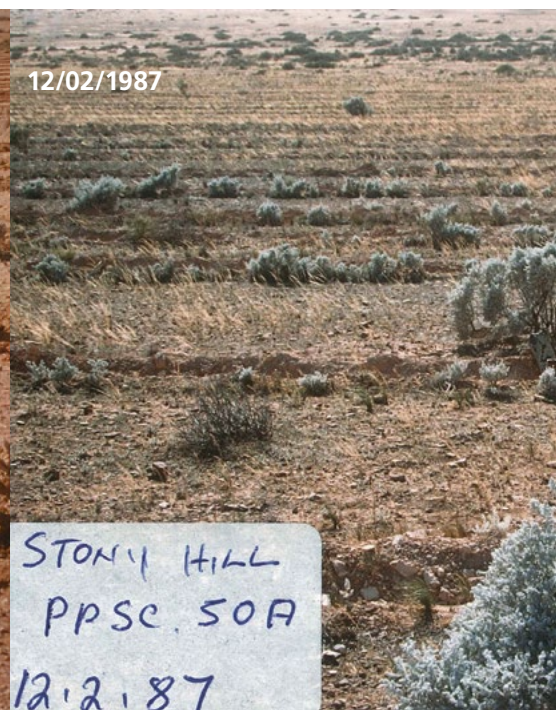
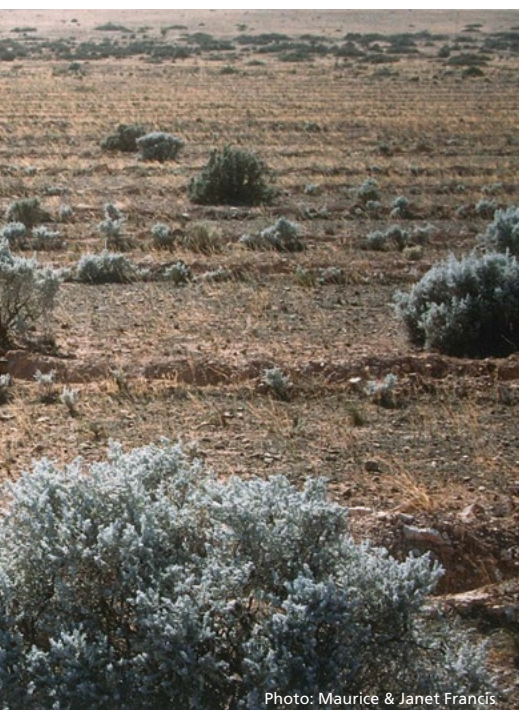
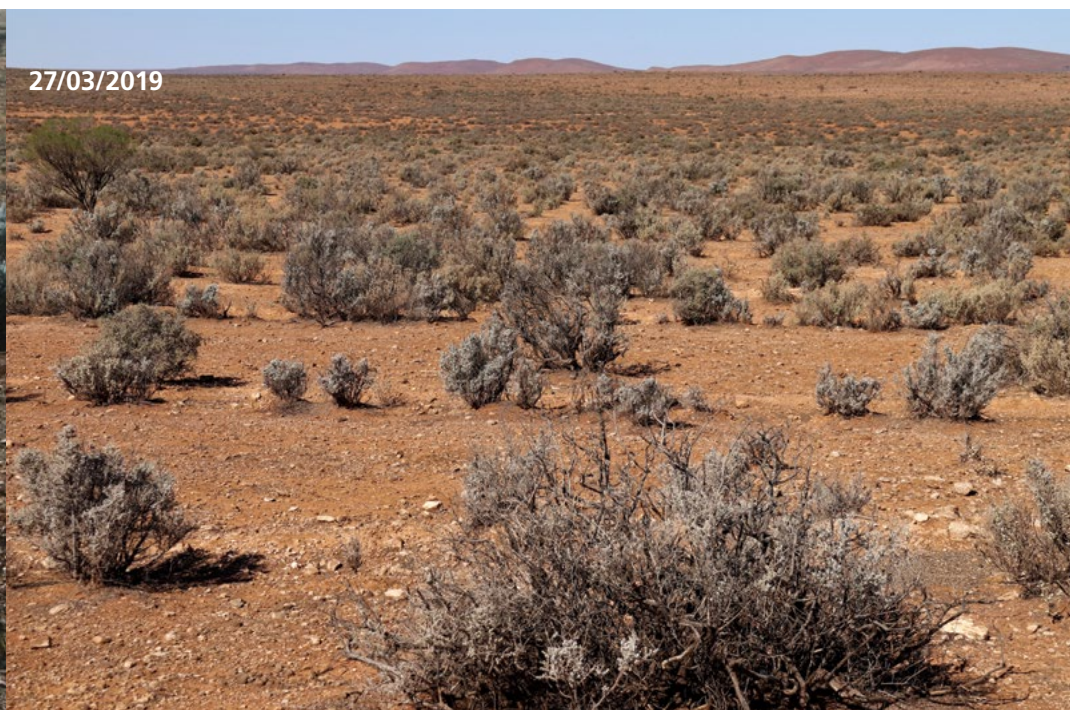
PHOTOPOINT 1983-2019

East Jumbuck paddock photopoint
site showing regeneration of Pearl
Bluebush.

Despite severe drought conditions
in 2019, bush cover is at least 25
times more than in 1983.

The furrows were ripped in May 1983 and after rains in July 1983, thousands of bluebush seedlings grew. Many of these persisted and grew and remain to this day.

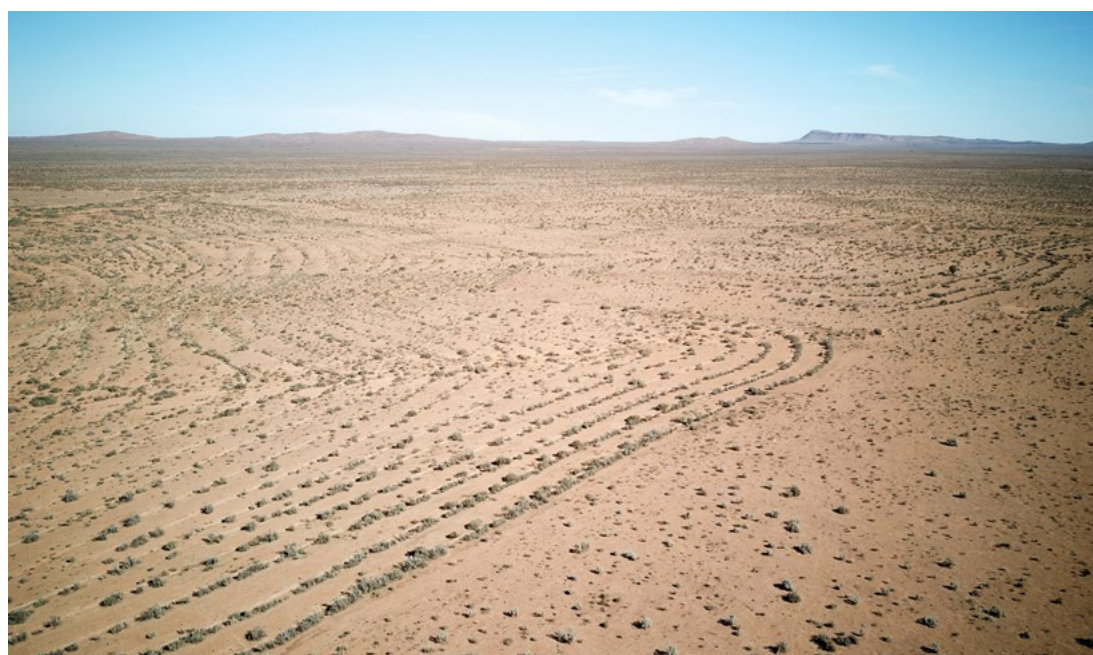
An aerial view of East Jumbuck shows how most of the bushes are in furrow lines.

The lines are continuous and Maurice says that one mistake they made at the time of furrowing was not to leave some breaks in the lines. This would have made it less rough and less time consuming for mustering and travel through the paddock.

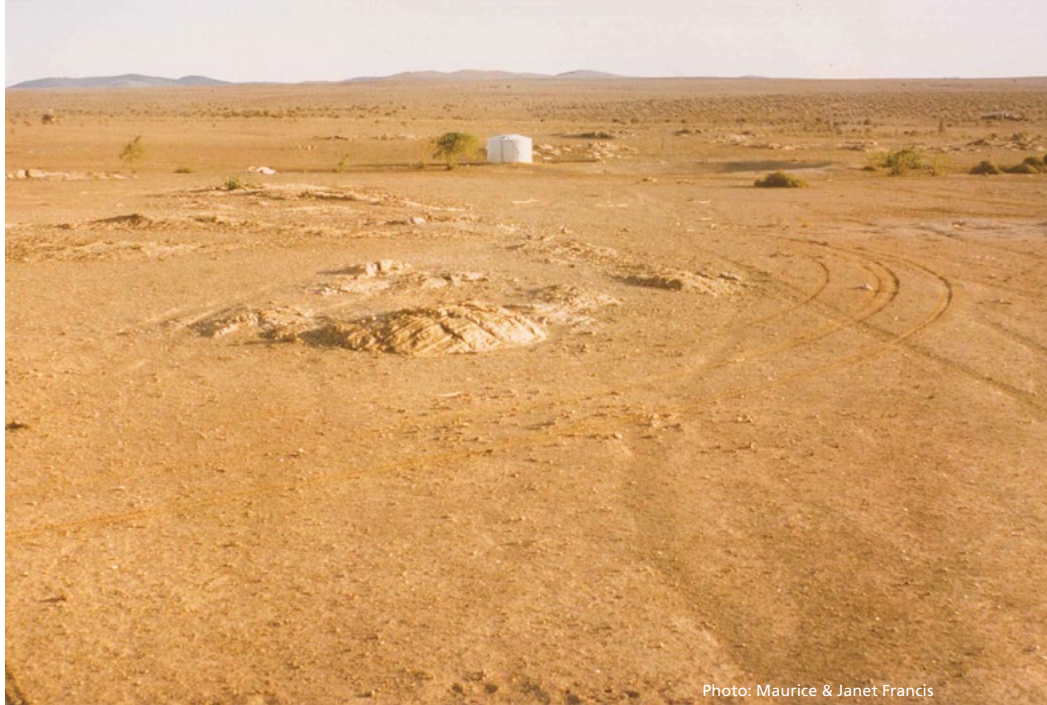
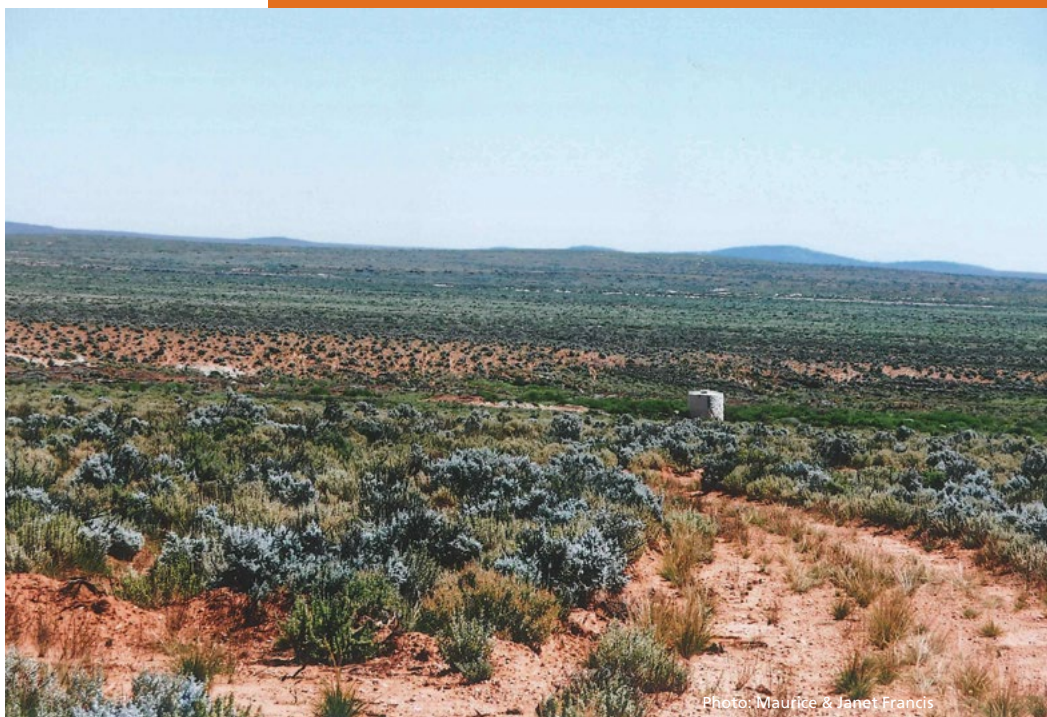
Other areas were furrowed to regenerate bush, with very good results. Bare land around a watering point was ripped to stop dust blowing and regrew very well. The photo above was taken in May 1983, the one below during a very good season in 2011.
