WILLOW SPRINGS

Recovering Eroded Land in SA's Pastoral Lands

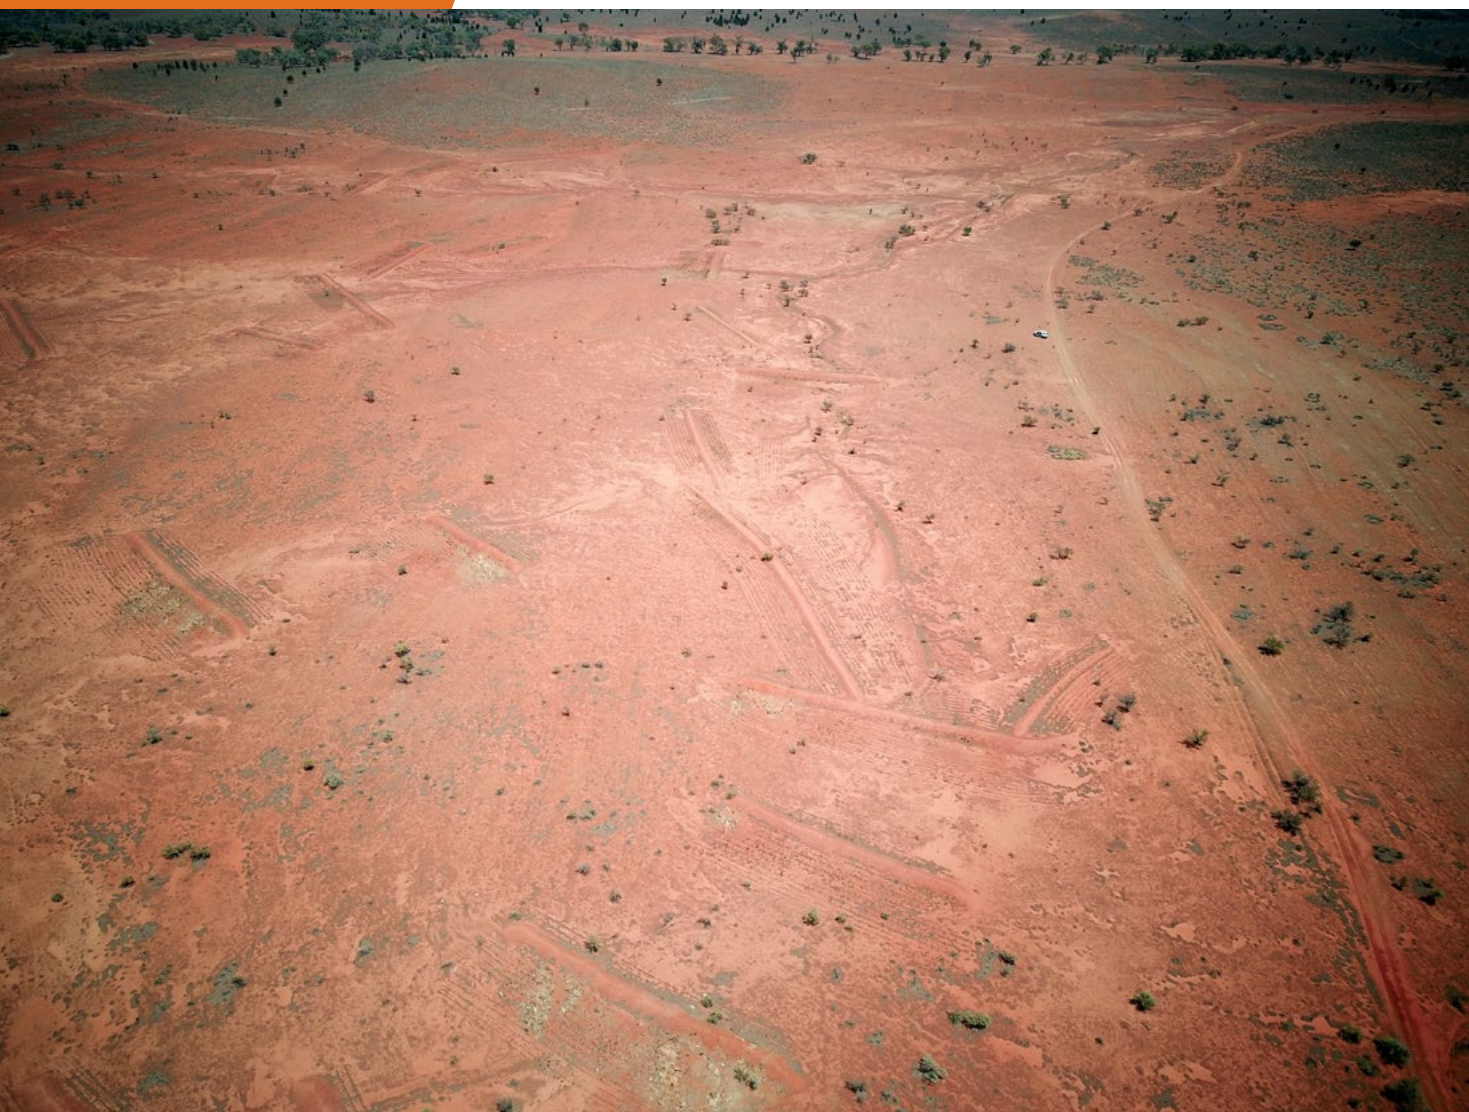
Aerial view of structures in Red Plain paddock. Water flows from the bottom of the picture towards the top right. Streams from culverts are intercepted by a bank which holds water in a sump. Overflow from the sump is directed to one side of the bank then towards another bank below. Banks around gully-eroded land in the middle area divert water onto gentle slopes where flows can spread out and move slowly down towards the watercourse. Eroded areas have been battered and ripped with bulldozer tines to slow flows and increase infiltration.

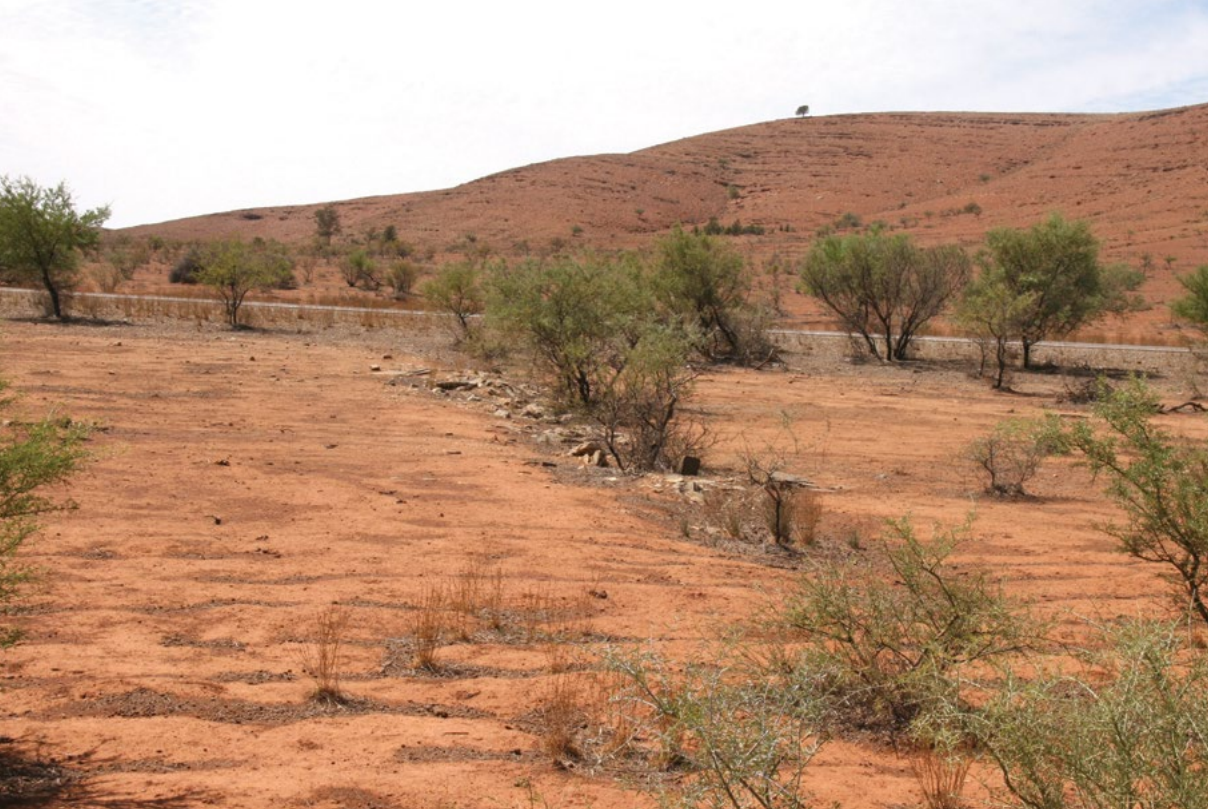
Culverts in the road concentrate water into a narrow stream that races downslope, causing erosion.

The 'Red Plain' paddock was chosen because it is one of the property's most productive paddocks and had the greatest potential for improvement. There was a significant area of bare land that shed water and had no productive value. Culverts in the road adjacent to the paddock were channelling runoff, accelerating its velocity and making it more erosive. It was considered that intercepting, diverting and spreading runoff would slow flows, improve infiltration of water into the soil and grow more plants.

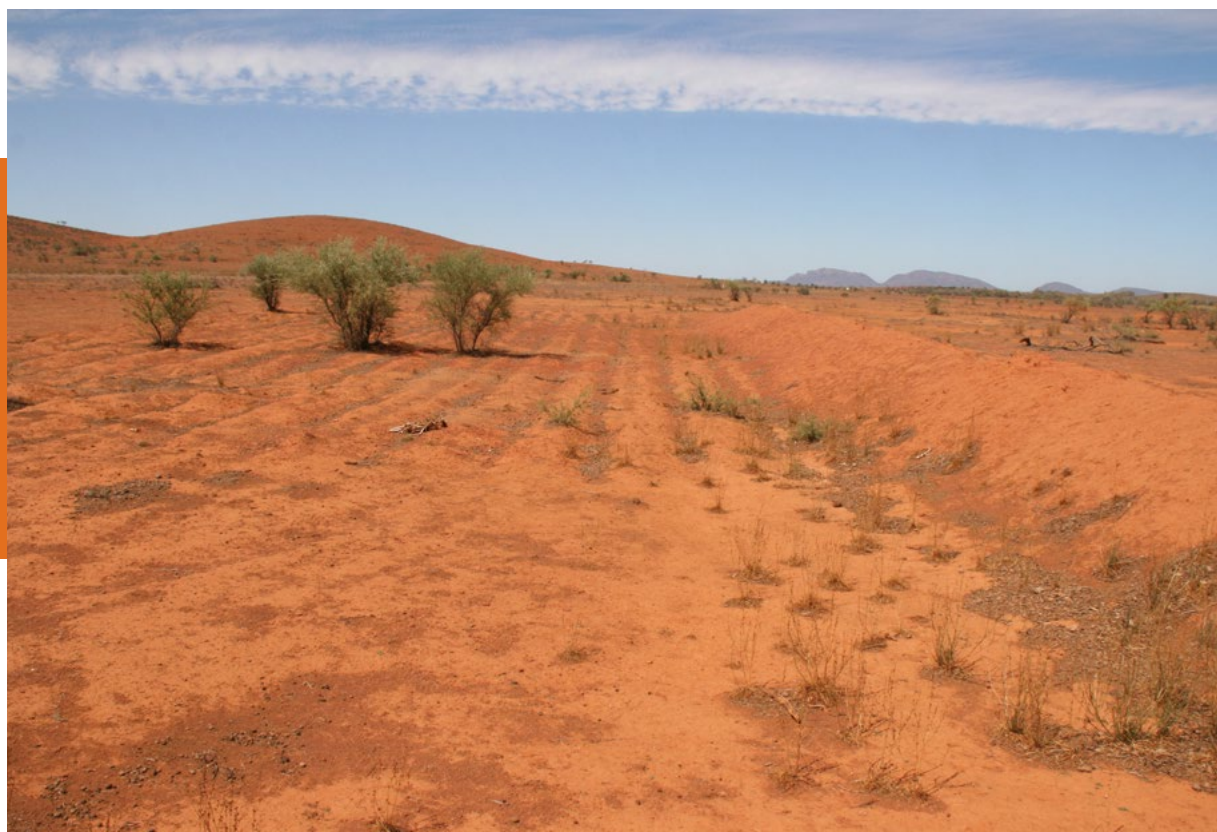
Sumps in front of diversion banks have been ripped to hold water, slow it down and allow it to soak into the soil.

Overflow from the sump flows via a wide, level sill at the end of the bank (foreground).

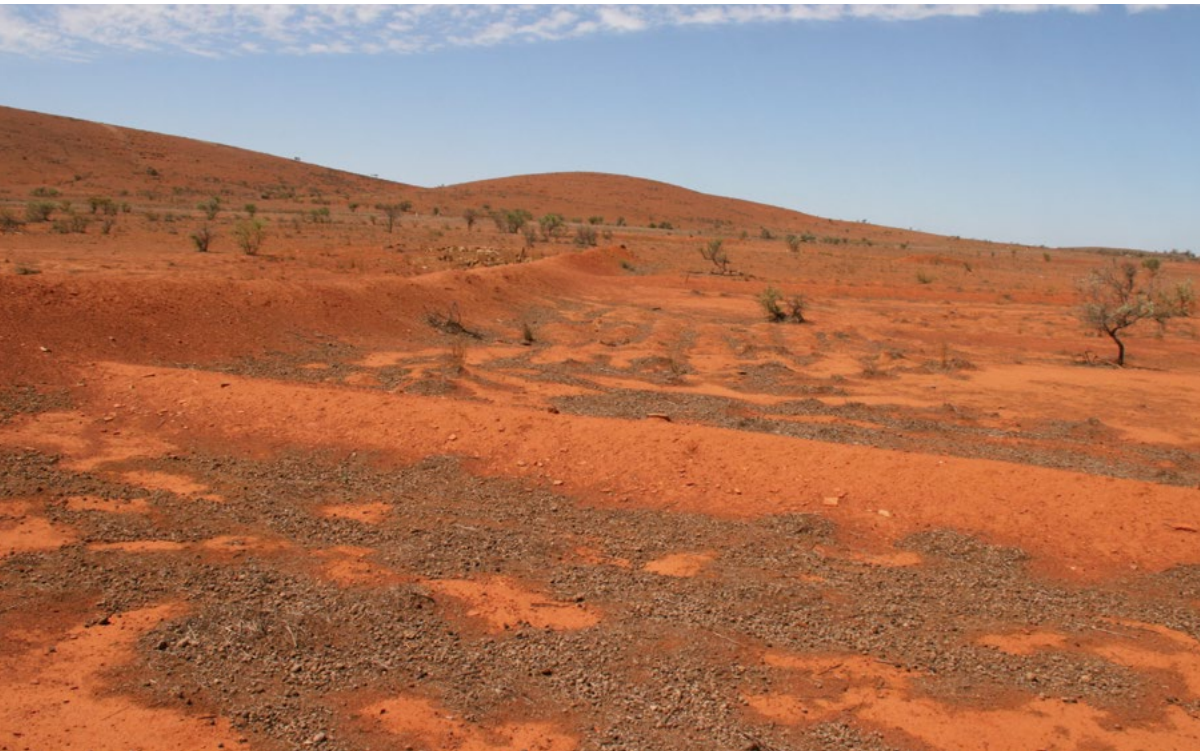
Runoff is diverted away from gullying watercourses by diversion banks above and to the sides of the gullies.

The erosion has been battered off and ripped to encourage infiltration of water and regeneration of plants.

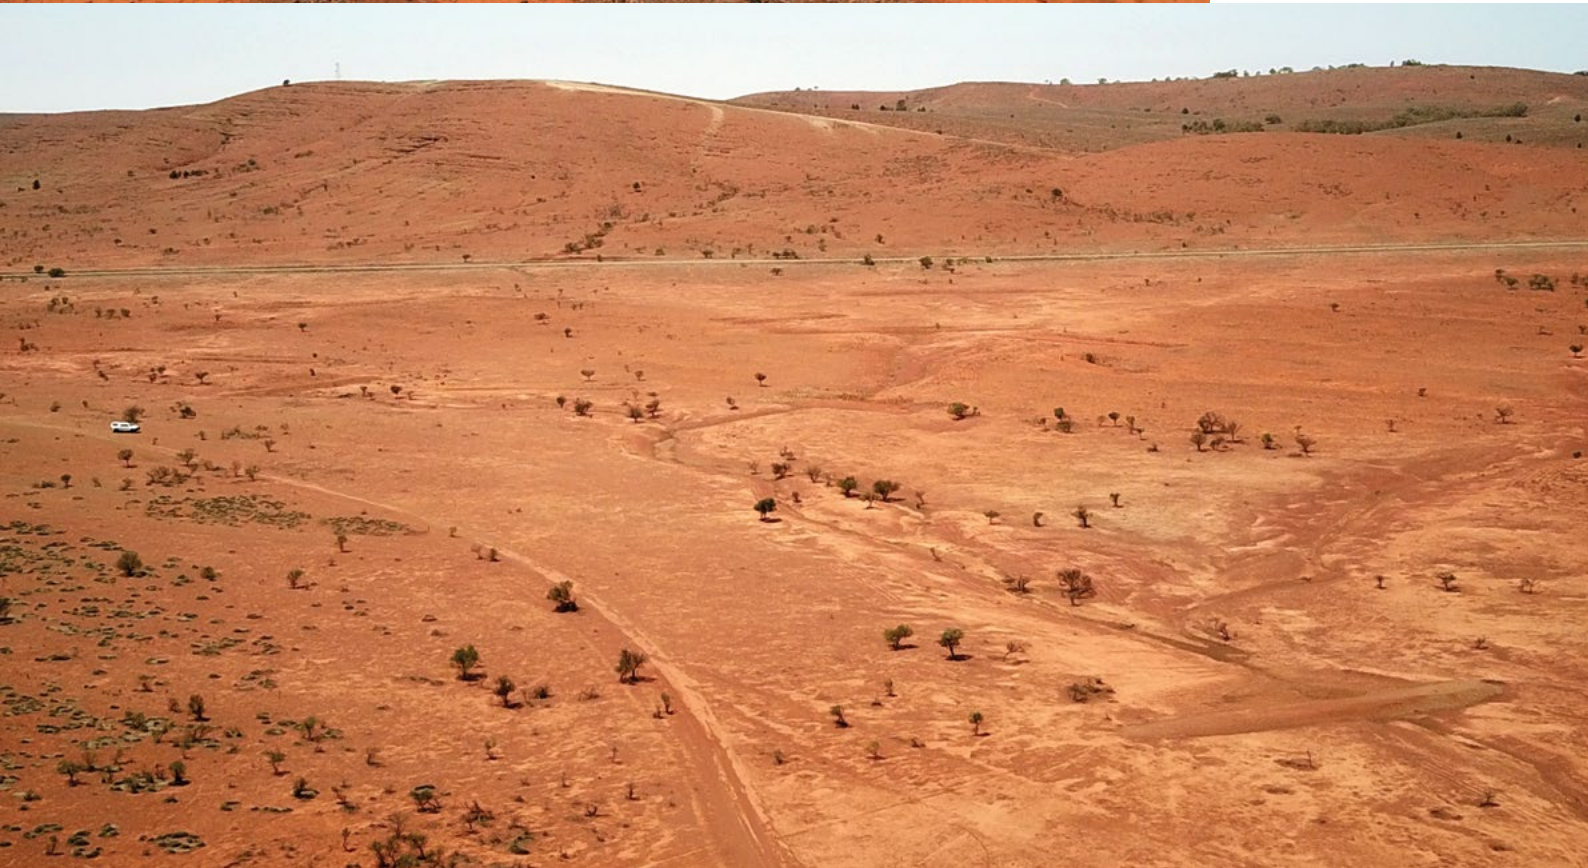
View of catchment looking from downstream towards the headwaters of the watercourses.

The road is in the mid-ground. The sparse ground cover reflects the drought conditions from 2017 to early 2019 when this photo was taken.

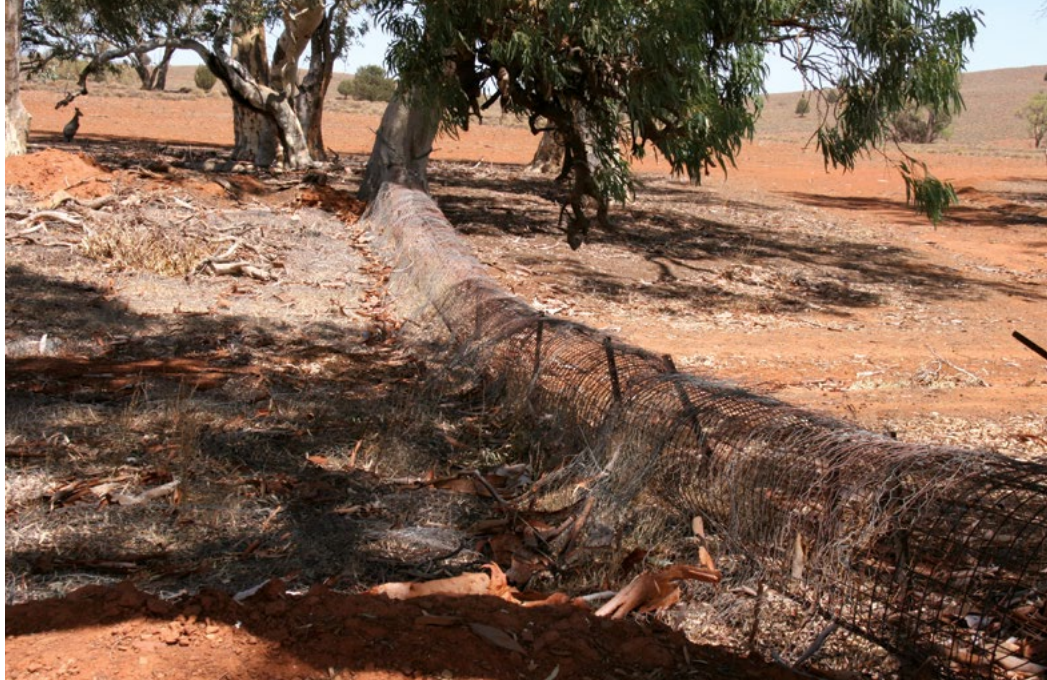
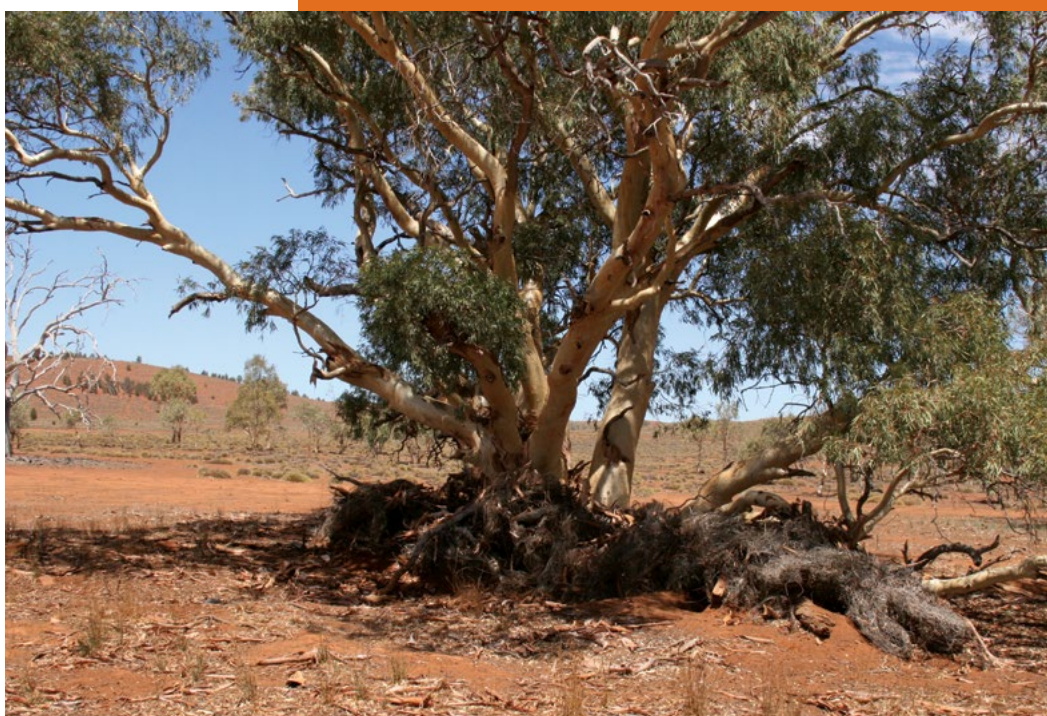
Debris traps constructed from mesh (above) and old fence material (below). Leaves and sticks have collected above the cylindrical barrier. Widening the breadth of the flow through the barrier has levelled out the watercourse downstream, which previously was a series of small ruts and channels.

Debris traps have been made in watercourses in two places to help slow and spread flows in the watercourses. One was made using wire mesh to form a cylindrical barrier that trapped sticks and leaves while allowing water to pass through the barrier. It was pegged down with iron droppers to ensure it did not float on top of flows or be washed away. The other was made from old fencing material, positioned around a tree in a watercourse.
