## WIRREALPA

# Recovering Eroded Land in SA's Pastoral Lands

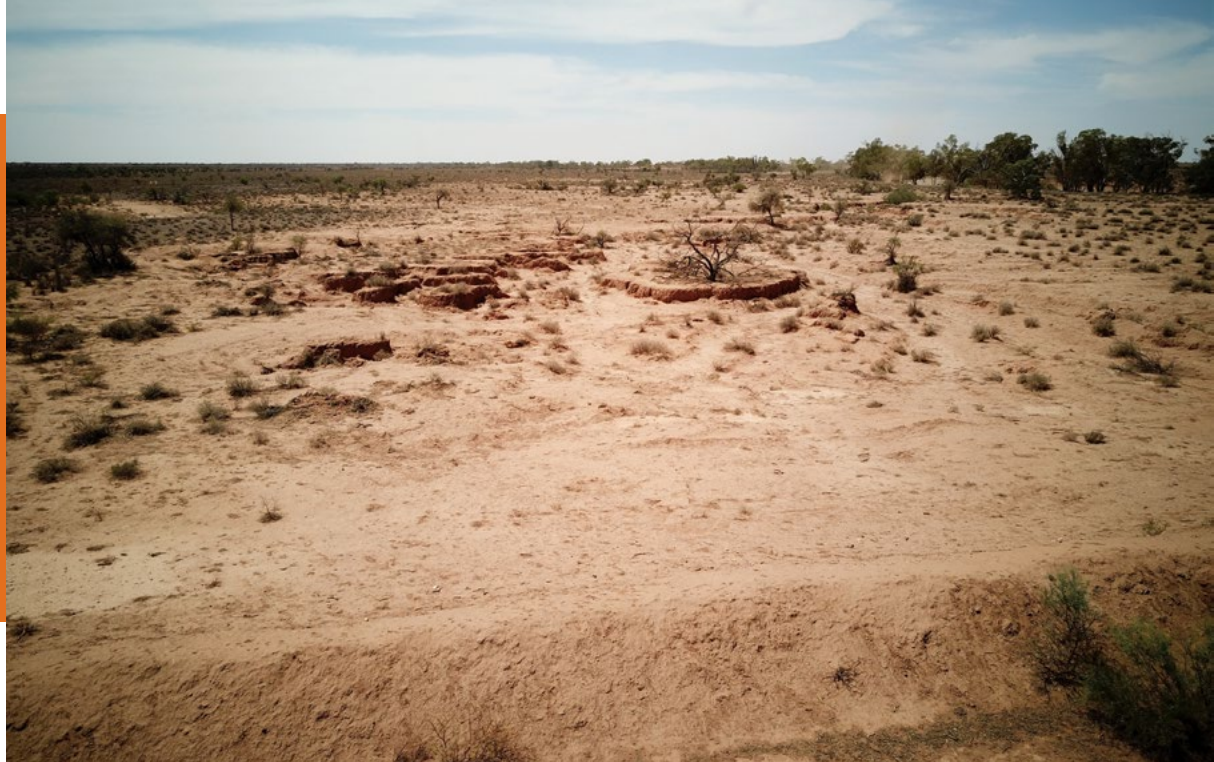
The bank in the foreground intercepts surface flows and diverts them to the left of this picture, away from gullying land near the creek. A sump in front of the bank holds and slows water; it has been ripped with bulldozer tines to increase infiltration of water into the soil.

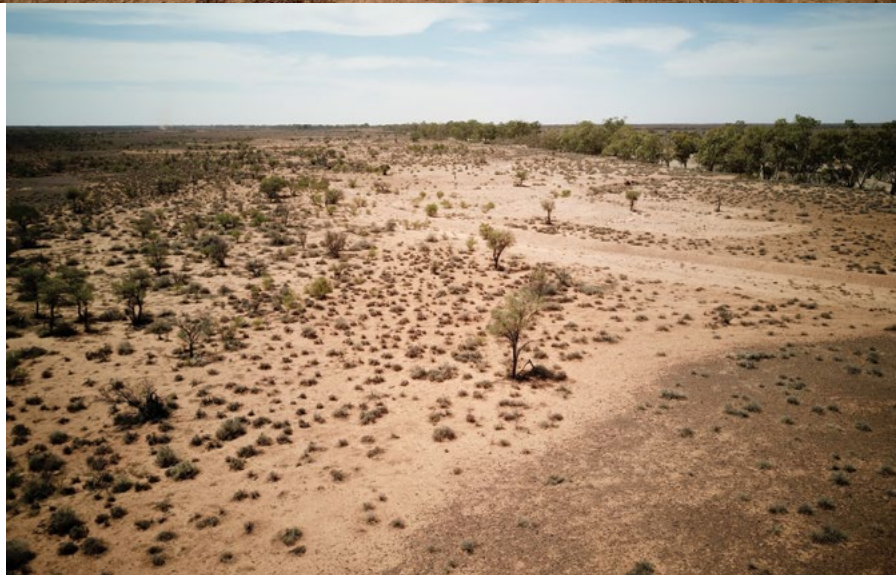
Aerial view of first (western-most) bank near Balcoracana Creek. Gullies behind the bank have been battered and levelled to encourage regrowth. Flows are directed towards open, well-vegetated land to the left hand side of the picture.

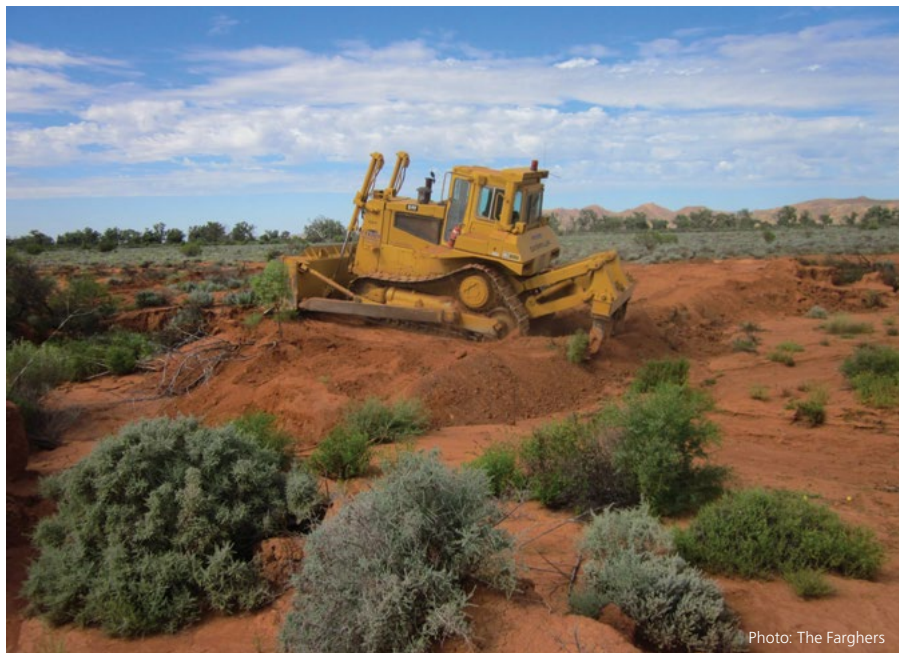
Building a diversion bank above a gully head near Little Belcrackna Creek. All construction work was carried out with a bulldozer and a grader.

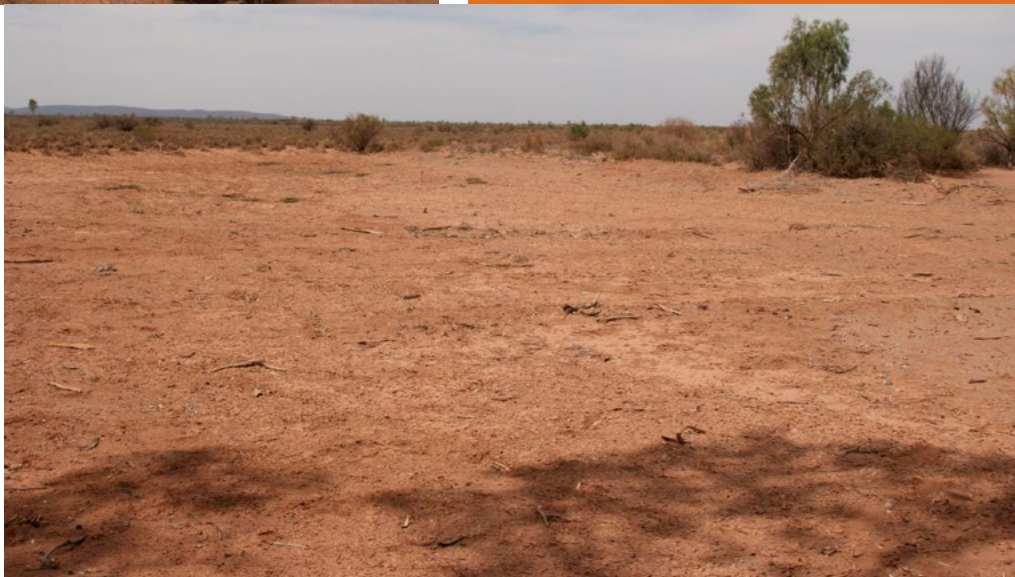
Level channels have been graded to spread flows from the Little Belcrackna Creek onto adjacent open country. Water will fan out, slow down and soak into the soil.

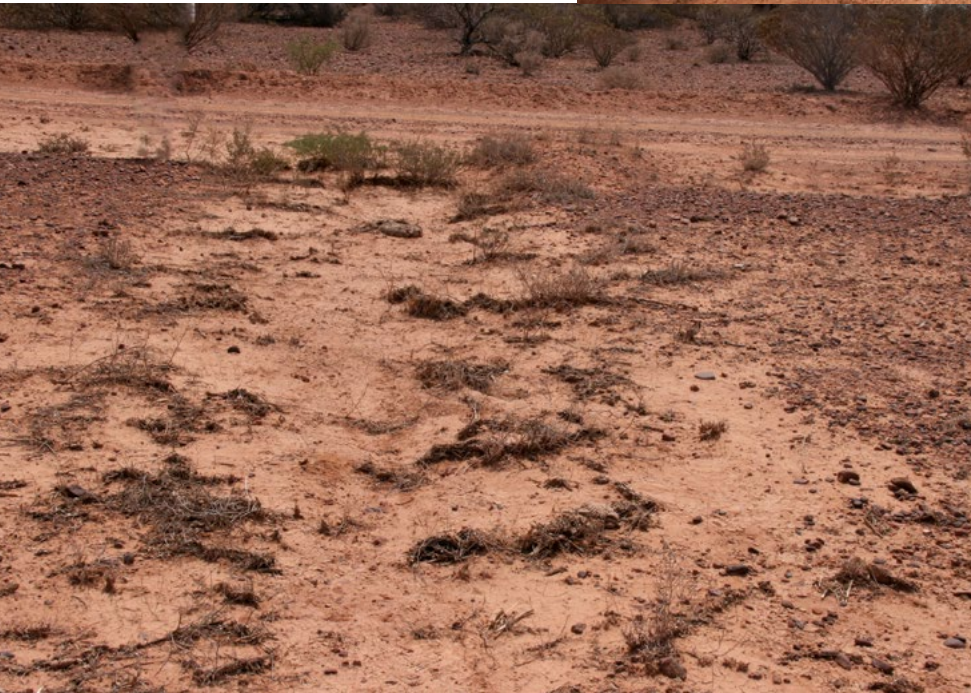
Runoff along the road is intercepted by small bank that directs flows onto a wide channel on adjacent land.

In various places on the property, small structures and treatments are used to slow water flows and hold the water on areas where it can soak into the soil and boost plant growth. Furrowing and pitting is used on bare areas to encourage regeneration of plants. Runoff from roads is diverted into wide, level channels that slow and spread the flows onto gently sloping adjacent lands.

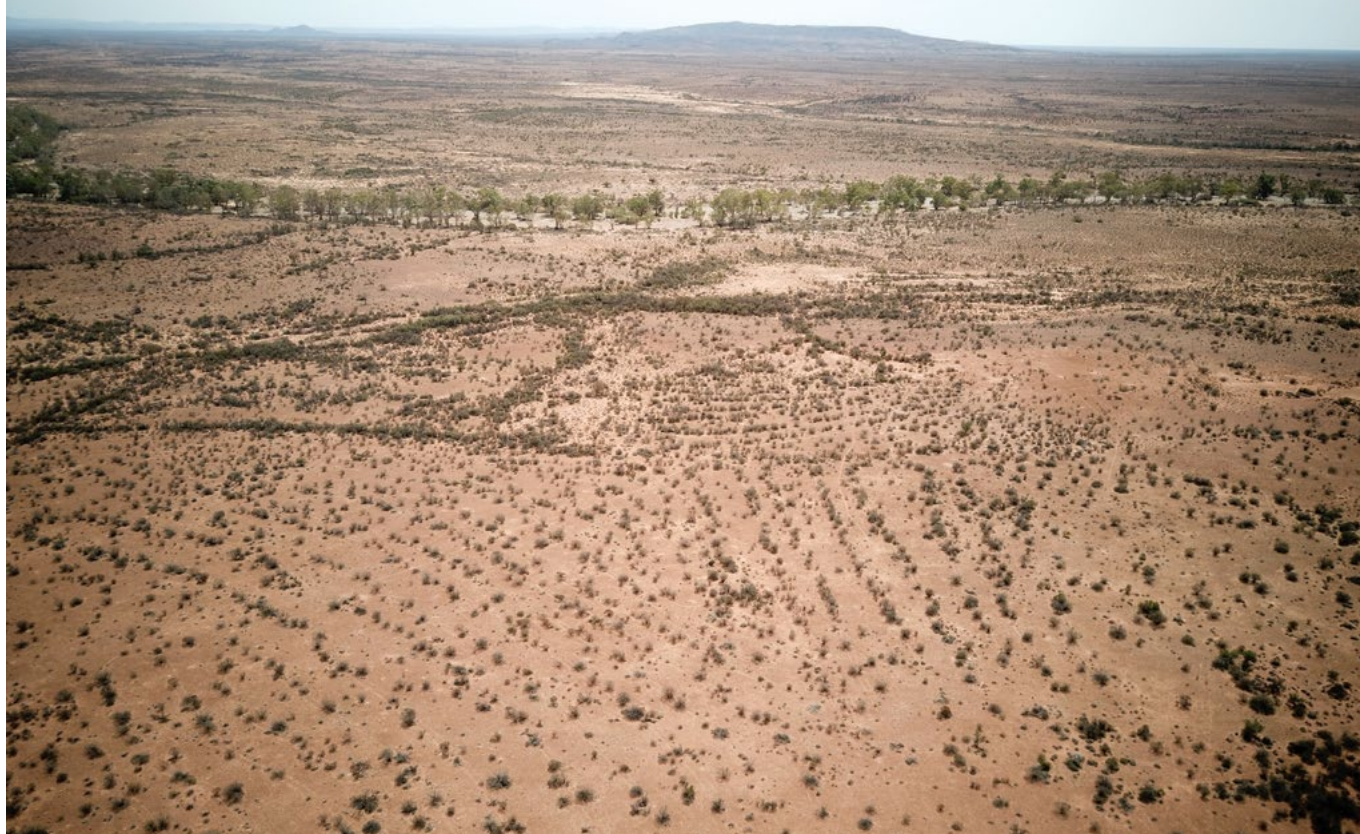
Aerial views showing regeneration of bush on land that has been furrowed. Most of the bushes have grown along rip lines.
