Hydrological assessment and analysis of the Cooper Creek Catchment, South Australia

HYDROLOGICAL ASSESSMENT AND ANALYSIS OF THE COOPER CREEK CATCHMENT, SOUTH AUSTRALIA

Report to the South Australian Arid Lands Natural Resources Management Board

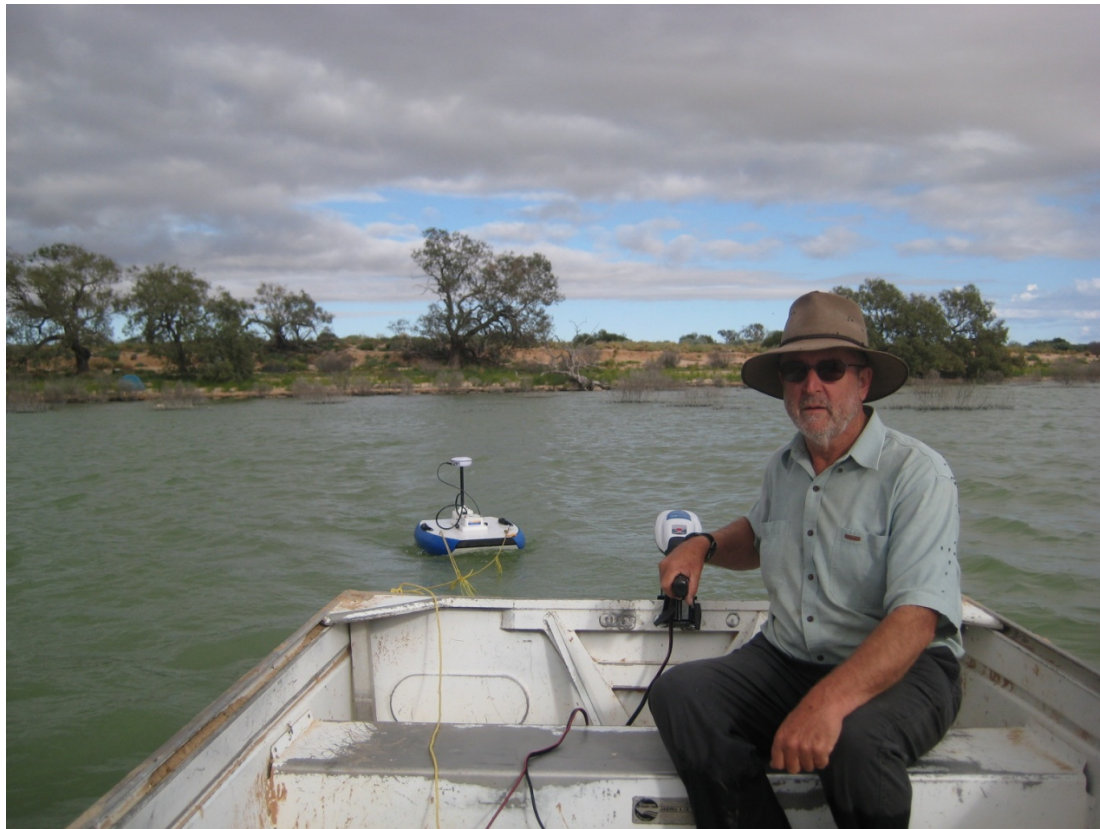
Figure 2. Top photo shows conducting a bathymetric survey at Lake Hope.

Using a boat supplied by Gary Overton and the ADCP being slowly towed behind the boat. The bottom panel shows the longitudinal profile data from the ADCP survey of the downstream half of Cullyamurra Waterhole. Typically, the ADCP is zig-zagged across the waterhole to capture as much bathymetric information as possible.

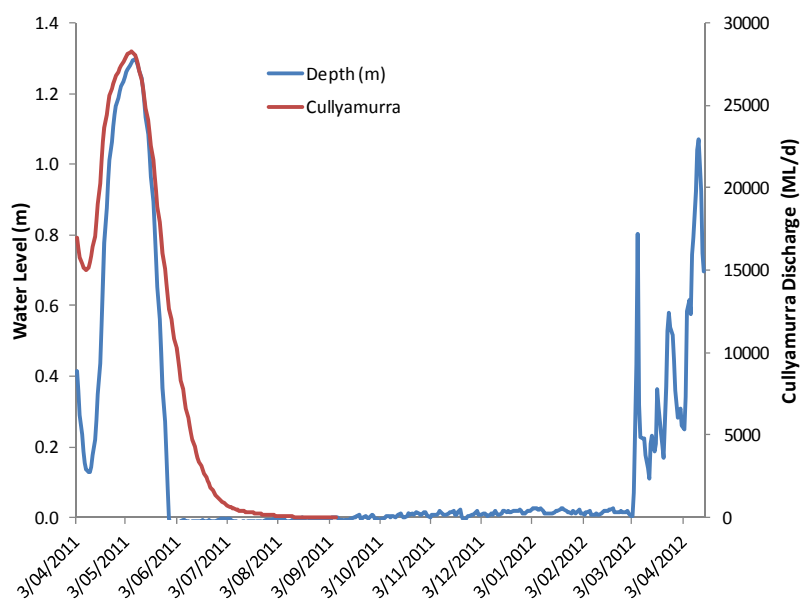
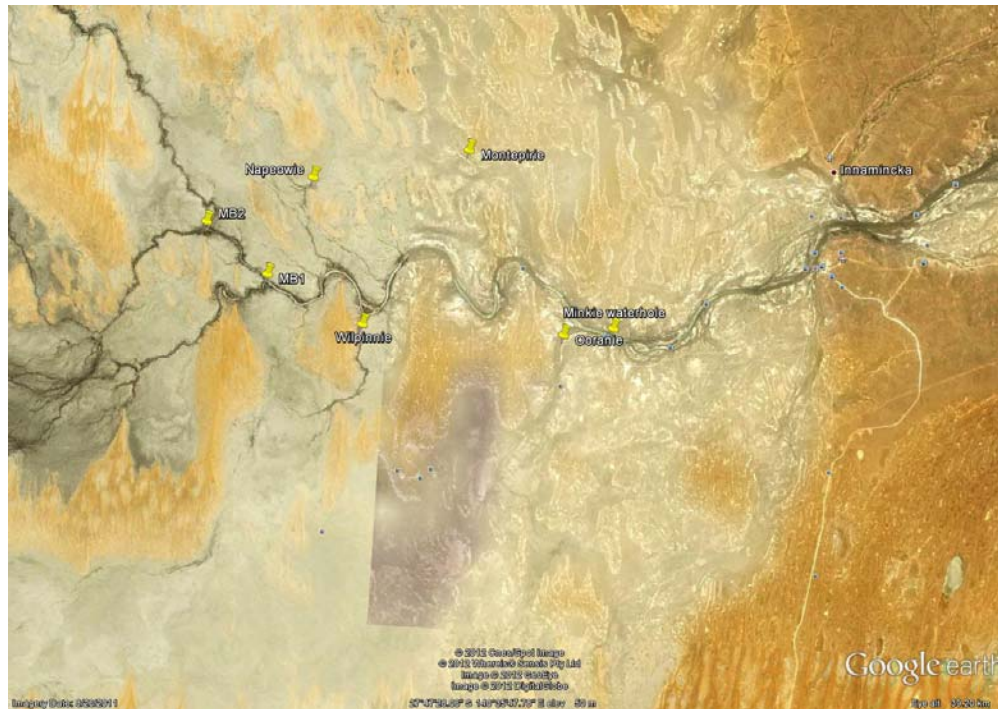
Figure 5. Hydrograph of Cullyamurra discharge compared to water level data recorded at Munga Munga Waterhole on Wilpinnie Creek.

Google Earth image shows locations of loggers at Wilpinnie Creek and Ooranie Creek.

(within two days) of the Cooper flow (measured at Cullyamurra) and the Wilpinnie Creek logger (Figure 5) indicate that the flow threshold for inflow to Wilpinnie Creek is lower than previously estimated but that this flowpath up to at least Munga Munga Waterhole acts as a backwater to Cooper Creek. The recession of water from Munga Munga Waterhole was very rapid and water levels dropped by approximately 2.6 m between April and November 2011 (Figure 5) which significantly exceeds the expected open water evaporation rate of 0.96-1.24 m for this period. This indicates that backflow into Cooper Creek occurred in this period. There was no evidence of significant flow past Munga Munga Waterhole in 2011. So, even though flow into Wilpinnie Creek was occurring at discharges of approximately 16,000 MLd⁻¹, the water appears to have flowed back into Cooper Creek during the recession of the flow and the threshold for flow in Wilpinnie Creek to flow south from Munga Munga Waterhole exceeds the peak discharge of the 2011 floods and is probably >40,000 MLd⁻¹.

The second water level logger was installed in Ooranie Creek which exits Cooper Creek upstream of Tilcha Waterhole (Figure 5). The channel contained some water in April 2011 and it was not clear if this was due to previous flow from Cooper Creek or local inflow. Unfortunately the logger was damaged by cows or dingos and went out of action on 29/07/11. The April to July record did not show any evidence of connection in response to the 2011 flows in Cooper Creek and so it appears the threshold is greater than the peak discharges of 2011 (e.g. >36,000 MLd⁻¹).

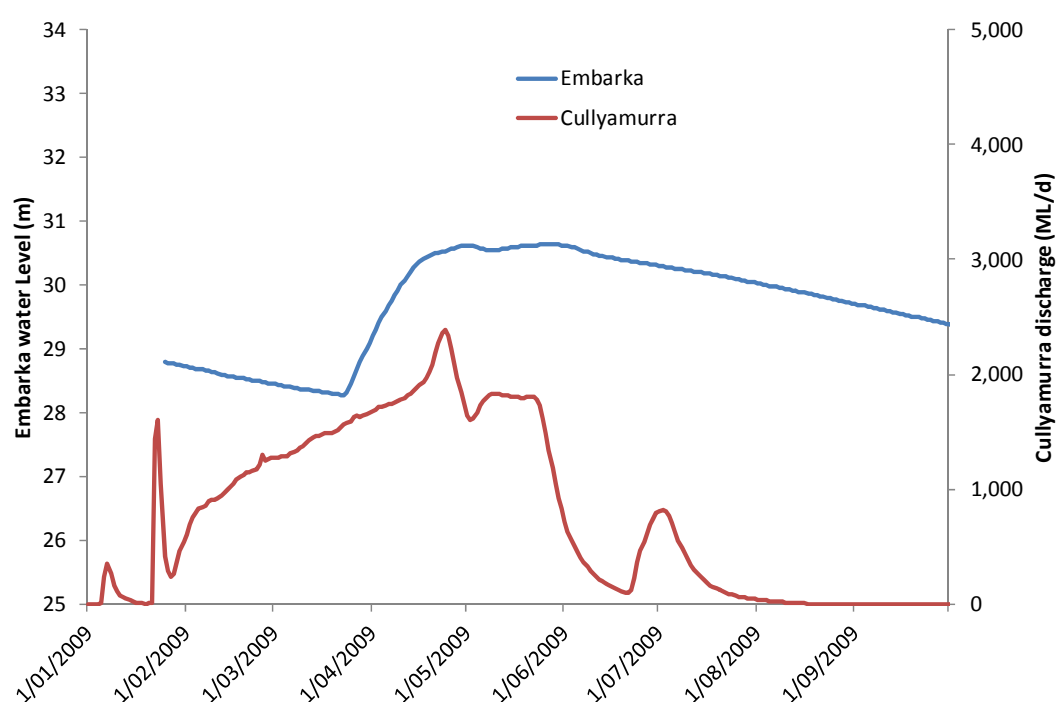
Figure 6. Top- Distribution of flow between the Main Branch and Northwest Branch during flow events in April 2011 and 2012. Bottom (next page) – hydrograph of water level at Embarka Waterhole and discharge at Cullyamurra during 2009

(first year of data from the SANTOS logger at Embarka Waterhole) started 78 days after flow commenced at Cullyamurra Waterhole, indicating that a flow threshold into the Main Branch occurs. This indicates that the threshold could be approximately 1200 MLd^{-1} at Cullyamurra (flow exceeded this threshold for 28 days prior to inflow to Embarka Swamp). In 2012, flow commenced into Embarka Waterhole 26 days after flow commenced through Cullyamurra and 17 days after the 1200 MLd^{-1} threshold was reached at Cullyamurra. It is likely that a combination of discharge threshold and total volume is required to get flow into Embarka Waterhole, i.e. significant flow could be stored upstream of Embarka Waterhole in the Main Branch before flow commences into Embarka Waterhole (see Google Earth image in Figure 6).

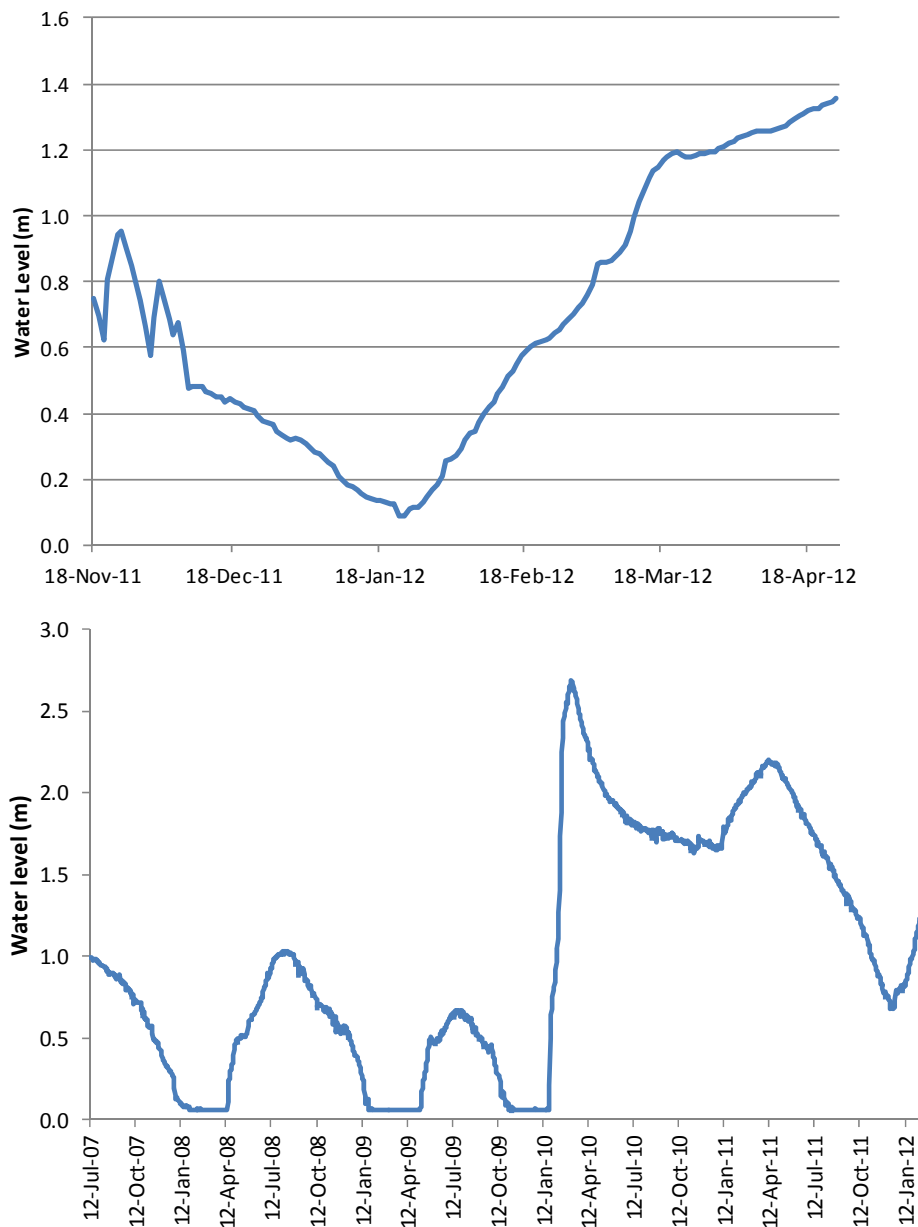
Figure 8. Water level recorded at the Northwest Branch near Coongie Lake (top panel) and at Ellar Creek near the inflow to Lake Goyder (bottom panel).

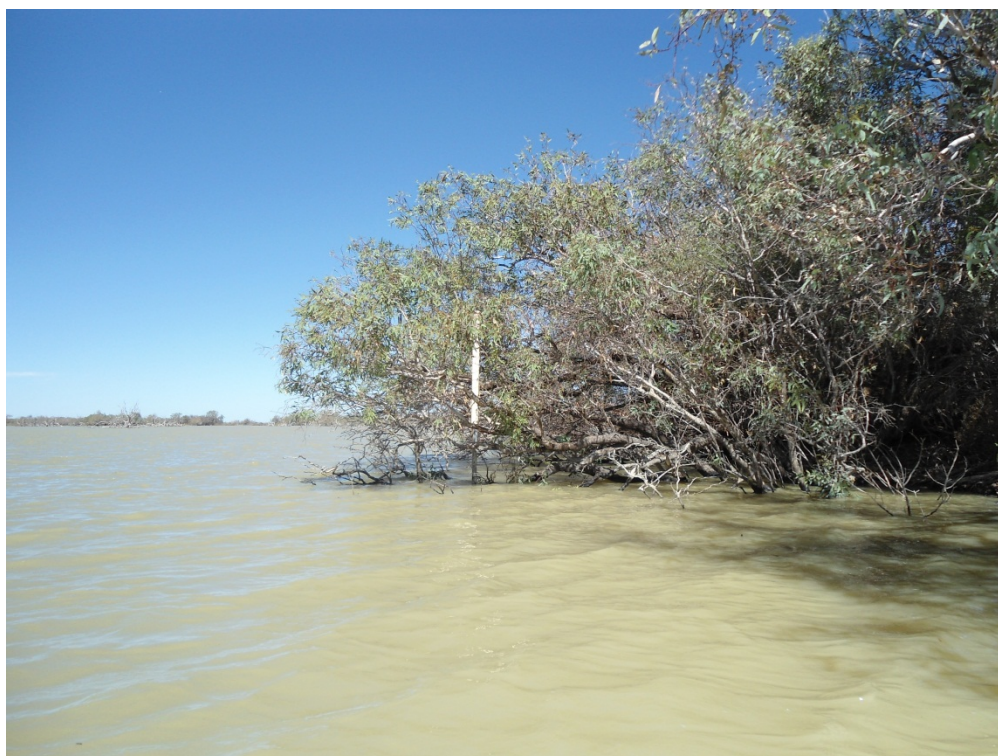
Figure 9. The logger position at the mouth of Ellar Creek and Lake Goyder.

This logger measured data from July 2007 until February 2012 without a change of battery or download. This location provides the most comprehensive record of events in the Coongie Lakes,

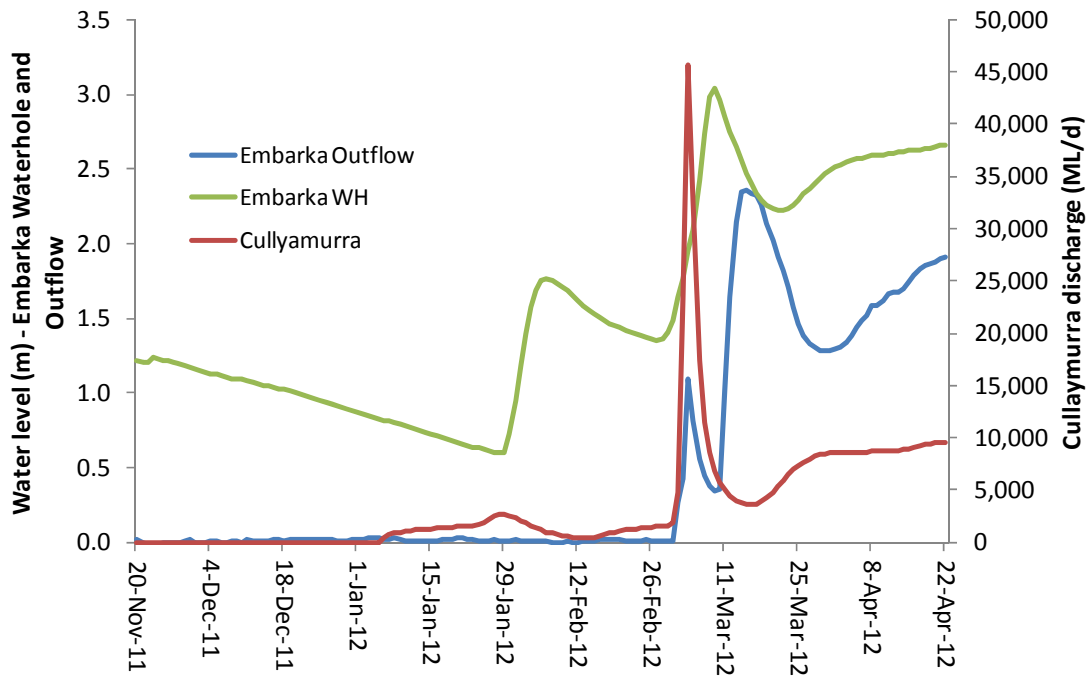
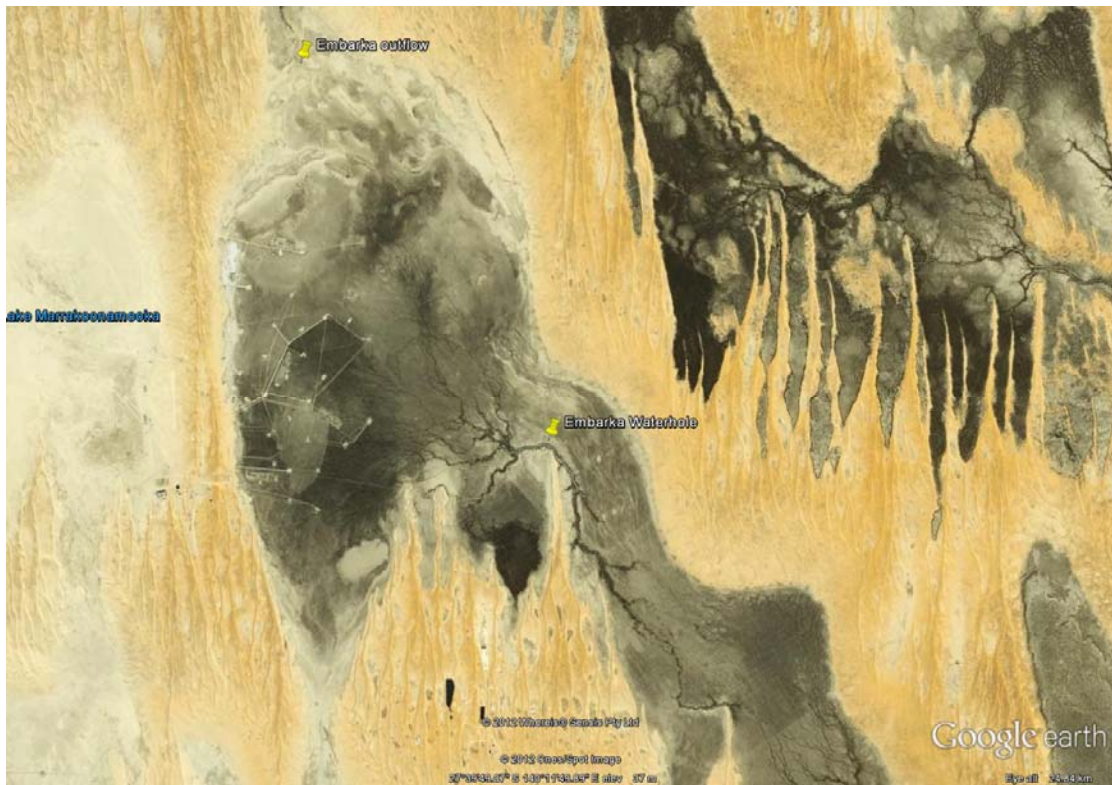
Figure 10. Top panel shows water level hydrograph at Embarka Waterhole (SANTOS) and Embarka outflow channel (old Moorari bridge) and discharge hydrograph at Cullyamurra gauging station. Bottom panel is a Google Earth image of Embarka Swamp showing location of Embarka Waterhole and the Embarka outflow logger.

Note the substantial built infrastructure downstream of Embarka Waterhole.

Given the amount of oil-gas production infrastructure in the Embarka Swamp area (see Figure 10), it is important that these structures do not impede the natural patterns of flow and storage in this area, and particularly for flow out of Embarka Swamp. Given the lack of channelization in the Embarka Swamp downstream of Embarka Waterhole, this area would be the most vulnerable to inadvertent changes in flow patterns from infrastructure and this could have substantial effects on the frequency of flow of the waterbodies on the Main Branch.

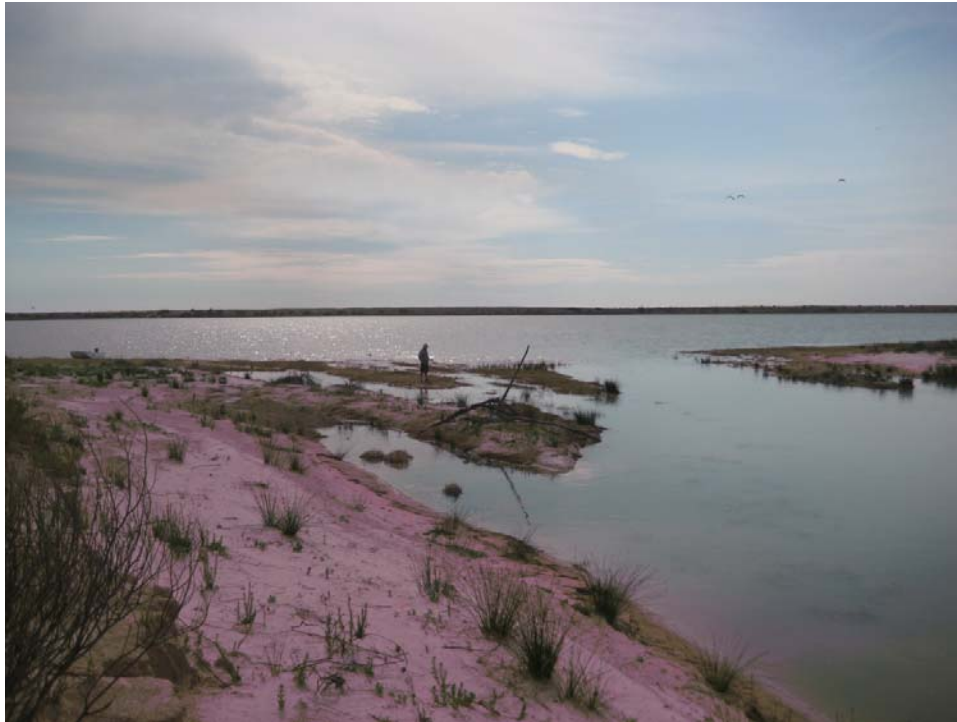
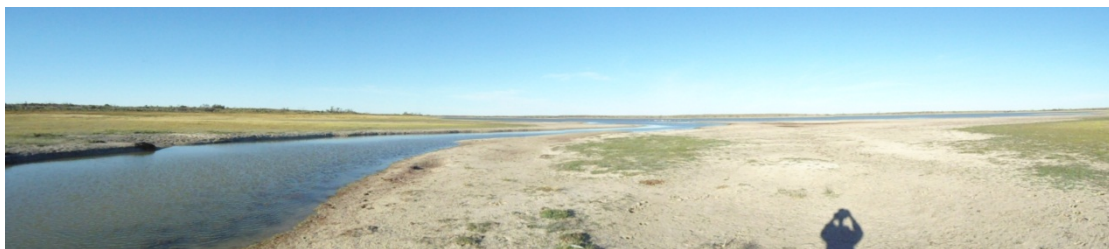
Figure 13. Google Earth image (top) showing inflow and outflow points for Lake Appadare. Middle photograph shows low level outflow channel from Lake Appadare in November 2011 and lower photograph shows Lake Appadare inflow channel under no flow conditions in April 2012.

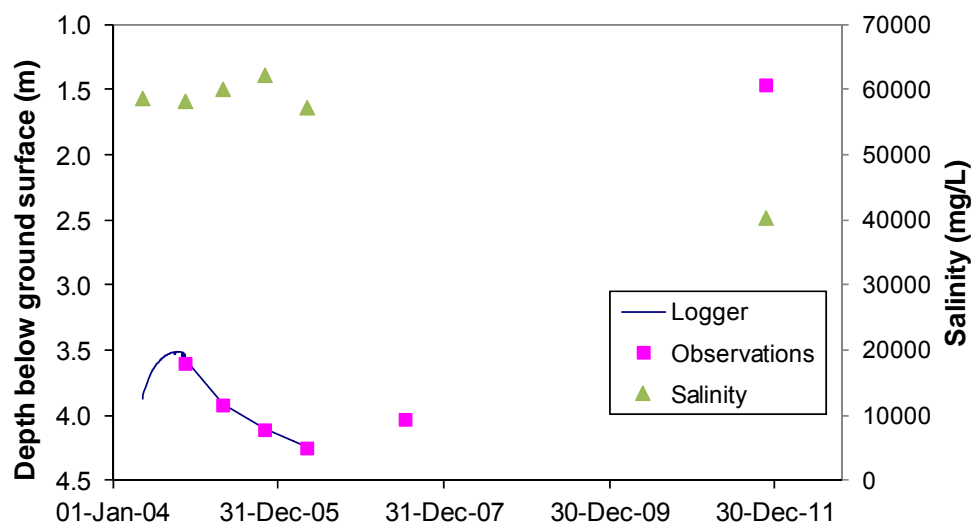
Figure 14. Upper panel shows unconfined groundwater level fluctuations from a monitoring bore located approximately 100 m north of the Lake Toontoowaranie riparian zone.

The blue line is from a logger and the purple squares show manual measurements. The lower panel shows a Google Earth image of Lake Toontoowaranie and the position of the monitoring bore.

ability of the riparian Eucalypt species to extract soil water for transpiration. This is illustrated using data from a monitoring bore located approximately 100-200 m from the northern riparian fringe of Lake Toontoowaranie (Figure 14). During the November 2011 field-trip, this monitoring bore was accessed and showed that the unconfined groundwater was significantly shallower and only moderately less saline compared to the 2004-2007 period, probably in response to recharge from the 2010 flood. The rise of highly saline groundwater (slightly more saline than seawater) to depths of around 1.5 m below the ground surface is likely to have significant effects on the riparian and floodplain vegetation distribution.

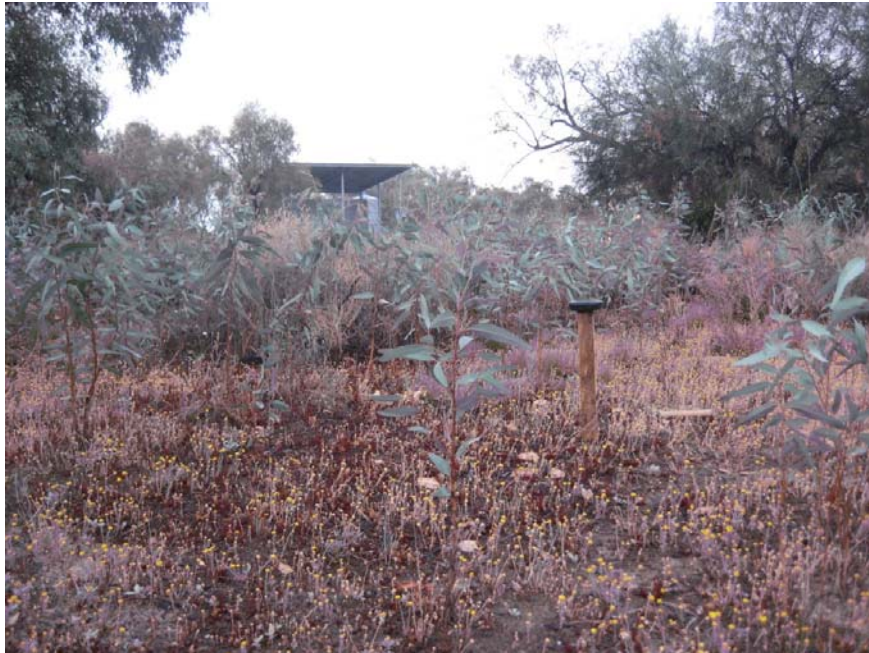
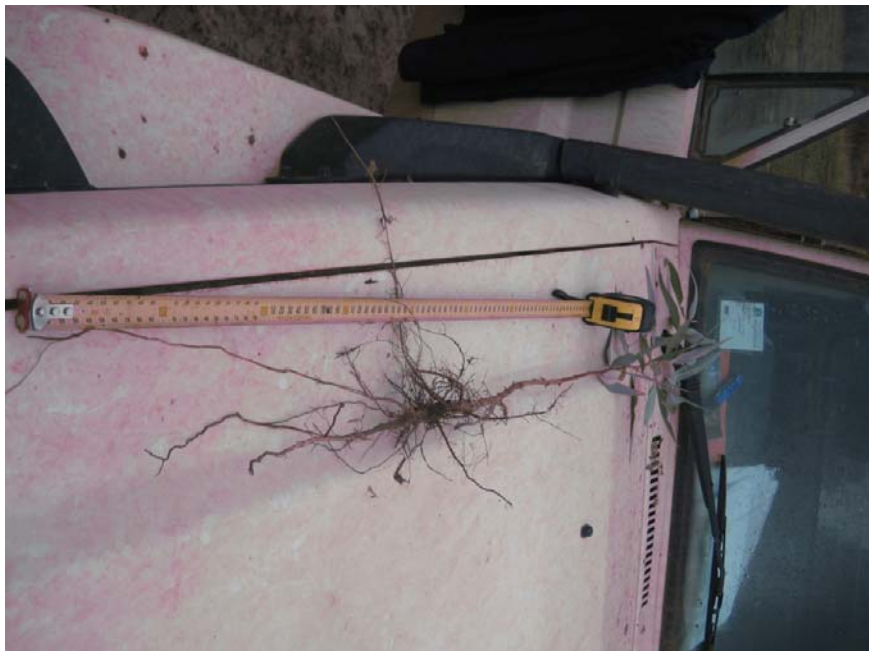
Figure 15. Top photo shows cluster of eucalypt seedlings (could be red gums or coolibahs) growing at the Northwest Branch windmill site. Bottom photo shows the extensive root system put down by these seedlings with the root length being equal to or longer than the seedling height.

- There has been a major regeneration event in response to the 2010 flood. *Eucalyptus* seedlings were commonly observed throughout the study reach (see example in Figure 15), including locations on the Northwest Branch, Main Branch and lower Cooper (at least as far as Gywdir's Crossing waterhole). The small size of the seedlings (typically 0.1-0.75 m high in April 2011) is consistent with germination in response to the 2010 flood. This regeneration event is likely to be highly significant for successful recruitment of riparian eucalypt species in the catchment.

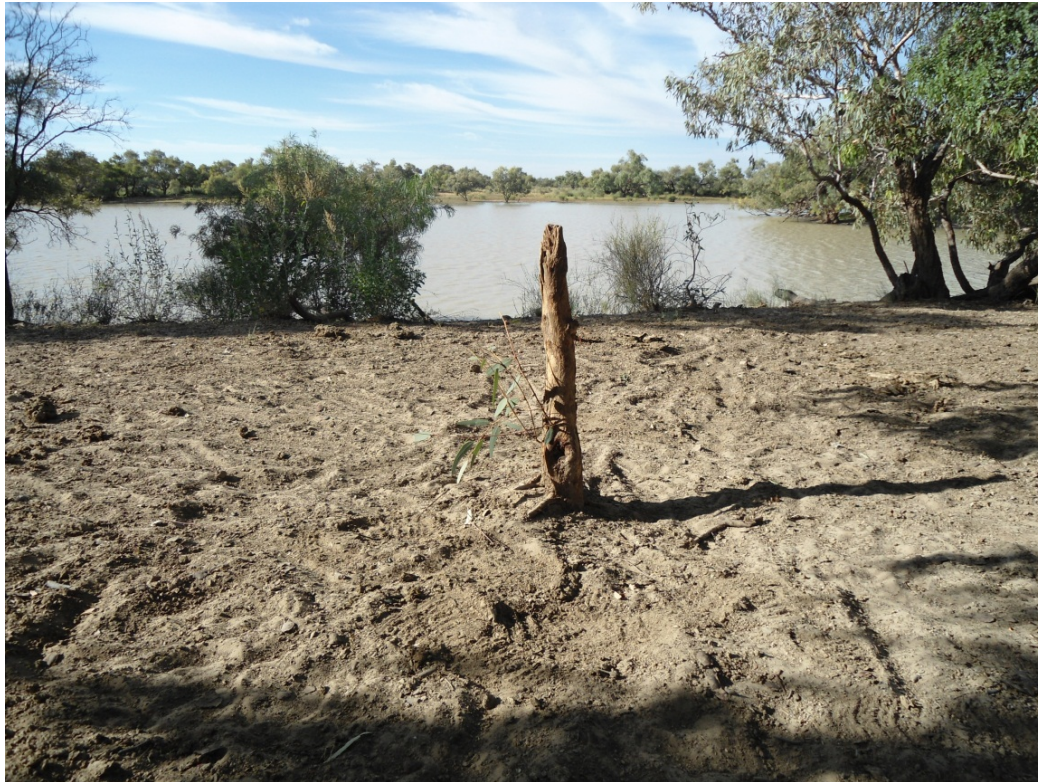
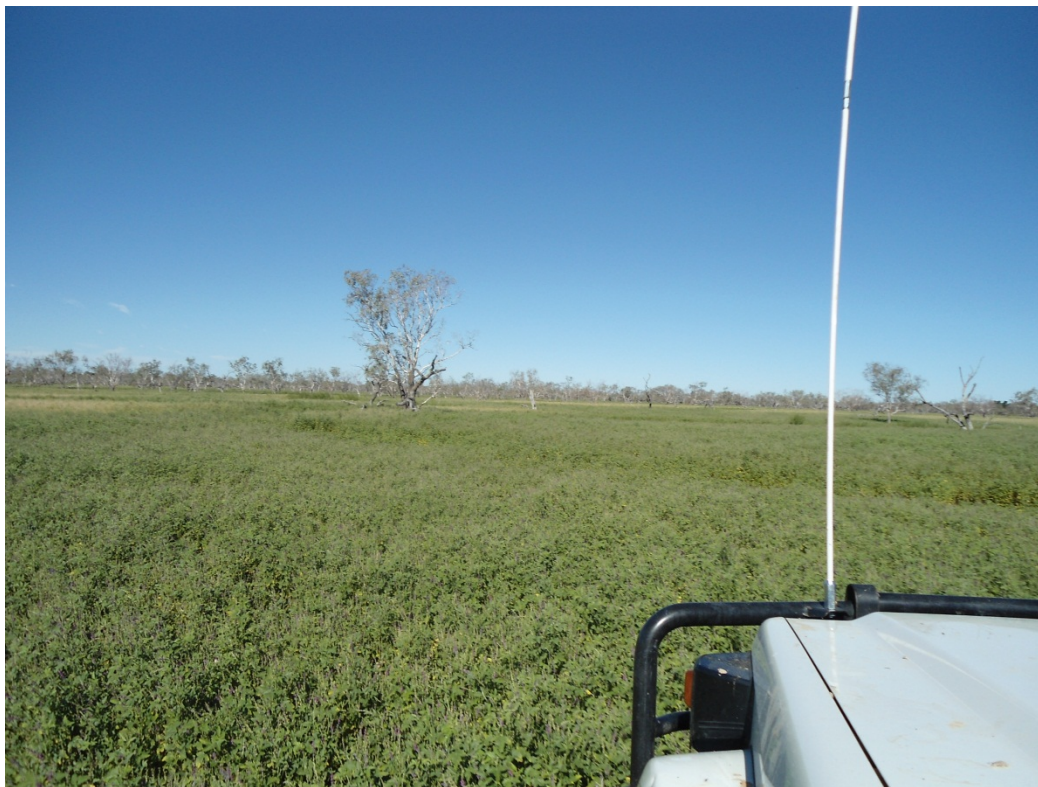
Figure 16. Top photo shows an example of the remarkable regeneration capacity of coolibahs – epicormic growth on a near-dead coolibah stump. Bottom photo shows the spectacular herbaceous growth on the floodplain surrounding Lake Dare (Coongie Lakes) in response to flooding and rainfall during 2010-2012.

- The remarkable toughness and capacity for grazed or damaged coolibahs to regenerate (to some degree) is shown in Figure 16. At a floodplain waterhole on the Northwest Branch, a near dead stump of coolibah, which has been

used as a rubbing post by cattle, shows some epicormic growth in response to the sequence of wet years from 2010-2012.
