# Recovering Eroded Land in SA's Pastoral Lands

## TODMORDEN

Marla - Oodnadatta

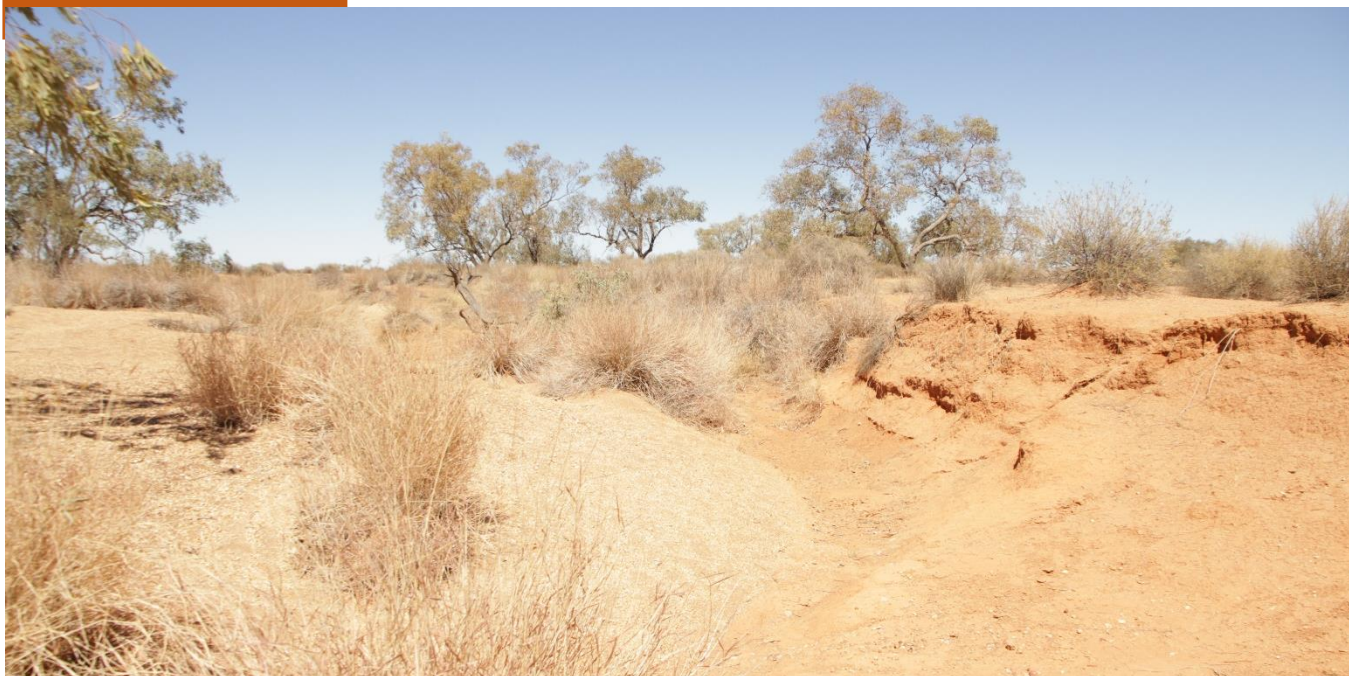
Reid's paddock site was being drained of water through expanding gully heads, damaging the sustainability of the ephemeral swamp

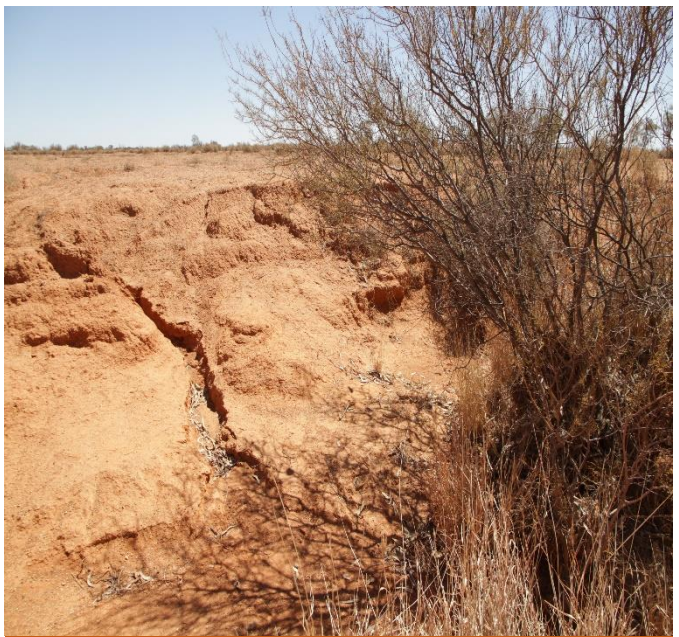
A gully head marching straight up the animal pad was sucking water out of the swamp and draining the landscape every time it rained.

Gully erosion in Reid's paddock creek causing the drainage of important water from the landscape.

With the site secure, work began at Reid's Paddock, where gully erosion was causing the draining of important water. A bulldozer was used to remove the gully head and build contour and check banks to address the problem.

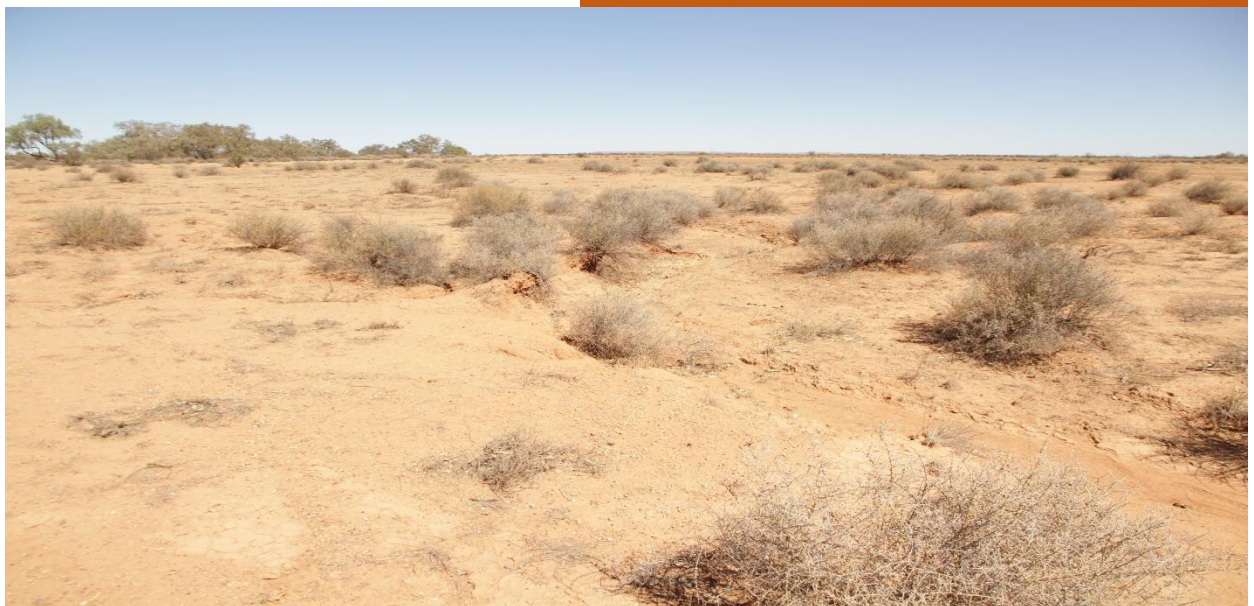
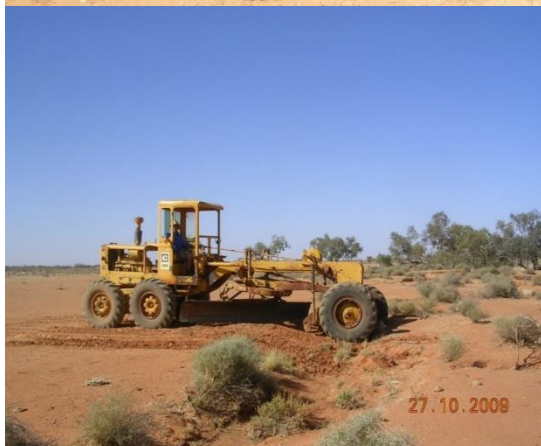
Reid's Paddock - Installing check banks below top contour bank and a gully head being addressed

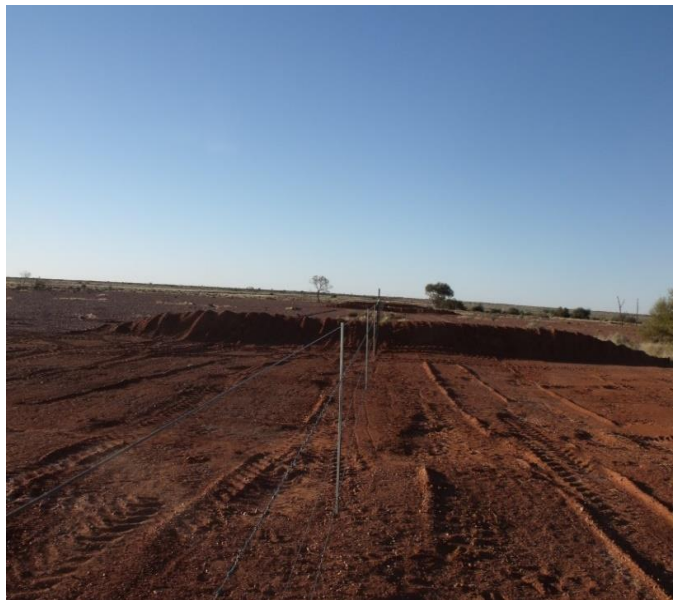
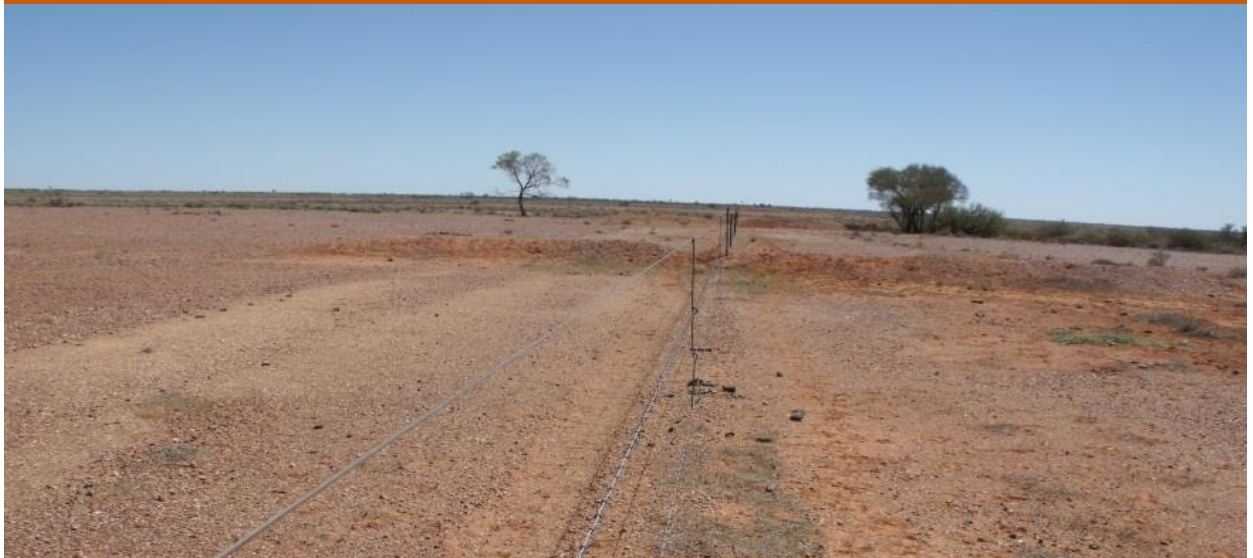
The Mary's Well site had similar issues, with water exiting the landscape too quickly due to animal pads and erosion processes, which altered the flow of overland run-off.

**Mary's Well – Check banks were built in 2010 (above). In 2014 (below) the banks remain, however cattle padding had created weaknesses. Douglas and his team are able to maintain them to ensure flow across the land.**

Check banks were built at the site in 2010, however cattle padding created weaknesses. Having learned from the first project, Douglas and the Todmorden staff were able to repair and maintain the banks to ensure water flows across the land.

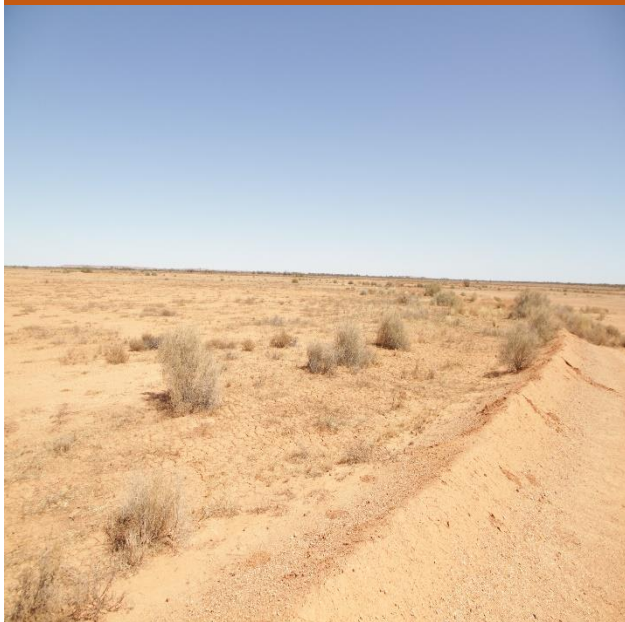
**Banks were created to encourage water flow**

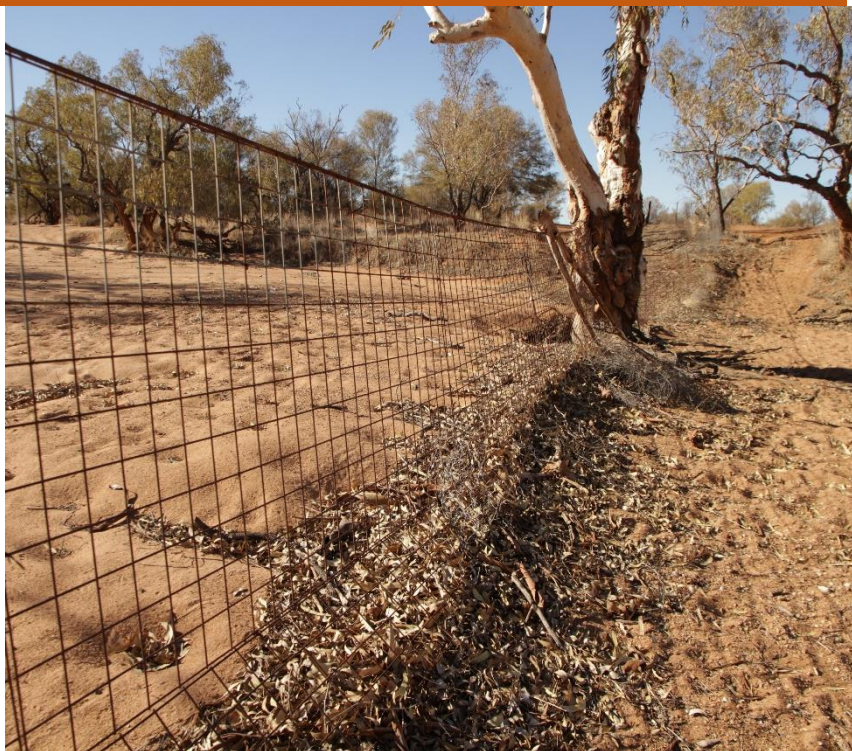
**Swing Filter at Alberga Creek (2019)** The purpose of the swing filter is to slow the flow of water in the creek and to minimise fence damage after flooding events.

Swing filters were placed across boundary fences and Kruse's Dam was fenced off, to allow better stock control. Dam water is pumped into a storage tank and cattle drink water from a stock trough, located within a trap yard.
