**Government of South Australia**  
South Australian Arid Lands Natural  
Resources Management Board

May 2011

# Geomorphological assessment and analysis of the Neales Catchment

Gresley A. Wakelin-King

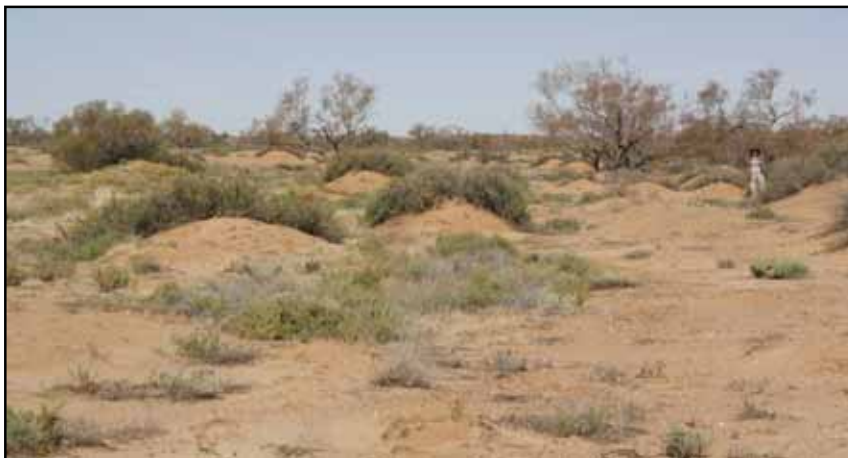
Fig.4 Hummocks: looking upstream at the silty tails of large hummocks centred around nitre bush, near the Algebuckina northwestern bank. Jay for scale.

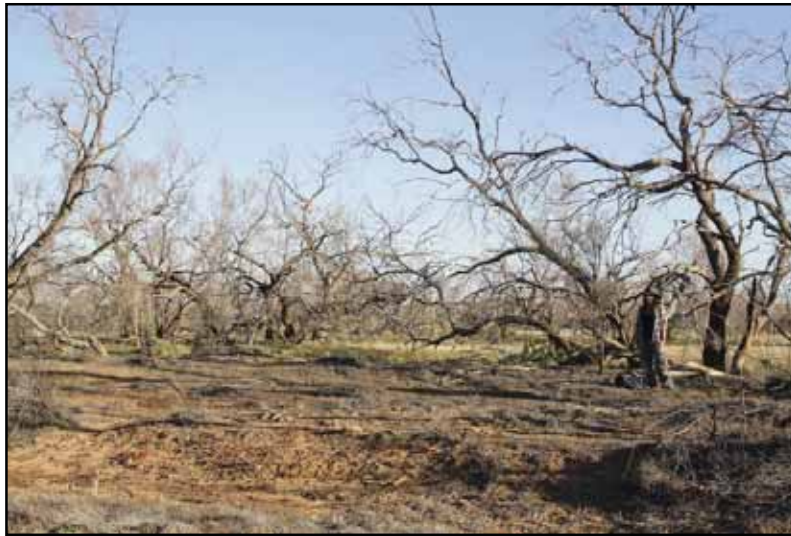
Fig. 5 Dead trees near the incised channel of the Neales just downstream of Ockenden Ck. Jay for scale.

The trees, hummock fields, and irregular topography of the floodplain are all roughness elements which serve an important function in the Neales River. They impede flow, decreasing its erosive power and allowing floodwaters time to infiltrate into the alluvial sediments. This is a key process for the ecological richness which characterises most of the alluvial valleys. Without this roughness, floodplain-level flow would be fast and erosive, channel downcutting would be triggered, and valley-floor incision would take place. At that point water would drain efficiently down the channel, bypassing the floodplain. Floodplain vegetation would die (Fig. 5).

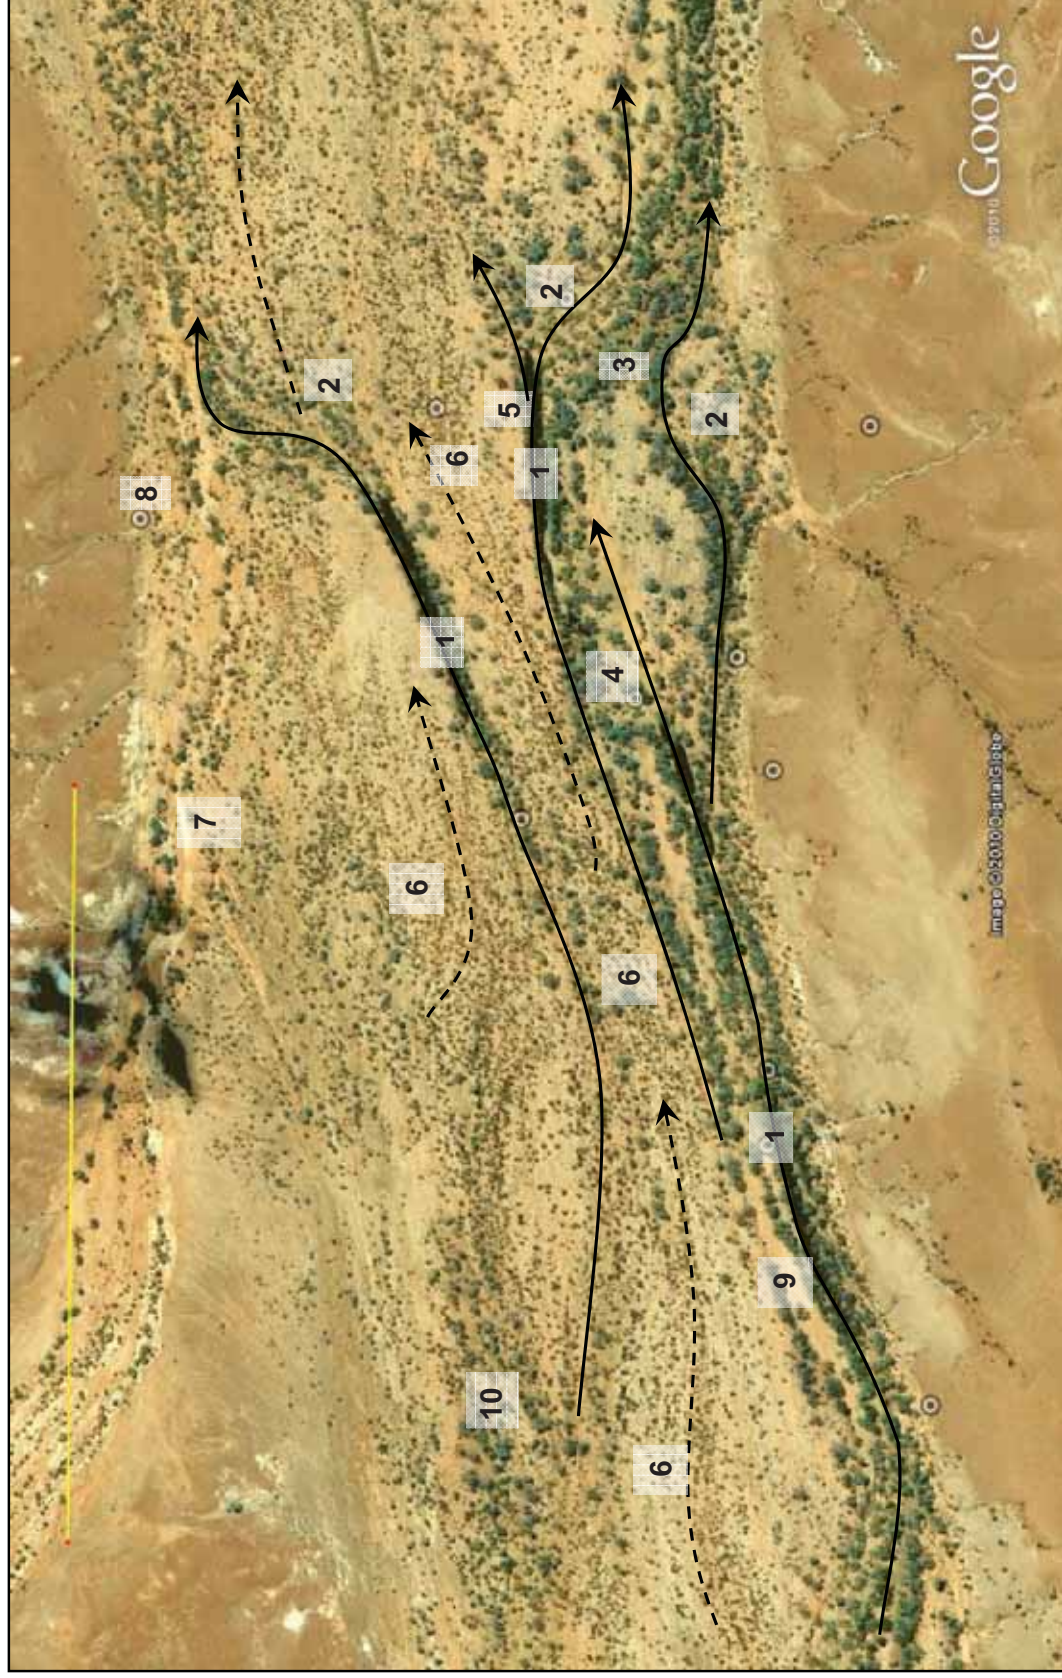
Fig. 6 Google Earth image of floodplain and channel elements at the Neales south branch; north to top, yellow scale bar = 1 km. Flow is from left to right, black lines show main flow paths, dashed black lines show the most prominent floodplain-height flow paths. 1 waterholes (lines of dark water, flanked by green trees), 2 riffles formed on downstream splays, 3 a dry swamp, 4 small channel complexes, 5 silty high plain, 6 hummock fields, 7 tributary channel and floodplain, 8 valley margin, 9 two abandoned channels run parallel to the present waterhole, 10 lines of large trees along frequently-inundated flow paths.

In the Neales Catchment waterholes often occur in clusters. Some reaches have many waterholes, and are associated with a rich variety of other landforms: short channel segments, small channel complexes, dry swamps (e.g. Fig. 6); whereas others have few or none (e.g. Fig. 3). Waterholes are most likely to occur in reaches likely to carry deep water where the topography promotes macroturbulence: rough, irregular boundaries where rocky outcrop protrudes through the floodplain (Hookeys, Peake Gap); valley margins (Mathieson, Cliff, Afghan); or complex flow conditions where two bodies of water meet (Angle Pole). Geomorphically complex reaches with a diversity of landforms are likely to have a diversity of habitats for non-aquatic plants and animals, and a range of options for migrating fish.

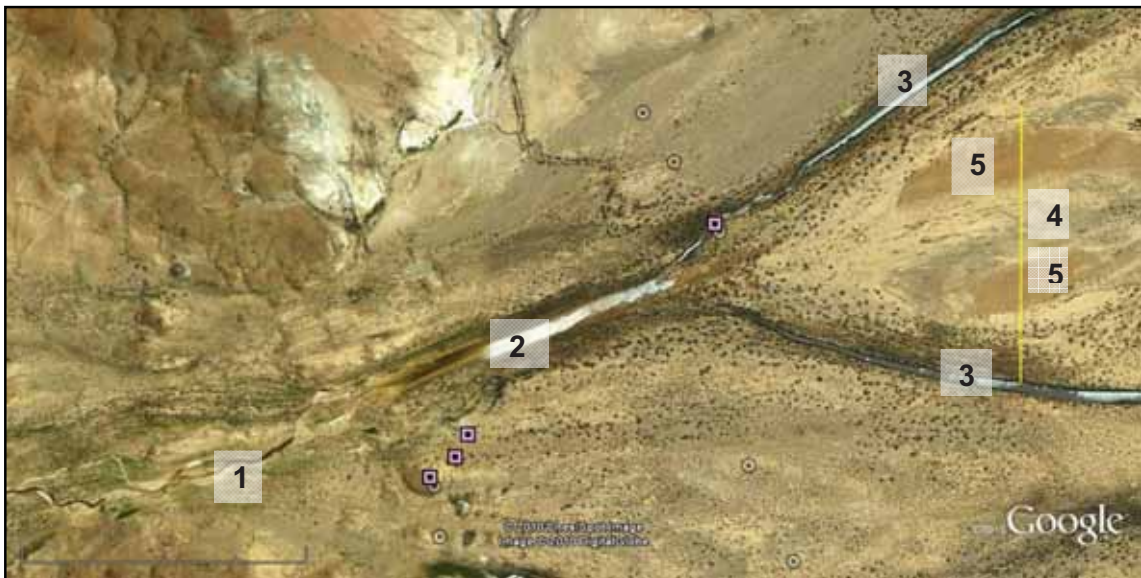
Fig. 9 Google Earth image of a remnant of an avulsed large waterhole at Peake Gap. 1 rocky Peake Gap, 2 the main channel, currently very shallow in comparison to its width, 3 Baltucoodna and Warrarawoona Waterholes in low-elevation parts of the valley, 4 abandoned path of the previous main waterhole, 5 old high silty plains flanking the previous waterhole. North to top, yellow scale bar = 1 km, flow left to right.

One possible trigger for channel or waterhole avulsion is the deposition of sediment pulses, blocking flow and diverting the next floodwaters down some other path. This was the likely cause of the abandonment of the Peake Gap waterhole at some pre-historical time. Originally, the waterhole was of a similar size to Algebuckina (Fig. 9). It was flanked by a very large high silt plains. A pulse of sediment from Arckaringa Creek was transported by a small flow but blocked the channel ~2 km downvalley from Peake Gap. The next floodwaters diverted around the blockage, switching to the low ground on either side of the high silt plains, and forming the current waterholes Baltucoodna and Warrarawoona.

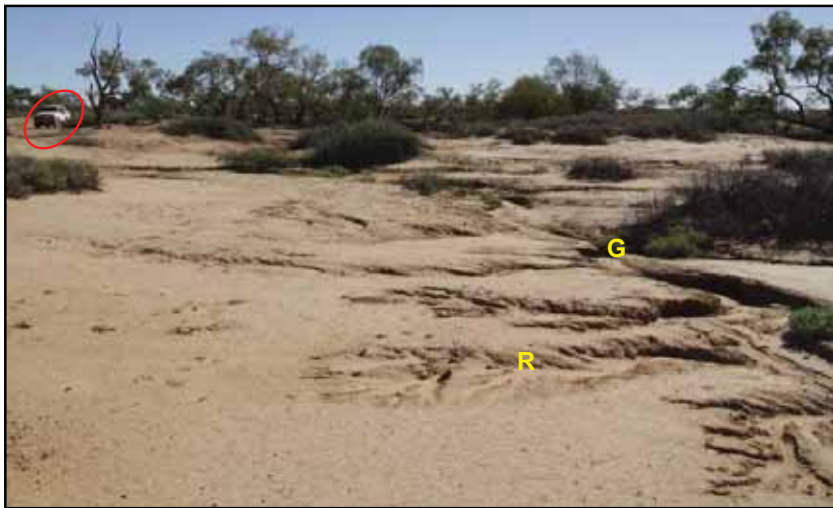
Fig. 10 At a part of Algebuckina visited by vehicles, dendritic rill systems (**R**) extend out across the high silt plain. They lead to gullies (**G**) which cut through the riparian ridge and drain into the waterhole. Vehicle for scale.

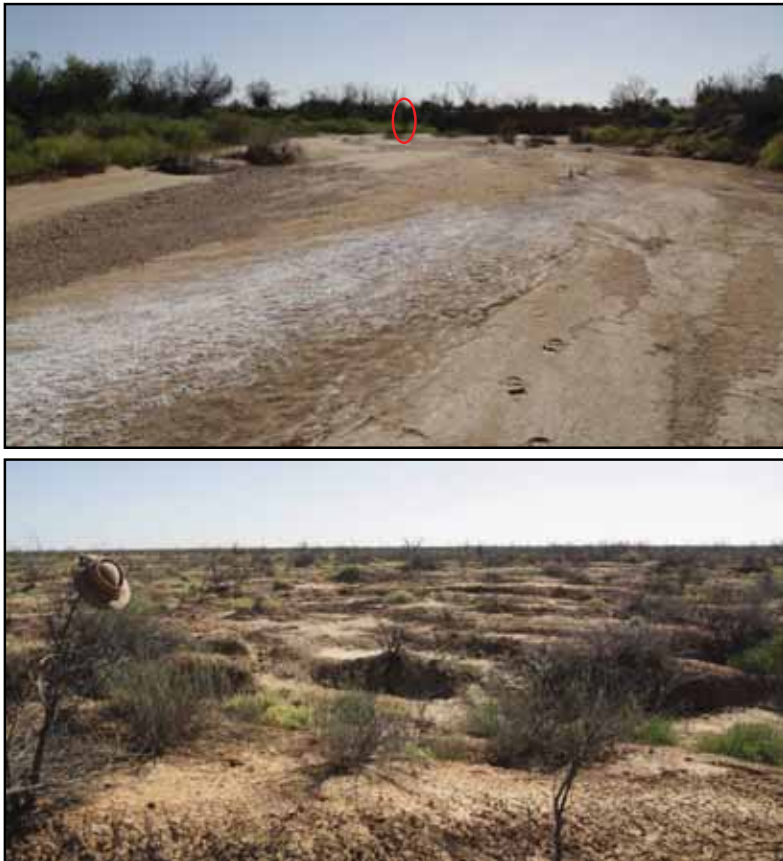
Fig. 11 Erosion in the Two Arroyos reach. Top, a wide arroyo near 6-Mile Bore, showing flat floor, steep sides, and dead trees at the bank top. Jay (circled) for scale. This wide channel is half the size of the same channel further downstream. Bottom, floodplain into which the badlands and arroyo are incised. This photo taken after good rain: elsewhere, floodplains were covered with waist-high grass. The original hummock field is now starved of flow: its hummocks are not being replenished by sediments brought down during flow events, and its vegetation is dead or dying. Hat for scale.

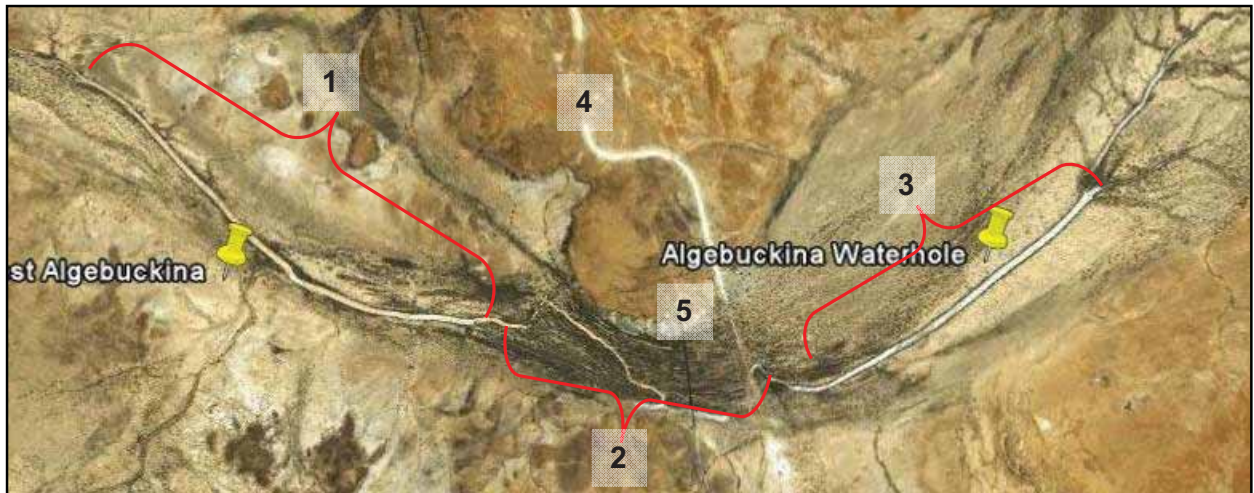
Fig. 12 Google Earth image of the Algebuckina area, north to top. 1 West Algebuckina, 2 Algebuckina Pinch, 3 Algebuckina Waterhole, 4 white line is the Oodnadatta Track, 5 dark line is the Algebuckina Railway Bridge.

Algebuckina Pinch is where the causeway and rail bridge go across the Neales River. The floodplain is narrowest here, constrained between hills of erosion-resistant rock. The Pinch is vegetated by dense scrubby trees, which are a valuable protection against erosion. A channel cutting through the trees looks to be small and inefficient. It crosscuts the major flow direction and may have developed from an old track. It would be detrimental if an efficient channel developed through Algebuckina Pinch, as this would allow silt accumulating in West Algebuckina to be flushed into Algebuckina Waterhole, reducing its depth and destroying its refuge value. It is critically important that any infrastructure development (e.g. the road crossing of the Oodnadatta Track) must avoid points of flow concentration (e.g. culverts).

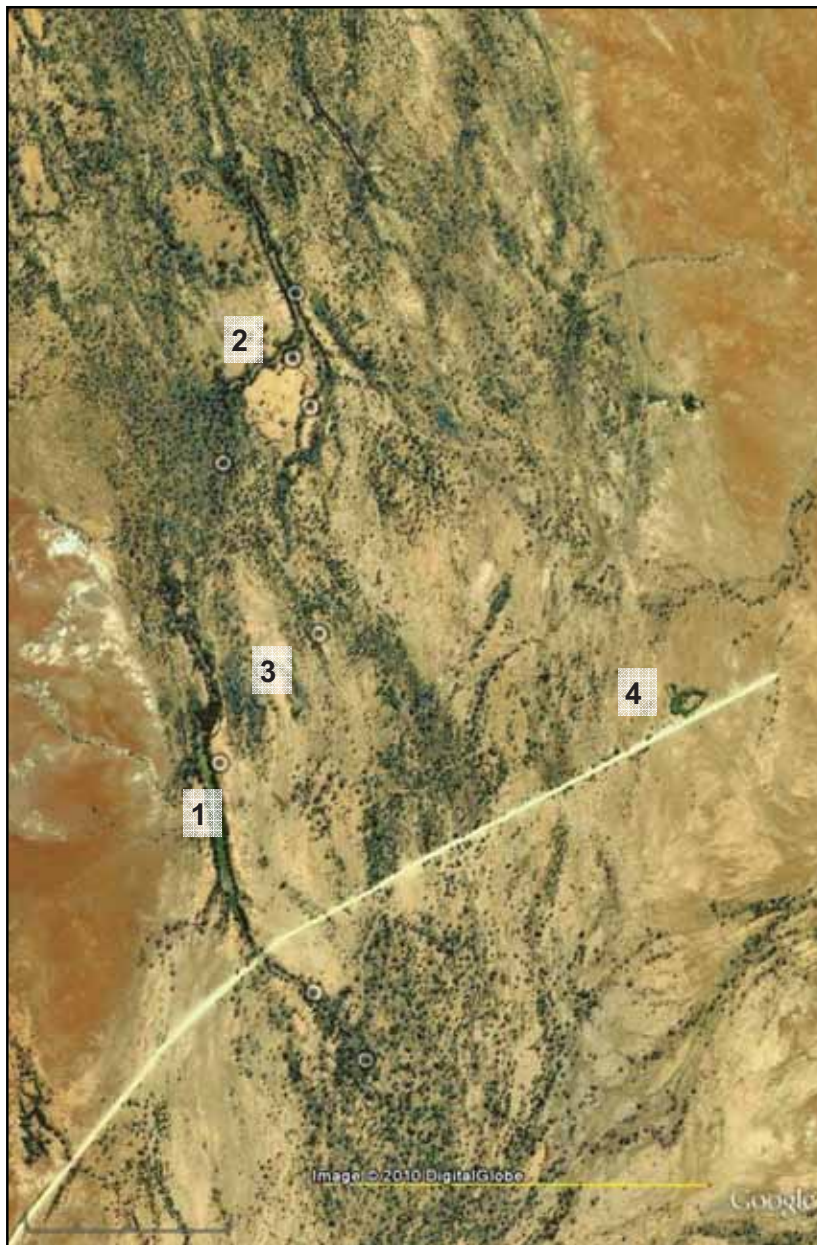
Fig. 14 Google Earth image of Hookey's reach of the Neales River south of Oodnadatta. 1 Hookeys Waterhole, 2 another moderately large waterhole which has high silt plains downvalley from sideways channels, 3 rocky outcrop here promotes turbulence, 4 the lowest parts of the valley are here, not where the waterholes are. North to top, yellow scale bar = 1 km, flow is from top to bottom, pale line is the Oodnadatta – Coober Pedy road

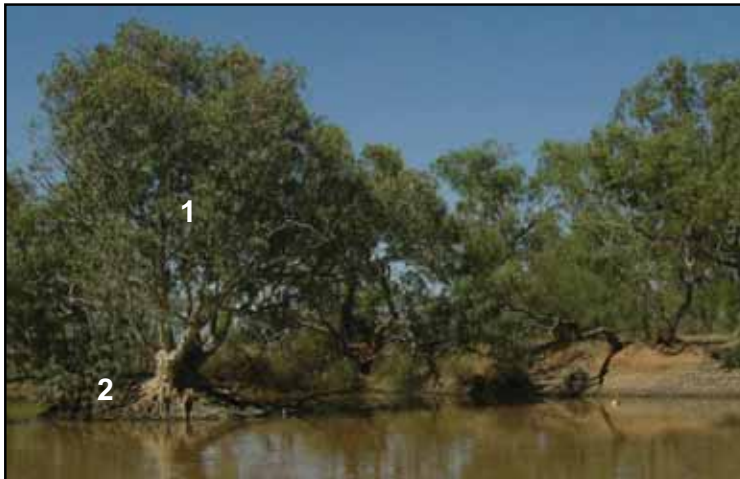
Figure 15 The downstream splay at Hookeys Waterhole. 1, this large tree is isolated from the bank by splay distributary channels. 2, The root mass is exposed but not actively eroding, and looks the same as in an old photograph in a book at the Oodnadatta Roadhouse. Photograph taken from the opposite bank, looking southeast.

There are areas of bank erosion and severe bank retreat in the waterhole's downstream splay, which is close to the road and subject to frequent recreational use. However, the erosion is not widespread – for example, a nearby tree isolated between splay distributary channels (Fig. 15) is the same now as it was during earliest European settlement. The indications are that landforms around Hookeys are generally stable and in reasonably good condition (with the exception of the erosion noted above). There do not appear to be any particular threats to waterhole or landform integrity in this area. Preservation of riparian vegetation, restoration of

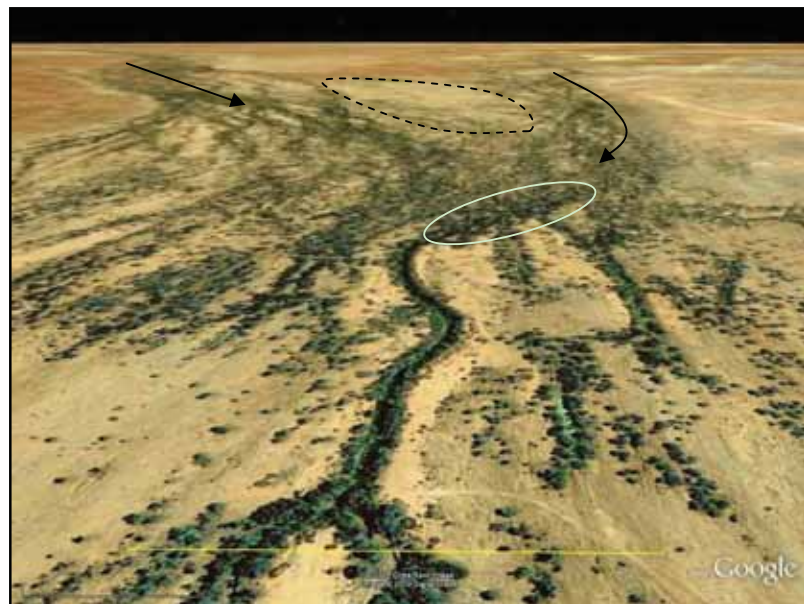
Fig. 16 Google Earth oblique image of Angle Pole waterhole, left arrow, South Branch, right arrow, North Branch. A complex of small channels has formed where the two flows meet (green oval). A possible megaflood deposit at the confluence is shown by the black dashed outline. Eye altitude 270 m, looking upstream, yellow scale bar = 0.3 km.

The Angle Pole Waterhole complex is downstream of the confluence. It owes its existence to the turbulence generated by the interface between two streams of water (Fig. 16). Like Hookey's, it is a cluster of waterholes, small channel complexes, and other landforms. It is likely to offer a variety of habitats to both aquatic and non-aquatic organisms.

A less-vegetated triangle in the floodplain near the North and South Branch confluence (Fig. 16) may be a tributary-confluence megaflood deposit. If so, its surface would be slightly above the general floodplain surface, so it would be less well-watered. The lack of vegetation may be either because it was never well-vegetated, or because being less well-watered, it is less likely to recover from grazing pressure.

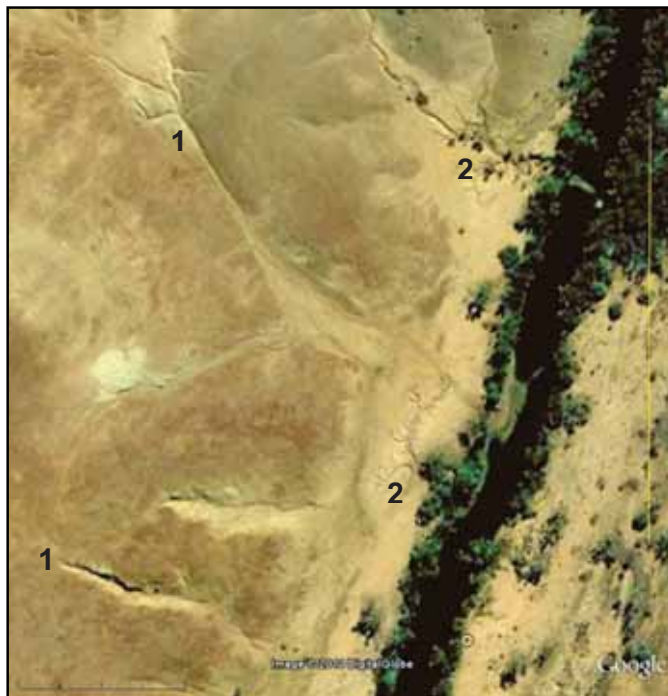
Fig. 17 Google Earth image of Stewart Waterhole. 1 gully cutting into gibber hillslope edges, 2 gully networks (badlands) cutting into silty high plains. North to top, yellow scale bar = 0.2km, flow top to bottom.

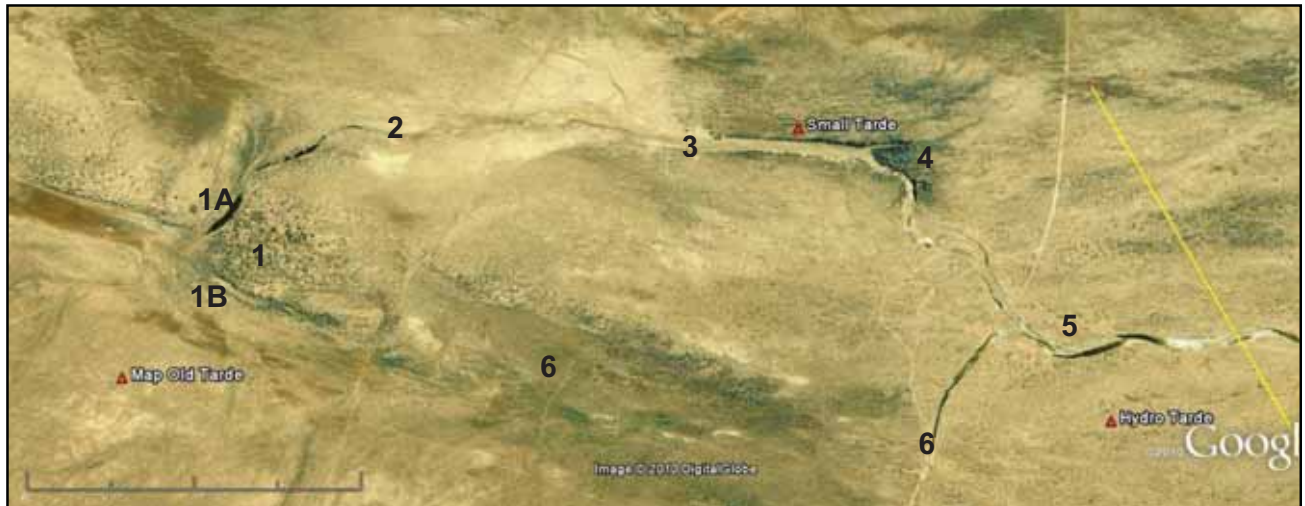
Fig. 18 Google Earth image of the channels extending downvalley from old Tardetakarinna Waterhole. 1 Old Tardetakarinna Waterhole's downstream splay (1A the northern distributary channel, 1B the southern distributary channel), 2 the channel linking Tardetakarinna Waterhole with Small Tarde, 3 Small Tarde, 4 Small Tarde's downstream splay, 5 a channel between Small Tarde and the Wood Duck Arroyo contains the small waterhole Hydro Tarde, 6 the diffuse Neales flow path. North is ~30° counterclockwise from photo top, yellow scale bar = 1 km.

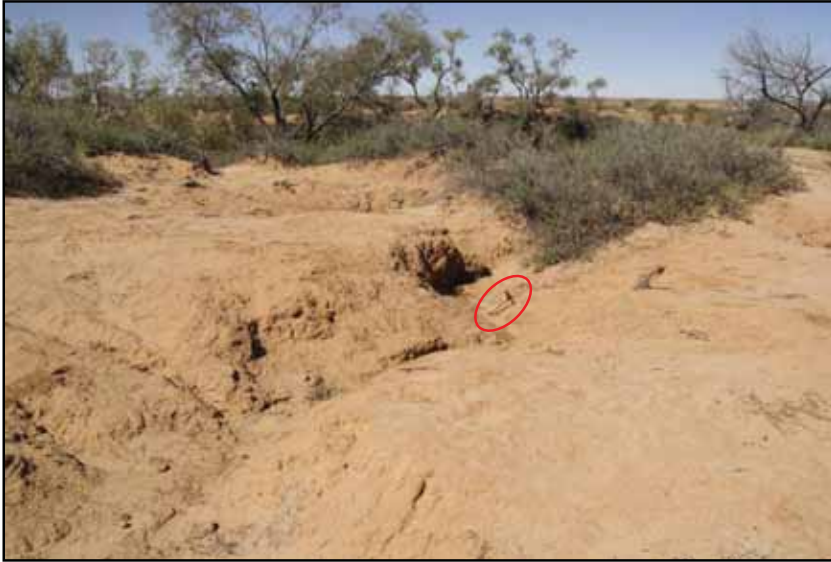
Fig. 20 This erosion gully in the non-tourist part of Algebuckina drains into a rabbit hole at some distance from the bank edge. Water emerges at the base of the bank, leading to undercutting and bank collapse. Rabbit hole is behind hammer (circled).

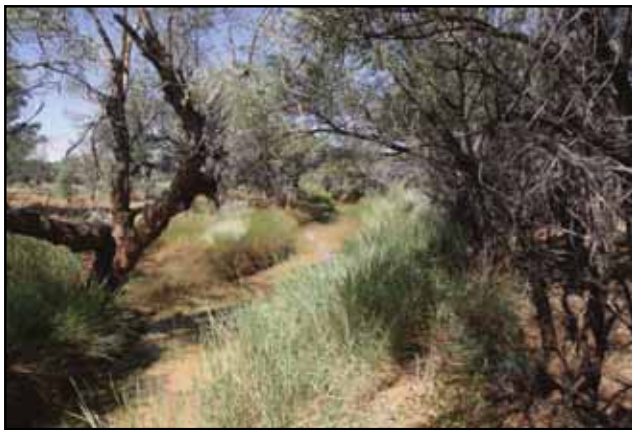
Fig. A1.3 The small-channel complex to the north west of Angle Pole Waterhole.

The small channels are similar to ordinary channels, but smaller: not visible on Google Earth unless the view is from very close in, and only several metres wide. Small channels seem to be more likely to silt up between big flows, but then small flows cut into silted-up channel bed. **Small channel complexes** are groups of small torturous channels, usually linking other, larger flow path elements. Typically they are small, and deep for their size, and densely vegetated – they look to be biologically quite rich (Figs. A1.3, A1.4).

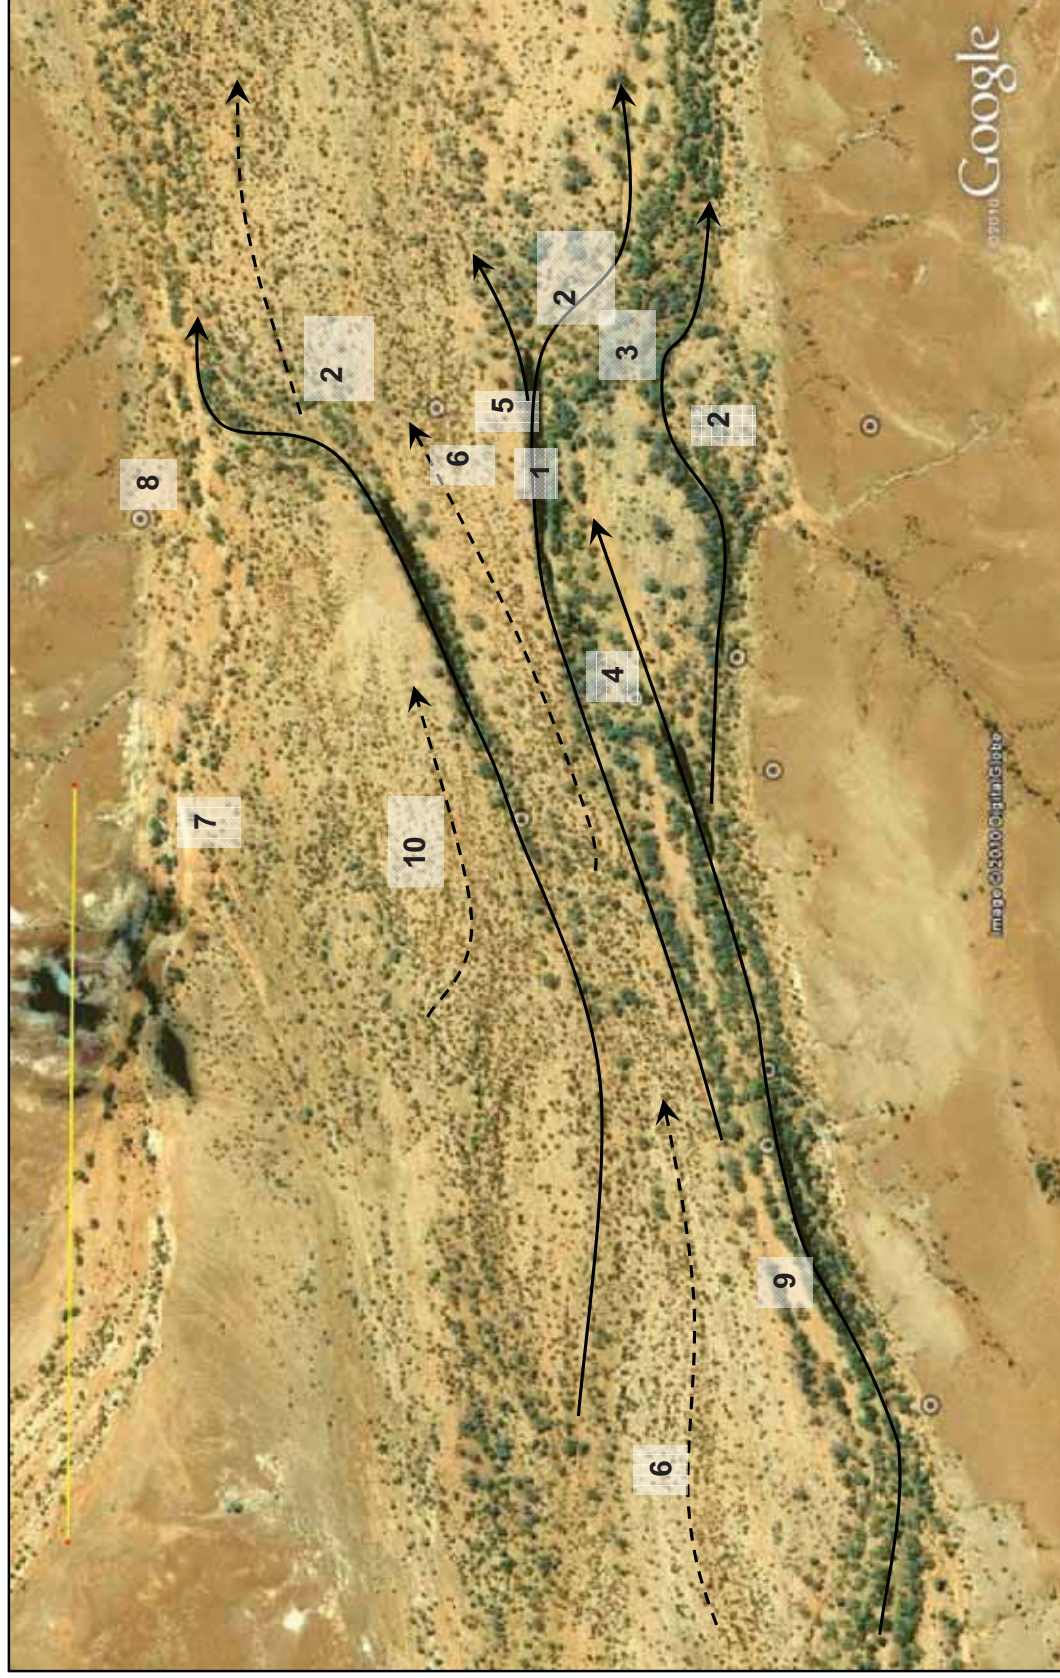
Fig. A1.4 Google Earth image of floodplain and channel landforms in the 4-Waterholes area of South Branch, ~4 km WSW of Lennon's Yard; white circle are geology sites, north to top, yellow scale bar = 1 km. Flow is from left to right, black lines show main flow paths, dashed black lines show the most prominent floodplain-height flow paths. Numbers indicate landform examples: 1 waterholes, 2 riffles formed on downstream splays, 3 a dry swamp, 4 small channel complexes, 5 silty high plain, 6 hummock fields, 7 tributary channel and floodplain, 8 valley margin, 9 two abandoned channels run parallel to the present waterhole, 10 lines of large trees along frequently-inundated flow paths.

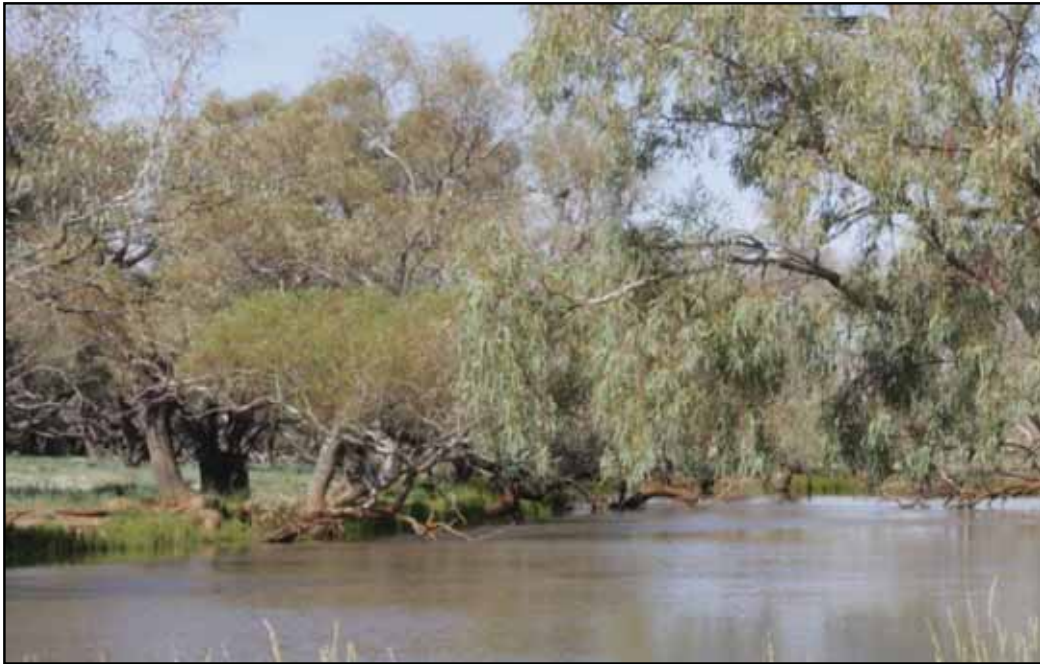
Fig. A1.6 Mt Carulinia Waterhole, on a tributary to the Neales South Branch. Riparian trees lean over, or have branches extending over the water. Branches have "elbows" which dip down to the water surface.

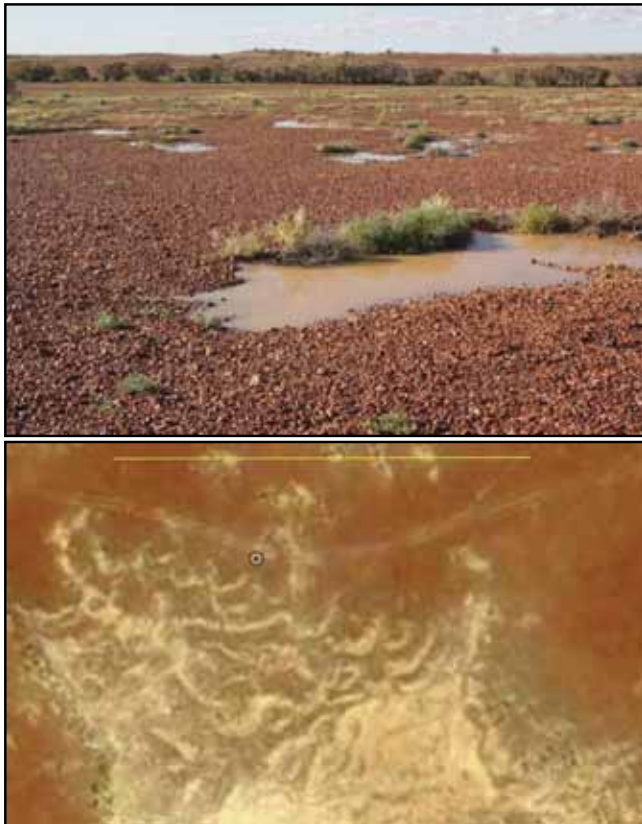
Fig. A2.2 Top: stony gilgai on the Flood Road near Hookey's Waterhole. Stony runoff surfaces shed rainwater, which is caught and held by less stony run-on surfaces (here, full of water from rain the previous week). Bottom, on this Google Earth image the stony gilgai is the pale and brown patterned ground. The red-brown ground without pattern is gibber plain without gilgai. Pale double line is the track, white dot is site of photo above, and yellow scale bar = 100m.

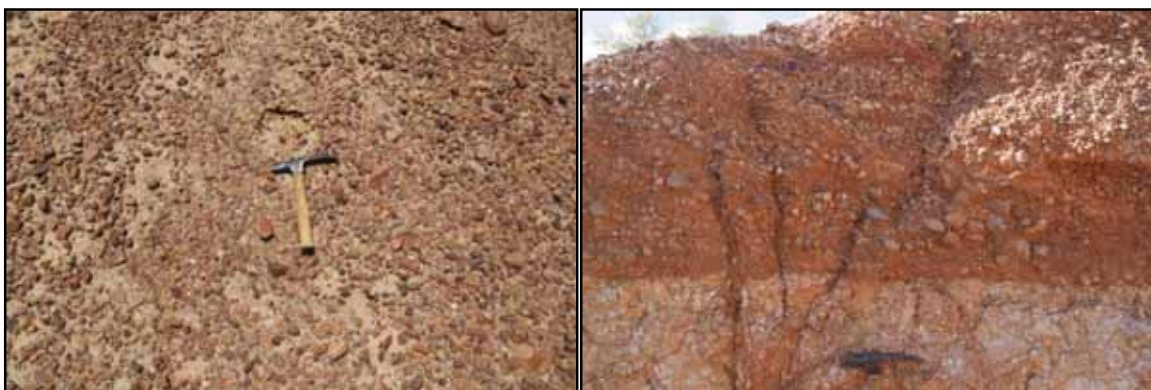
Fig. A2.3 Left: The packed stones of a desert pavement are underlain by soft swelling clays and silts; footprints (above the hammer head) and wheel tracks sink in. Right: Sandy gravel regolith (red-brown) overlying white Bulldog Shale. Hammer for scale.

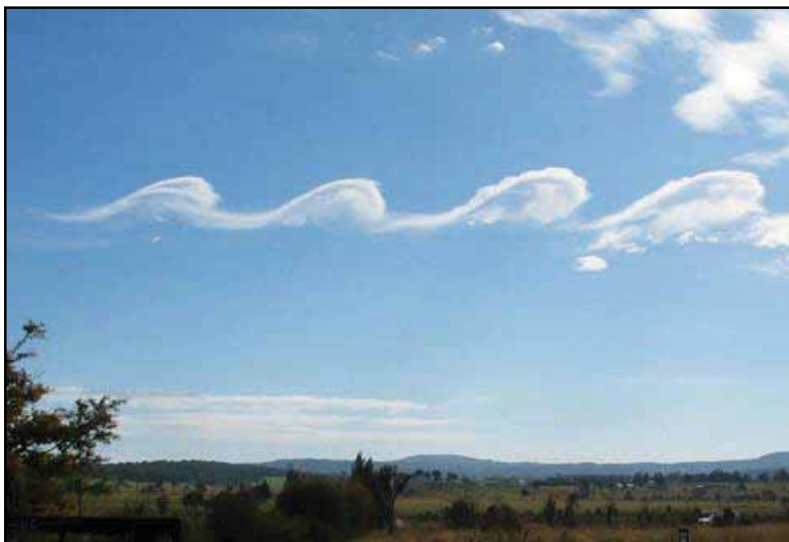
Fig. A2.10 A Kelvin-Helmholtz instability in the atmosphere creates vortexes along the boundary between two wind layers. Water vapour condenses in the low-pressure areas, and the resultant clouds outline the vortexes. A similar process happens when two bodies of water, both flowing in the same direction, merge. Image from WikiCommons, Wavecloudsduval.jpg.

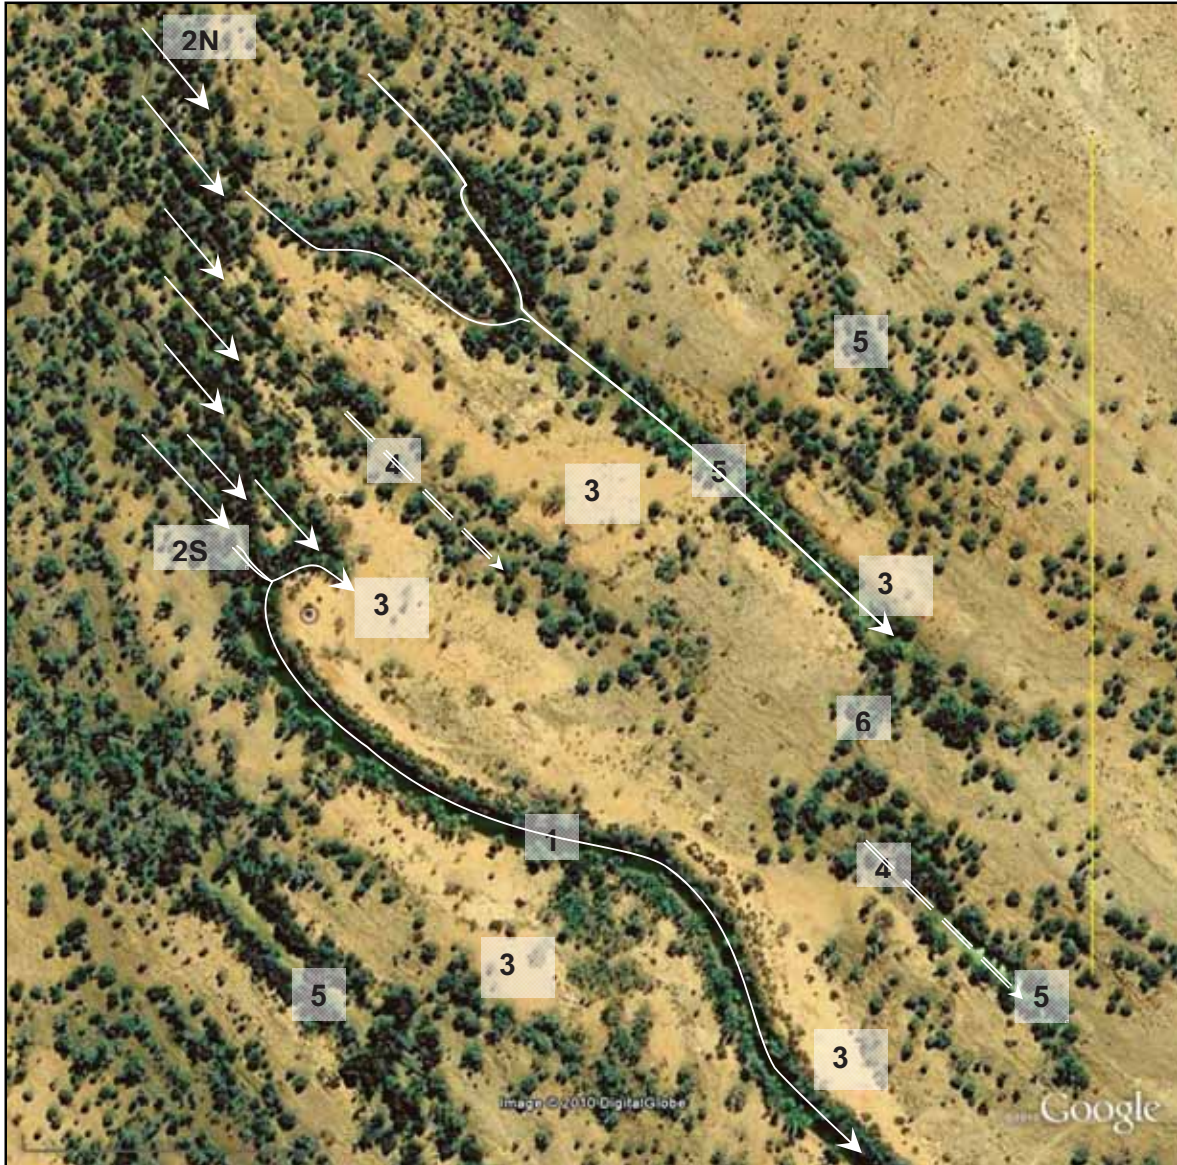
Fig. A2.12 Google Earth image of Angle Pole waterhole. North to top, yellow scale bar = 0.5 km, flow top left to bottom right. Pink numbers: 1 main waterhole (longest, deepest. most continuous channel segment), 2N & 2S north and south extent of the nest of en-echelon small waterholes, 3 various silty high plains, 4 dry swamps, 5 minor waterholes, 6 a sideways channel. Flow is shown by white arrows, and double dashed-line arrows for less deeply scouring flow.

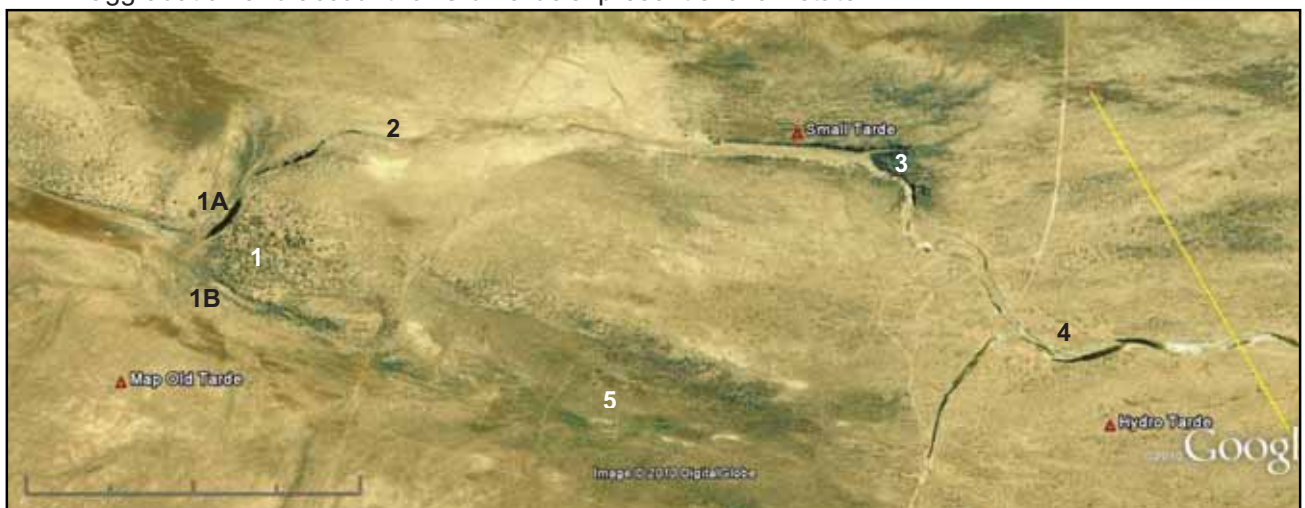
Fig. A2.17 Google Earth image of Old Tarde's downstream splay, and Small Tarde; north is  $\sim 30^\circ$  counterclockwise from photo top, yellow scale bar = 1 km. 1 Old Tarde's downstream splay (1A the northeastern channel, 1B the southwestern channel), 2 the channel linking Old Tarde with Small Tarde, 3 Small Tarde's downstream splay, 4 a relatively recently developed channel between Small Tarde and the Wood Duck Arroyo, 5 the diffuse Neales flow path.

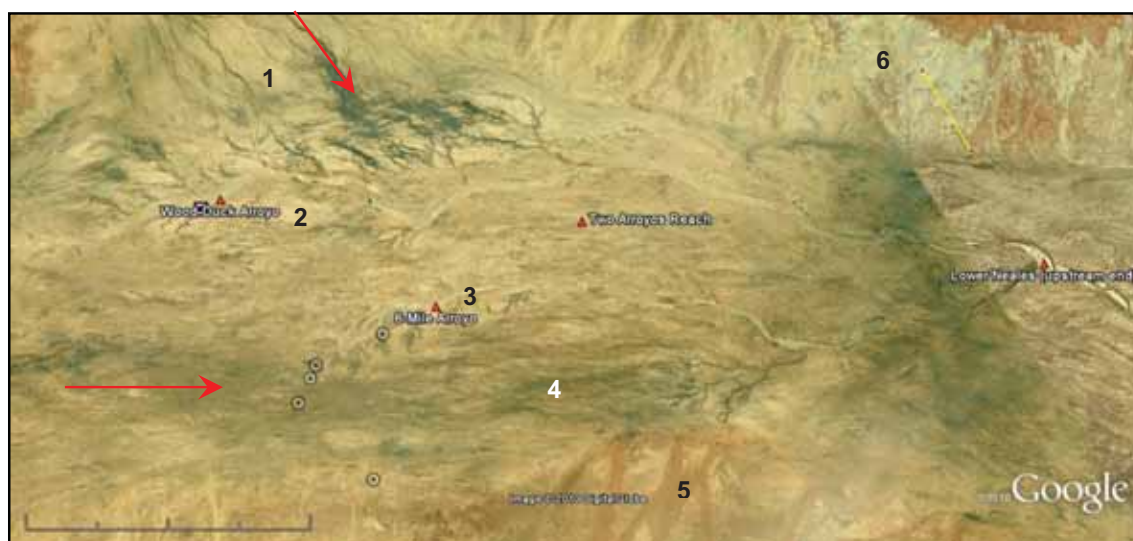
Fig. A2.18 Google Earth image of the Two Arroyos reach of the Neales River; north is  $\sim 20^\circ$  from photo top, yellow scale bar = 1 km. 1 Wood Duck Floodout, 2 Wood Duck Arroyo (the off-white, slightly sinuous thick line extending from left to right across the floodplain), 3 6-Mile Arroyo (the off-white slightly sinuous line), 4 the diffuse flow path, 5 sand dunes on the hillslope above the floodplain margin,  $\sim 3$  km east from 6-Mile bore, 6 high-runoff slopes extending from the old land surface down to the floodplain margin. Red arrows indicate flow direction. White circles are geology field sites. The pink square (obscured by the text "Wood Duck Arroyo" is the fish site "Not-Tarde". The diagonal line where the floodplain changes colour, to photo Wright, is the boundary between two different satellite images.

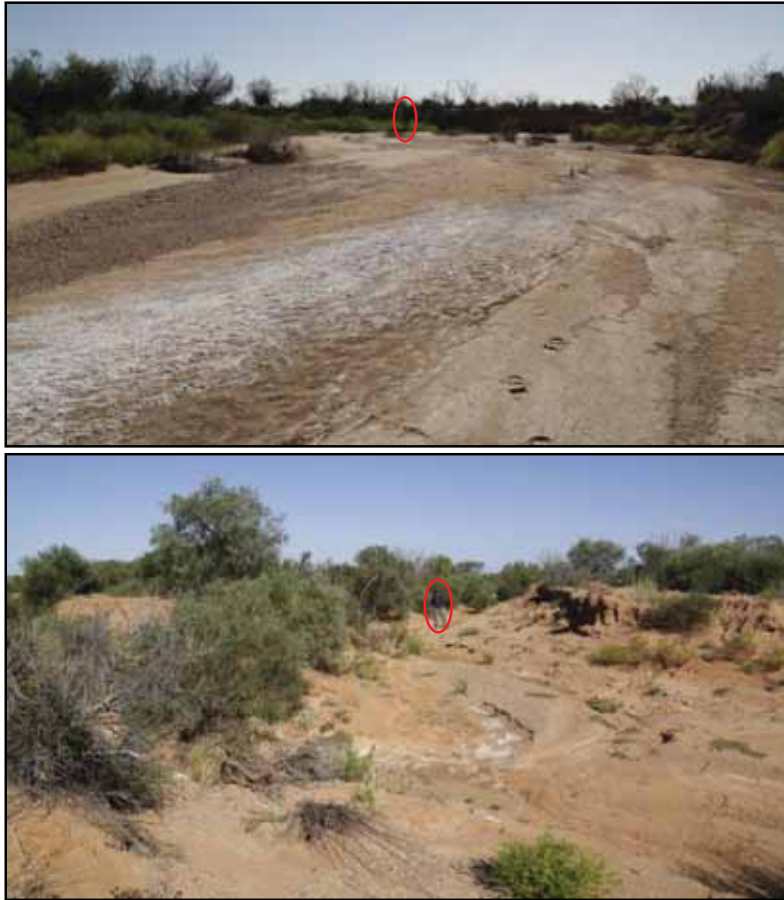
Fig. A2.19 Erosion in the Two Arroyos reach. Top: The wide **arroyo**, showing flat floor, steep sides, and dead trees at the bank top. White patches of salinity are visible in the bed. Jay (circled) for scale. This channel is half the width of the same channel further downstream. Bottom: **Badlands** with dense scrub growing close to the gully walls, where vegetation benefits from water captured from the floodplain above. Jay (circled) for scale.

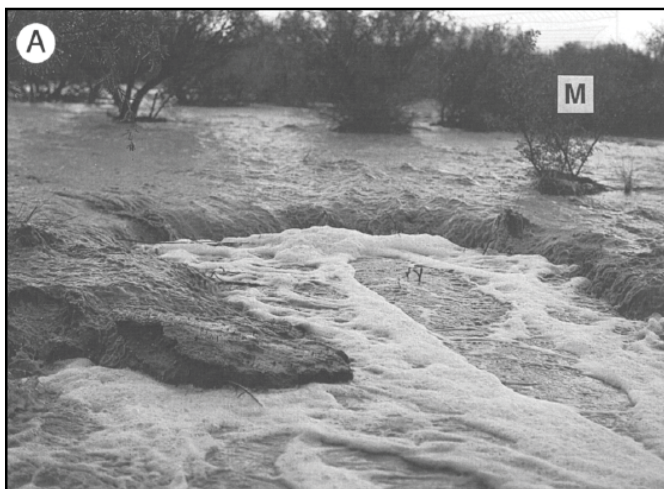
Fig. A2.20 A gully headcut capturing sheetflow in the USA (Bull 1997, his Fig. 12 A, the label M is a mesquite bush).

The smallest upstream tributaries of the arroyos are gullies, which extend in an upstream direction by erosion at the gully head, this being the location of greatest erosive power (Fig. A2.20). Individual gullies coalesce to form gully networks (badlands), and the badlands form small arroyos that merge with the larger arroyos (Fig. A2.21). Bushy scrub growing in many gully heads is benefiting briefly from the gully's interception of floodplain water (Fig. A2.19). However, this vegetation will die as the gully extends headwards. Large solid masses of crystalline gypsum at gully-floor level were observed in gully heads at 35m AHD, a location corresponding to the >59,000 year palaeolake level.

possibility of a flow being big enough to overtop the arroyo channels. Also, the conditions under which the amount of water flowing into the arroyos is sufficiently large to overcome the arroyo efficiency and allow sufficient connectivity for fish to swim upstream (that is, to look like Fig. A2.20) is limited in time and space. Such connectivity is only likely to be achieved at flood peak discharges, and in locations where the gully heads are shallow and rough: scrubby badlands (Fig. A2.19 bottom, and Fig. A2.21 #1). Overall this suggests that fish will be able to migrate downstream into the badlands/arroyos, but upstream migration will be disadvantaged.

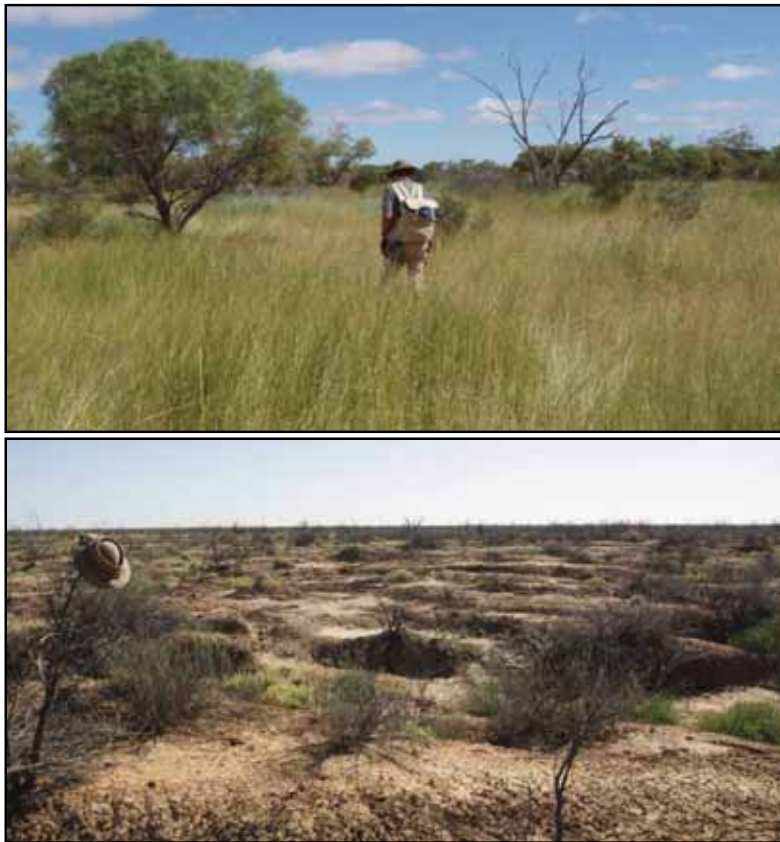
Fig. A2.22 Floodplain vegetation during the field work, photos taken within 14 days of each other. Top: Rich grass in the intact (unincised) floodplain upstream from the Neales-Peake confluence (Gresley for scale, photo: Jay Stafford). Bottom: Floodplain into which the badlands and arroyo are incised. The original hummock field is now starved of flow: its hummocks are not being replenished by sediments brought down during flow events, and its vegetation is dead or dying. Hat for scale.
