**Government of South Australia**  
South Australian Arid Lands Natural  
Resources Management Board

May 2011

# Geomorphological assessment and analysis of the Neales Catchment

Gresley A. Wakelin-King

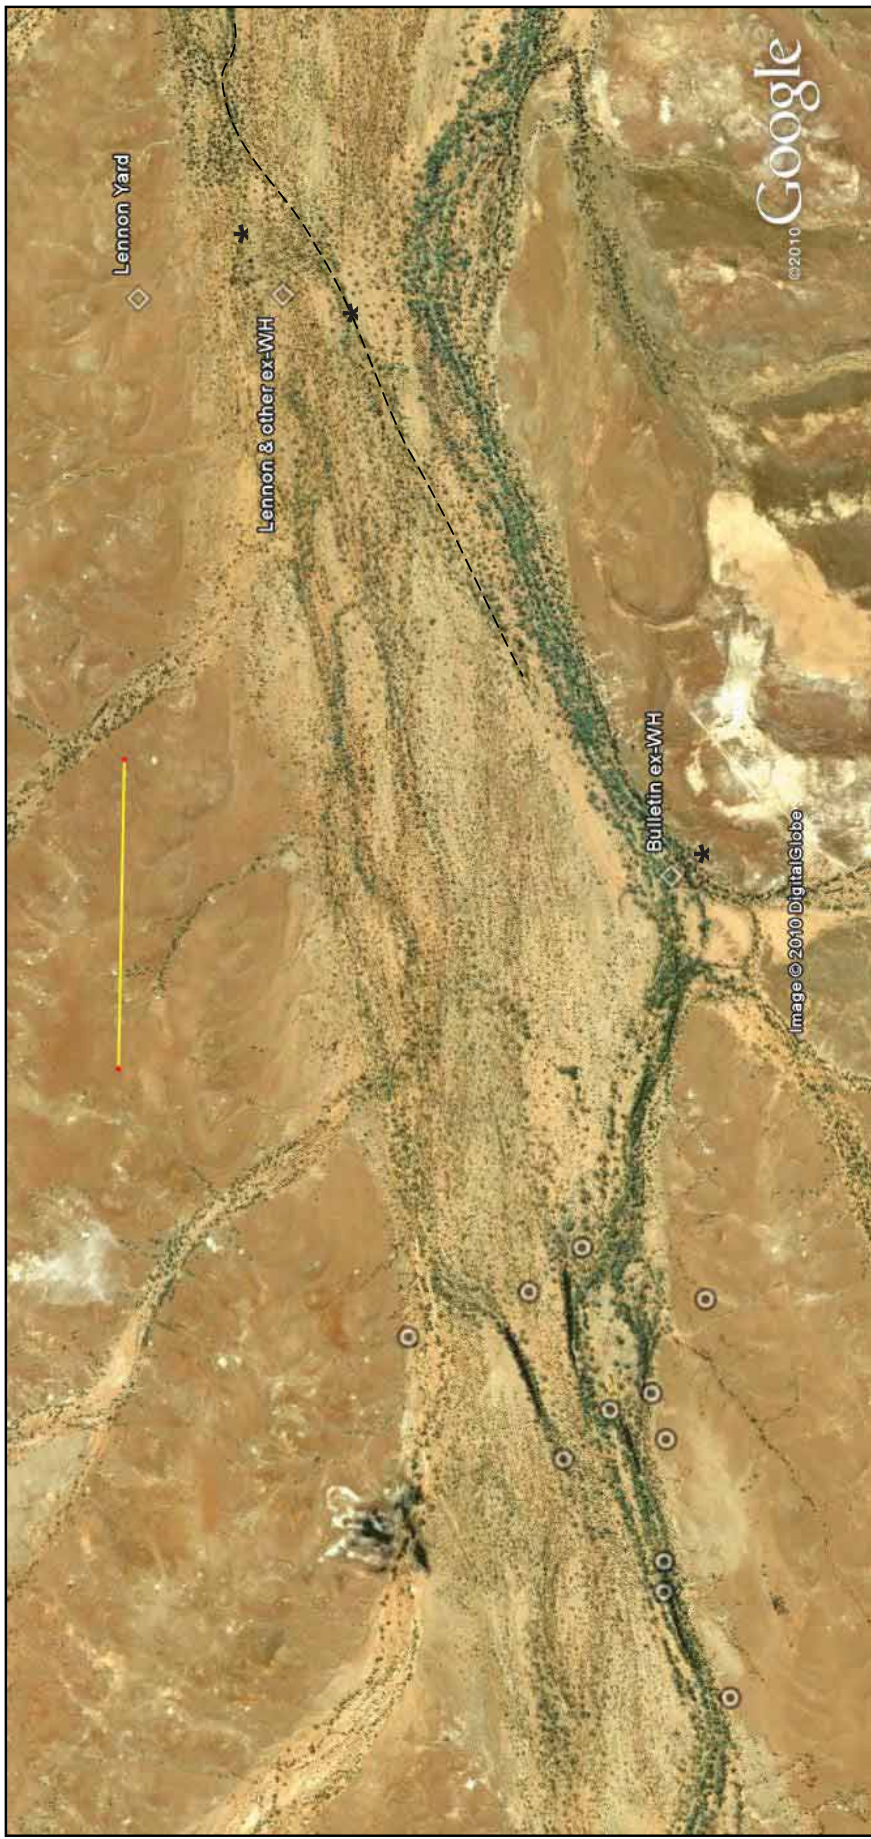
Fig. A2.25 Google Earth image of the Lenin-Bulletin Waterholes area (right) and the 4-Waterholes reach (left); north to top, yellow scale bar = 1 km, white circles = geology sites. The two ex-waterholes (asterisks) near Lennon Yard are located along a flow path (black dashed line) which was once, but is no longer, the primary flow path of these reaches. The modern primary flow path is shown by double line of dark green trees on the south side of the alluvial valley). Bulletin ex-waterhole is also marked with an asterisk; the main flow has bypassed it due to chute cut-off. Also see Fig. 16.

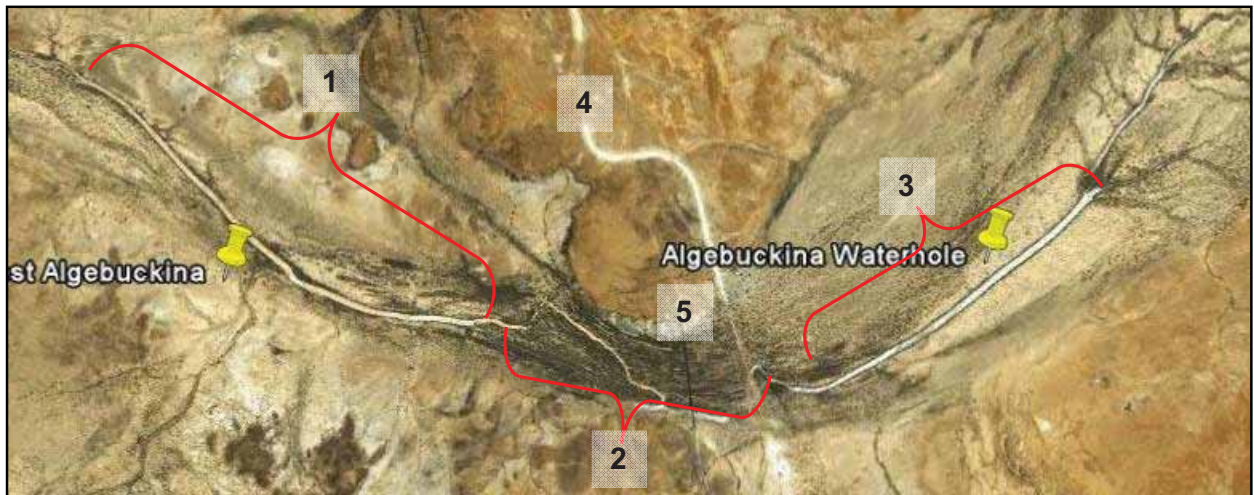
Fig. A2.26 Google Earth image of the Algebuckina area, north to top. 1 West Algebuckina, 2 Algebuckina Pinch, 3 Algebuckina Waterhole, 4 white line is the Oodnadatta Track, 5 dark line is the Algebuckina Railway Bridge.

the waterholes, contributing to waterhole shallowing (Costelloe 2010). Another cause can be upstream valley-floor incision. For example, the shallowness of West Algebuckina (in comparison to its width) is likely to be the result of the relatively recent incision of the upstream valley floor at Ockenden Creek, releasing silt to accumulate in West Algebuckina.

The shallowing of West Algebuckina highlights a potential risk to the depth (and thus, refuge qualities) of Algebuckina Waterhole. At the moment, West Algebuckina is separated from Algebuckina Waterhole by Algebuckina Pinch, a narrow floodplain hemmed in by resistant hills and vegetated by a thick belt of scrubby trees (Fig. A2.26). Only a small irregular channel threads through the trees. If a substantial channel was to develop, linking West Algebuckina to Algebuckina Waterhole, it is likely that flow events would flush substantial silt into Algebuckina Waterhole, effectively destroying it. A similar sequence of events probably led to the loss of Tardetakarinna Waterhole (page 89). Algebuckina Pinch is where the railway bridge and Oodnadatta Track cross the river. If infrastructure development leads to a new road crossing, very great care should be taken that the flow is not concentrated. This would create a point source of gullyng, connecting the two waterholes and moving silt from West Algebuckina to Algebuckina Waterhole. A common arid-zone situation leading to flow concentration and gullyng is where flow is passed under the roadway in culverts which are only designed to match channel size. When overbank flow happens (as is invariably the case in variable-flow arid-zone systems), the floodwaters become erosive where they emerge from the culverts. Ideally, the

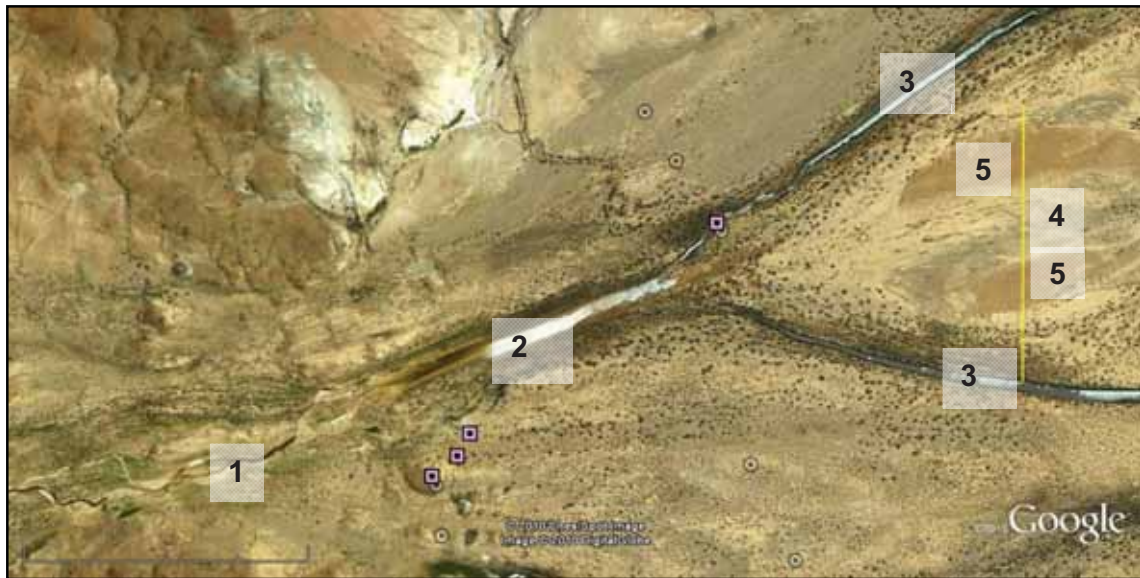
Fig. A2.28 Google Earth image of Peake Gap, north to top, yellow scale bar = 1 km, flow left to right. Numbers: 1 the rocky gap, 2 the main channel, currently very shallow in comparison to its width, 3 Baltucoodna and Warrarawoona Waterholes in low-elevation parts of the valley, 4 abandoned path of the previous main waterhole, 5 older high silty plains flanking the previous waterhole.

lower elevation pathways along the valley margins. This is the origin of the landforms at Peake Gap (Fig. A2.28): the dry and relatively shallow channel near Freeling Springs is the original channel (its width is not in the scale of its depth, indicating it was once much deeper); Baltucoodna and Warrarawoona Waterholes are relatively new, and the remains of the previous waterhole's old channel and high silt plains can be seen between Baltucoodna and Warrarawoona. Baltucoodna and Warrarawoona are the only waterholes in the study which are not perched on high silt plains.

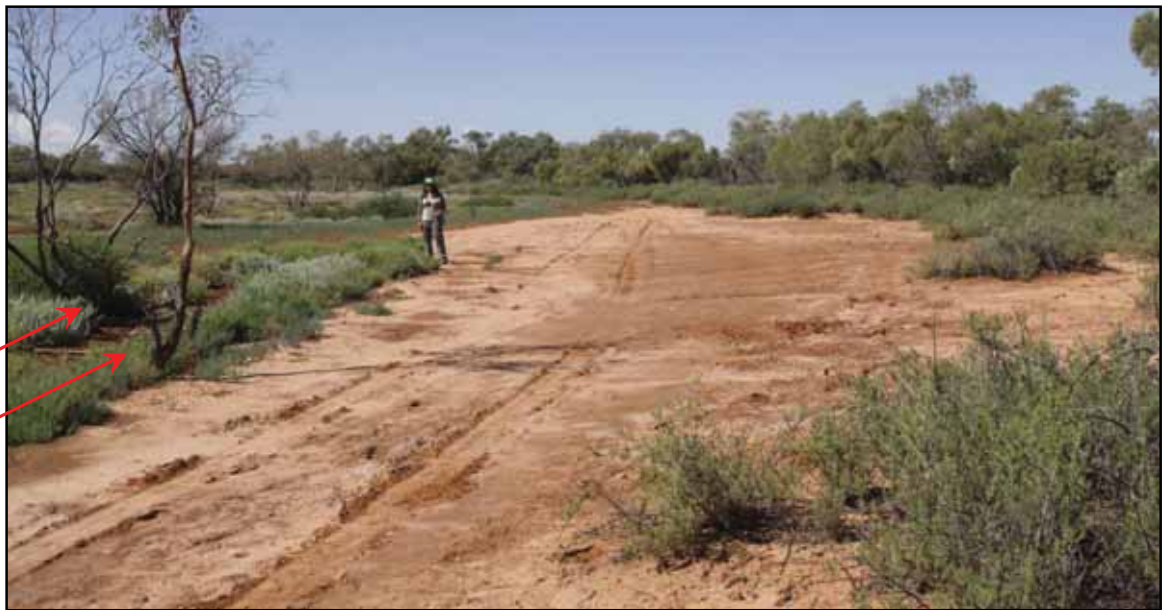
Fig. A2.30 The silty high plain at Angle Pole waterhole is bare along its flank, providing easy vehicle access. Its crest is colonised by nitre bush with trees along the waterhole bank (right). Left, a small scour into the top of the silt is a waterhole in miniature: bed (dark mud showing between banks), banks (red arrows) and bank vegetation mimic waterhole landforms, while its orientation matches the orientation of the main channels. Jay for scale.

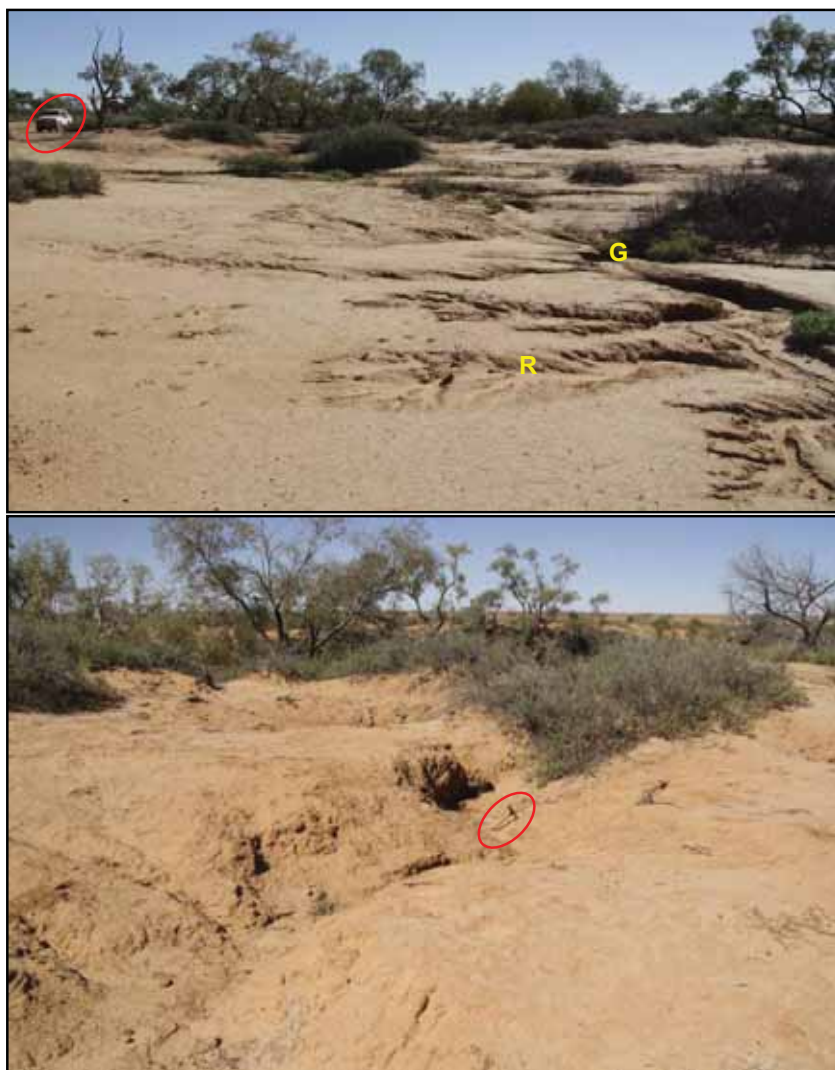
Fig. A2.31 Rills and gullies at Algebuckina. Top: One of the dendritic rill systems (**R**) extending out across the high silt plain of in a part of Algebuckina visited by vehicles. It leads to a gully (**G**) which cuts through the riparian ridge and drains into the waterhole. Vehicle for scale. Bottom: This erosion gully in the non-tourist part of Algebuckina drains into a rabbit hole at some distance from the bank edge. Rabbit hole is behind hammer (circled).

and rill/gully networks (see below). There was a strong correlation between vehicle access and the development of rill/gully networks in the high silt plains. All the popular human visitation sites showed dendritic gully networks (Fig. A2.31) on the high silt plains, connected to narrow deep gullies through the riparian ridge and bank tops. Where the rill networks are most strongly developed, it is evident that there is considerable sediment transport from the high silt plains into the waterhole. This matches observations made during the hydrology investigation that the waterholes are becoming shallower at these points (Costello 2010).

A common and effective method of dealing with gully erosion is stabilising the gully head by re-vegetation. There may be some difficulties with this where the rill networks are cutting into the high silt plains (e.g. Fig A2.31). The high silt plains are naturally poorly vegetated, suggesting that when the plains formed, they were unfavourable to plant growth. This is consistent with their material: well-sorted quartzose silt would pack down hard, providing little opportunity for seed lodgement or root growth, and it would not contain nutrients or retain moisture. On the other hand, very old high silt plains eventually host some vegetation, so perhaps planting may succeed if the hard packing is loosened, and some organic material is supplied. However, riparian revegetation should be a higher priority than gully head planting.

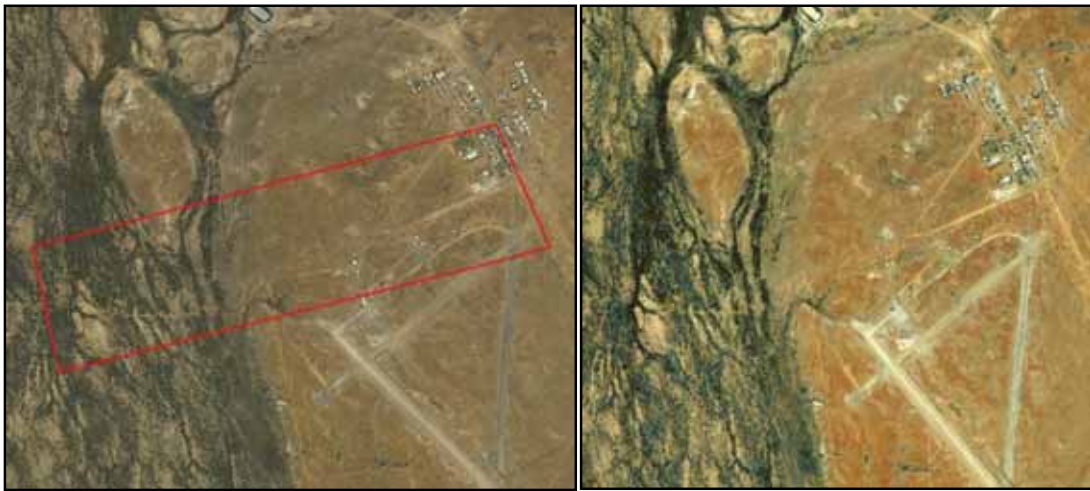
Fig. A3.1 Comparison of SPOTMaps image, left with Digital Globe (Quickbird, from Google Earth) image, right. The SPOT image artificial colour is only a moderate representation of the true colour, and the resolution is not as good as Quickbird, but it is very good value for money.

In this project Google Earth (Pro) was used during this technical analysis. Its images are either SPOT (2.5 m pixel, artificial colour) or Digital Globe QUICKBIRD (sub-metre pixel, true colour). It is suitable because it provides a picture of the land, and (with a Pro subscription) has some GIS capability. Its disadvantages are that it is not 3-D, it cannot be compiled into other GIS, and the licensing conditions are very stringent (images can't be used for public display). There are specialised Google Earth subscriptions and capabilities which will allow it to be used in the Neales project website, and this is recommended here.

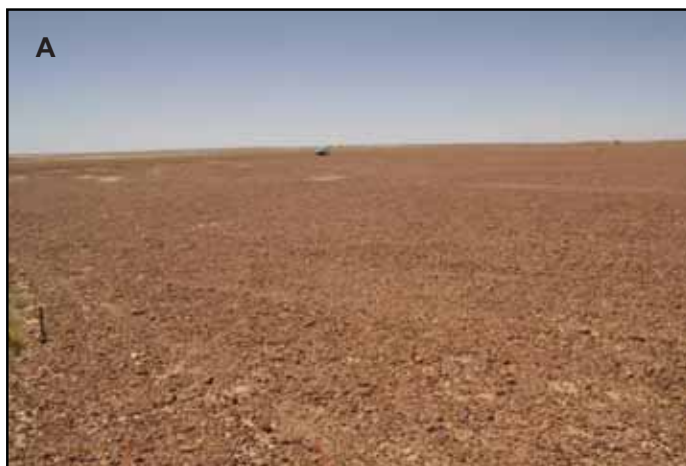
Fig. A3.3 A, The low-relief gibber slope near Nilpinna, chosen to test DEM quality. B, This graph compares raw (pink) and smoothed (blue) 1-second SRTM data from the gibber hillslope; minor gridlines approximate data pixel size. C, This graph compares 1-second (pink) and 3-second (blue) smoothed SRTM data from the gibber hillslope; the agreement is good.
