MARTINDALE HALL

CONSERVATION MANAGEMENT PLAN

REV. A / NOV 2021

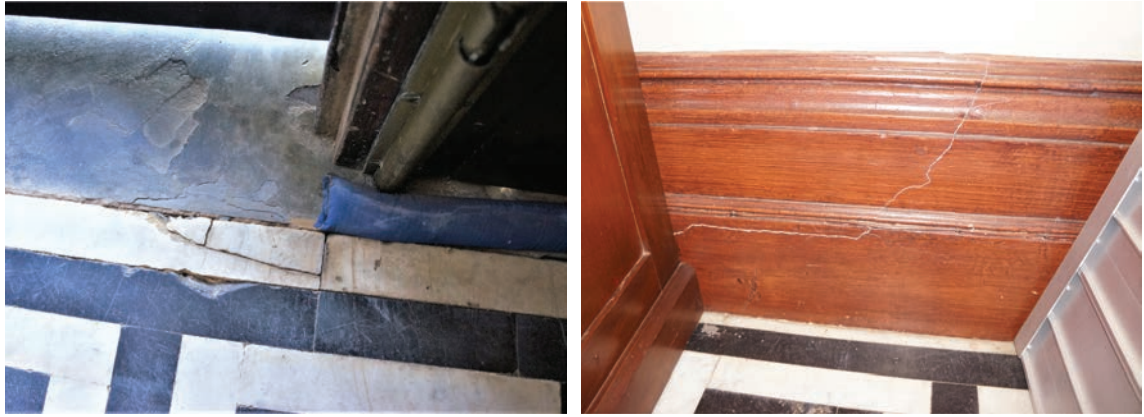
Figure 12: Above left: Damage to the white and black marble along the edge of the main entrance slate threshold, which is also showing signs of wear and tear.

Figure 13: Above right: High Victorian style moulded Parian cement skirting. Note the cracking.

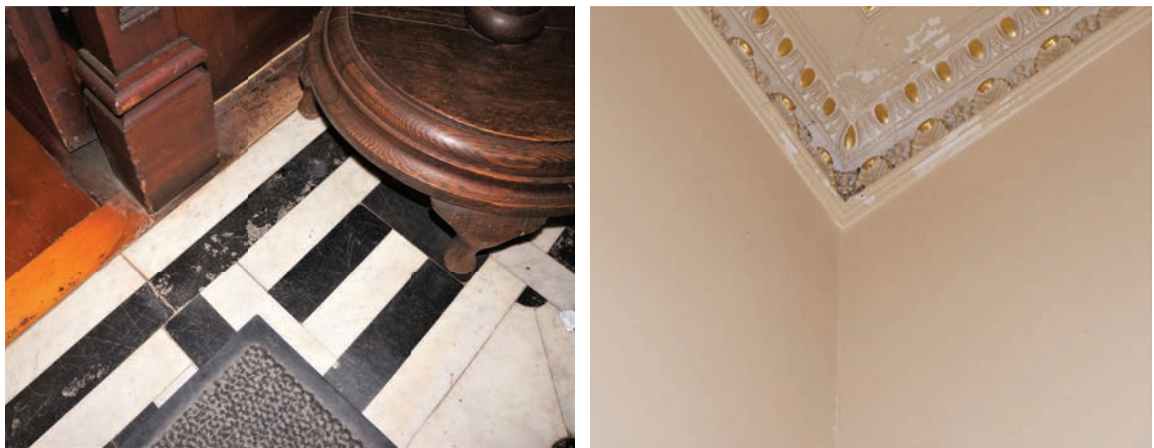
Figure 14: Above left: Signs of wear and tear to the black St. Ann's marble at the junction with the Vestibule flooring.

Figure 15: Above right: View into north east corner of moulded egg and dart/acanthus leaf cornice. There are cracks in the cornice and in the plain plaster directly beneath. The peeling paint suggests damp in the outside wall.

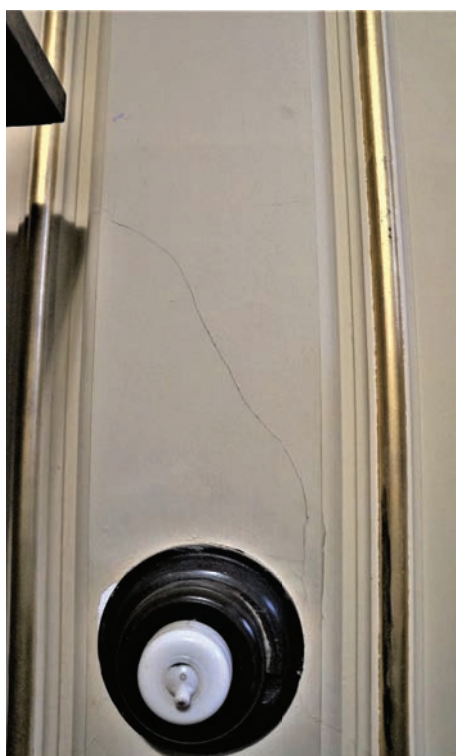
Figure 17: Left: Cracking in the cement panelling to the right-hand wall as viewed when facing towards the Central Stair Hall.

Room 2. Programmable Works			Priority (Highest priority is 1)		
Era type	A	Bowman	1	2	3
2.1	Refurbishment of parquet floor			2,500	
2.2	Redecorate throughout incl repairs to cement skirtings, wall render ceiling plasterwork			5,000	
2.3	Review furniture/ general presentation of space				2,000

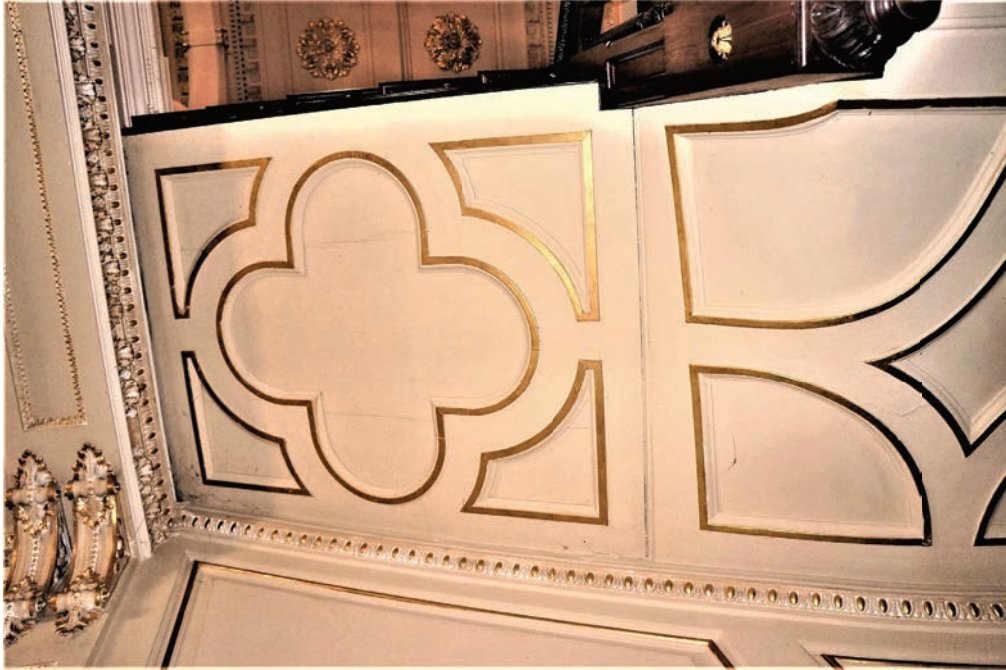
The main staircase soffit is timber panelling ornately ornamented with mouldings in quatrefoil pattern, again with simple egg and dart cornice decoration. There are movement cracks along joint lines and mouldings have been chipped in places. Once more, the paintwork would benefit from being freshened up.

Figure 22: Looking up at the timber panelled soffit of the main stair. Note the movement cracks along joint lines.

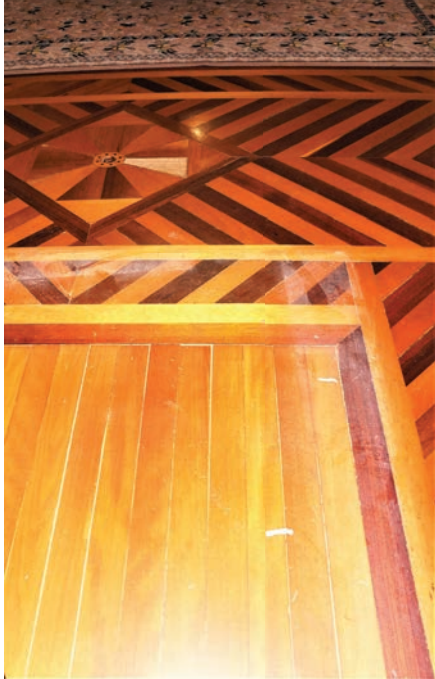
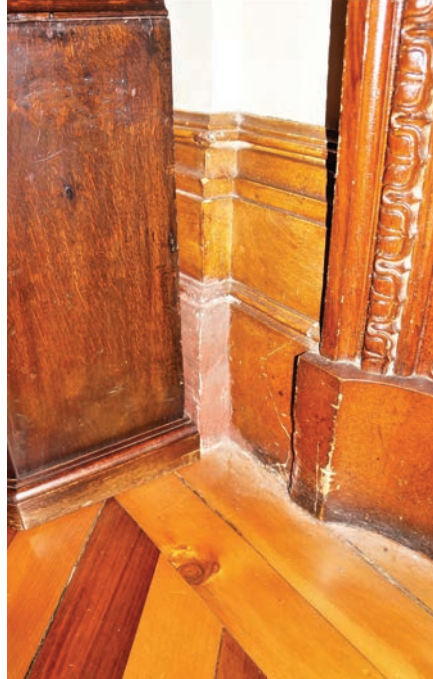
Figure 24: Far left: Hall flooring. Note the poor colour choice of joint filler to the plain boarding. Note also, to the top of the picture, the poor-quality repair to the central decorative feature in the parquet flooring.

Figure 25: Left: Poor quality repair to the Parian cement skirting behind furniture.

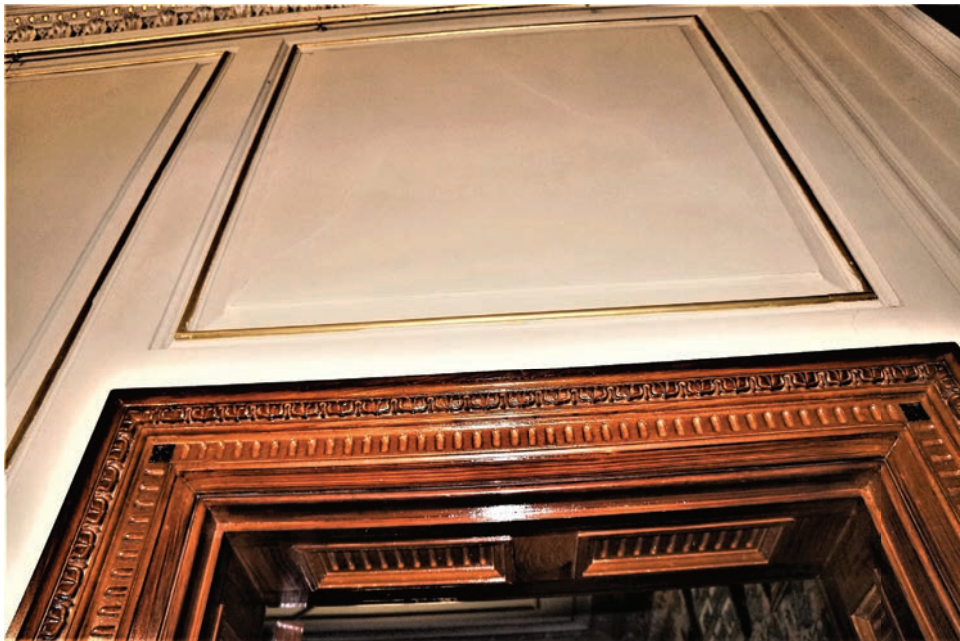
Figure 26: Left: Moulded plaster panel above door. Note the cracks in the plain plasterwork that have been repaired.

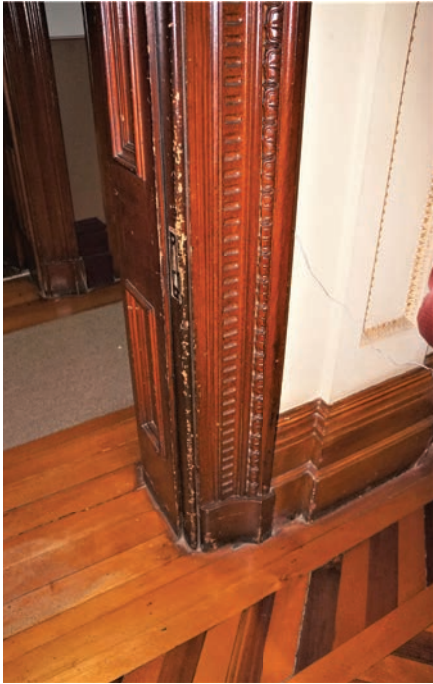
Figure 27: Far left: Jamb of door leading to servants' passage in the north west corner of the Central Hall. Note the damage to the edge of the frame, presumably from trolleys, etc.

4. Programmable Works			Priority (Highest priority is 1)		
Era type	A	Bowman	1	2	3
4.1	Refurbish parquet floor			6,000	
4.2	Repair damage to cement skirtings & rendered wall panels			5,000	
4.3	Wash down & redecorate throughout incl touching up woodwork			15,000

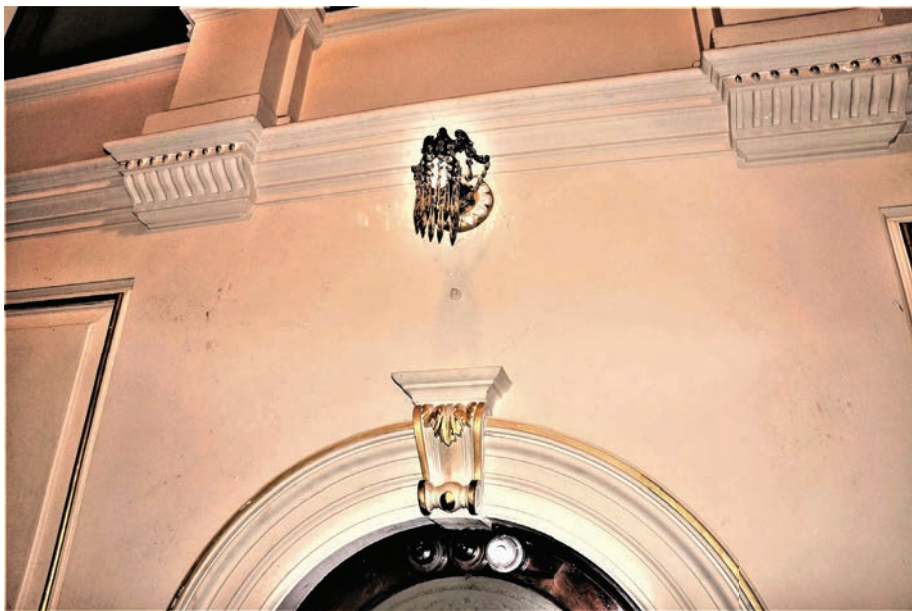
The landing is decorated with an aedicule window, acid etched glazed and ornamented with the initials EB (Edmund Bowman). There are cracks in the plaster over the window and, for some unknown reason that should be investigated, the paintwork has blistered on the walls to either side above the window. See Figures 30 and 32.

Figure 32: Head of
aedicule window over
central stair landing.
Note the cracking
and past plaster
repair around the
light fitting and the
blistering paint.

5. Programmable Works			Priority (Highest priority is 1)		
Era type	A	Bowman	1	2	3
5.1	Replace missing stair rod		750		
5.2	Repair woodwork to newel posts			2,000	
5.3	Repair damage to cement skirtings, rendered wall panels & all associated decorative render			5,000	
5.4	Wash down & redecorate throughout incl all walls & woodwork			20,000

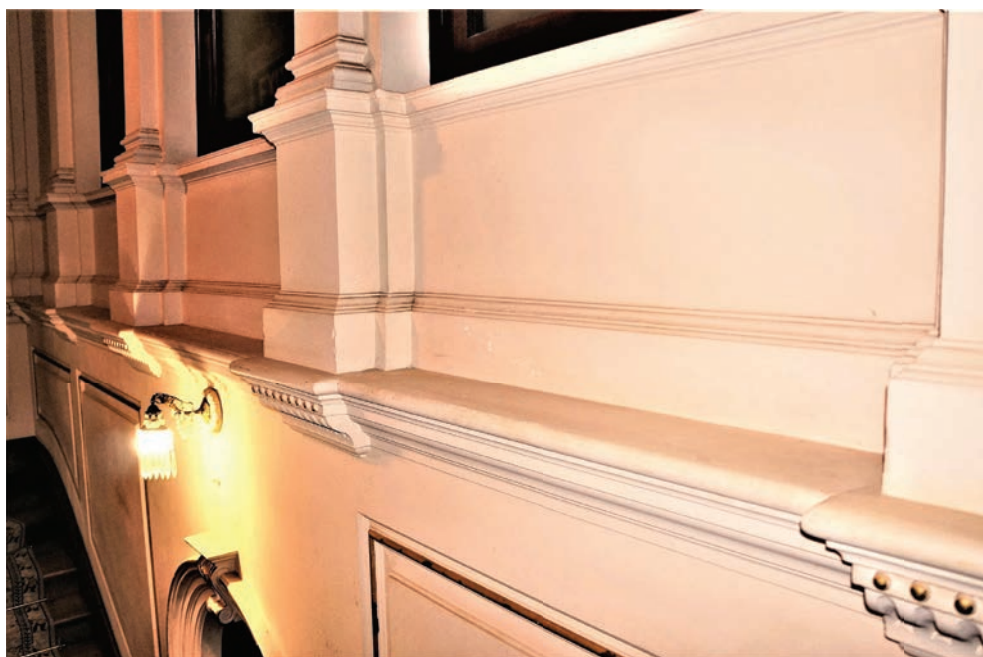
Figure 33:
There is minor damage and spoilt paintwork to the Parian cement base of the arcade of Corinthian columns.

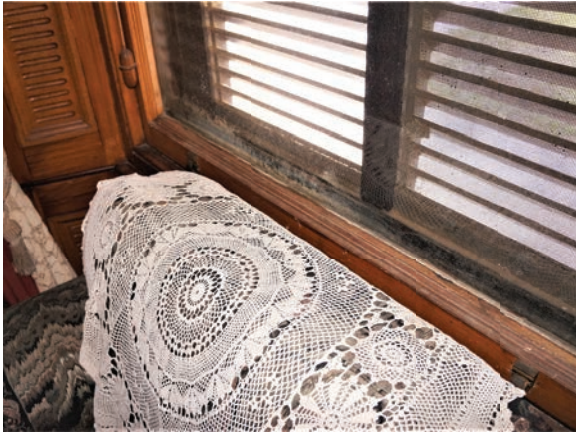
Figure 38: Above left: Grained woodwork and window hardware in need of refurbishment. Note the window glass has been 'etched' by bore water from sprinklers watering the lawn outside.

Room 6. Programmable Works			Priority (Highest priority is 1)		
Era Type	B	Mortlock	1	2	3
6.1	Repair damage to cement skirtings, rendered walls & cornices			5,000	
6.2	Conserve/ refurbish/ renew decoration throughout incl all walls, ceiling & woodwork			25,000	
6.3	Refurbish/ repair & redecorate timber flooring			5,000	
6.4	Conserve/ replace damaged hand-painted tiles to fireplace			3,000

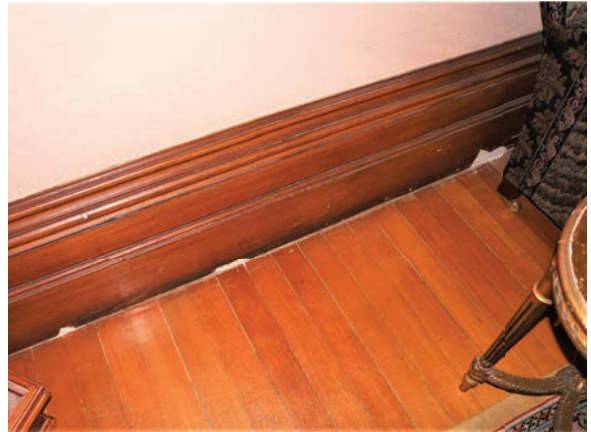
Figure 39: Above right: Damage to Parian cement skirting.

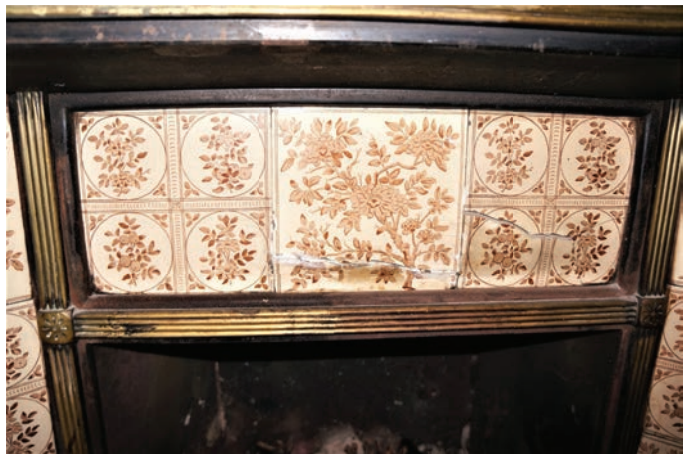
At the southern end of the room is an Edwardian style decorative brass and cast-iron fire box with inset hand painted tiles. The mantelpiece is elaborately carved in white Carrera marble. The hearth is tiled and protected by a white marble surround and all are seated on a Mintaro slate base. All is in reasonable condition but for some damage to the tiles above the firebox.

Figure 41: Above right: Damage hand-painted tiles over the fire box.

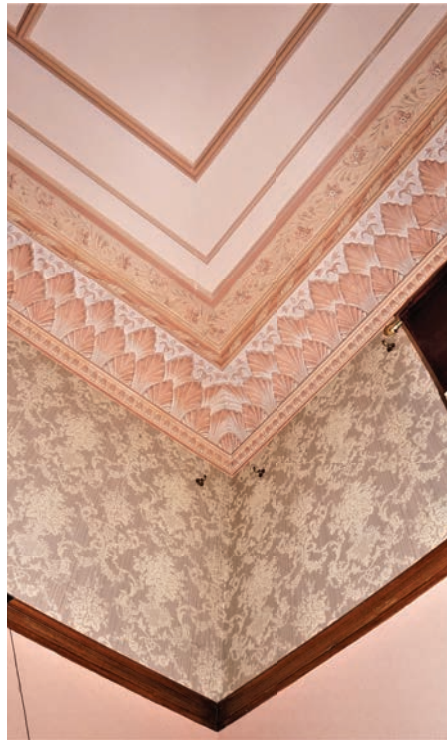
Figure 43: Left: View into the north east corner of the room. The wall paper here appears to have suffered the effects of damp.

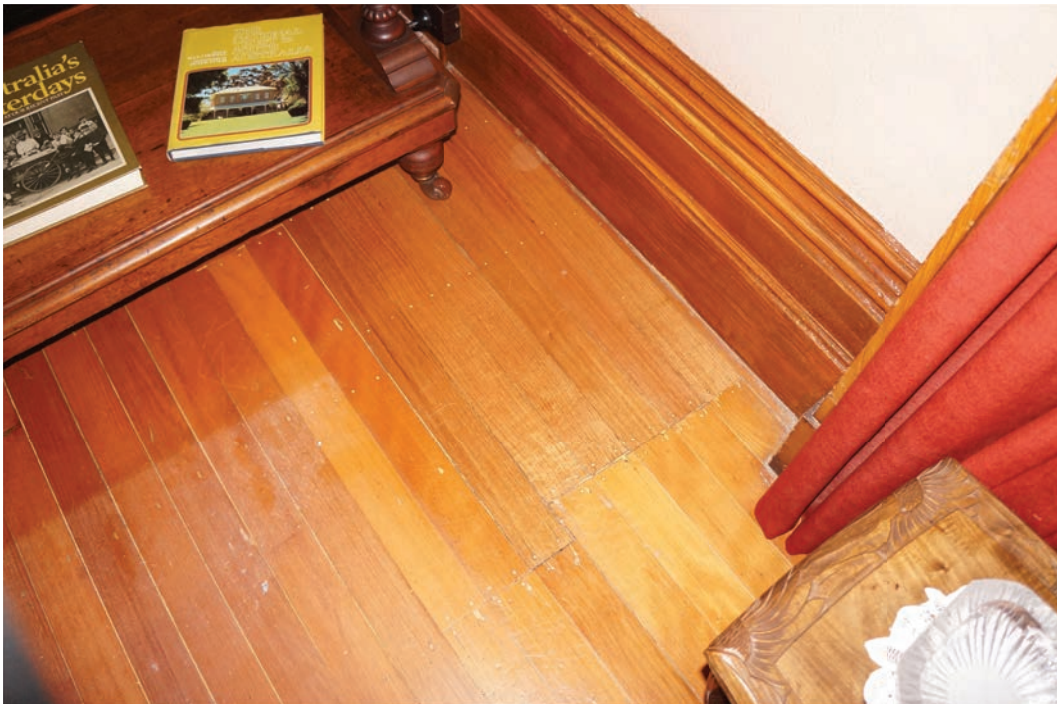
Figure 44: An area where the floor boards have been cut and lifted in the past.

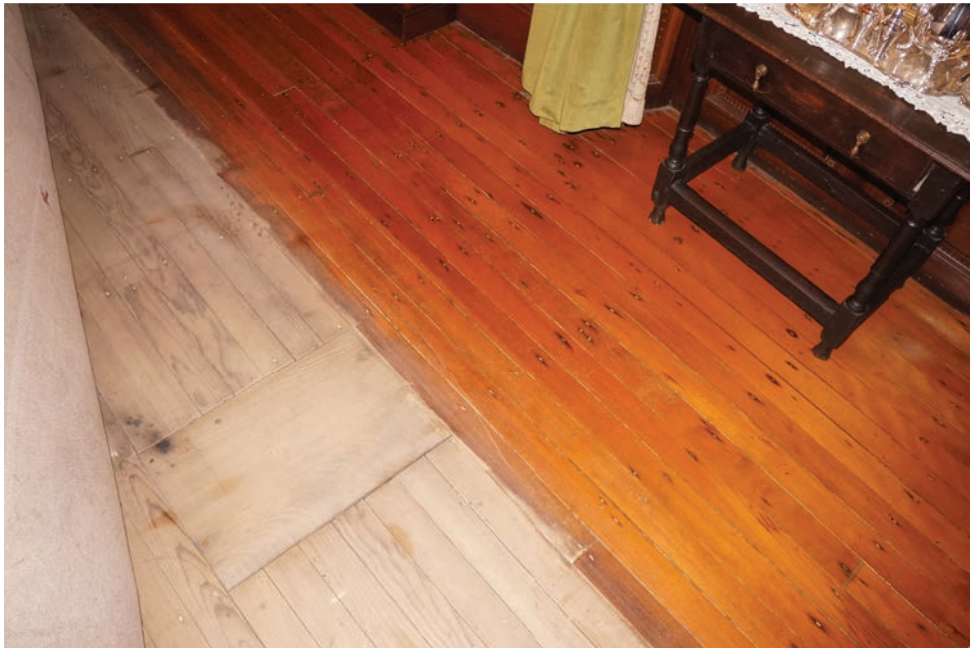
As with the Drawing Room, the floor has been lifted and not been well repaired afterwards. The area of timber flooring beneath the central rug is unfinished and has had an access hatch formed in it.

Figure 50:
Access hatch
concealed
under the
floor rug.

Room 7. Programmable Works			Priority (Highest priority is 1)		
Era Type	B	Mortlock	1	2	3
7.11	Repair damage to cement skirtings, rendered walls & cornices			5,000	
7.2	Conserve/ refurbish/ renew decoration throughout incl all walls, ceiling & woodwork			25,000	
7.3	Refurbish/ repair & redecorate timber flooring			6,000

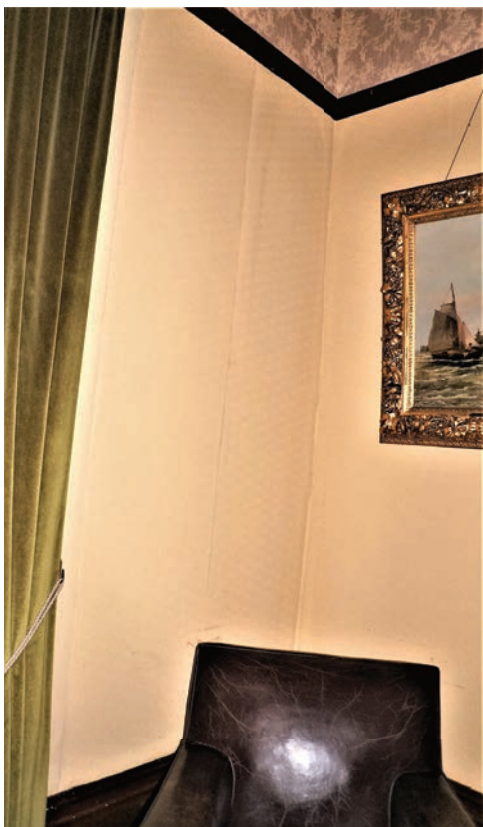
Although the south west corner looks to have been damp, where plaster is peeling off the wall, moisture readings taken during the survey proved negative. There is a rainwater pipe embedded in the external wall in this corner and this should be leak-tested.

Figure 51: Far
left: The wall
paper in the south
west corner is
peeling,
possibly due to
past damp- there
is a downpipe
embedded in the
external wall in
this corner.

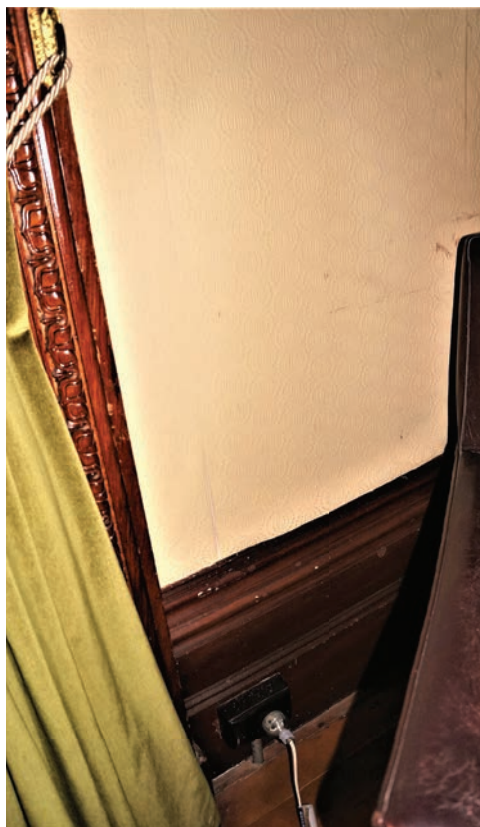
Figure 52:
Left: Close up of
peeling
wallpaper.

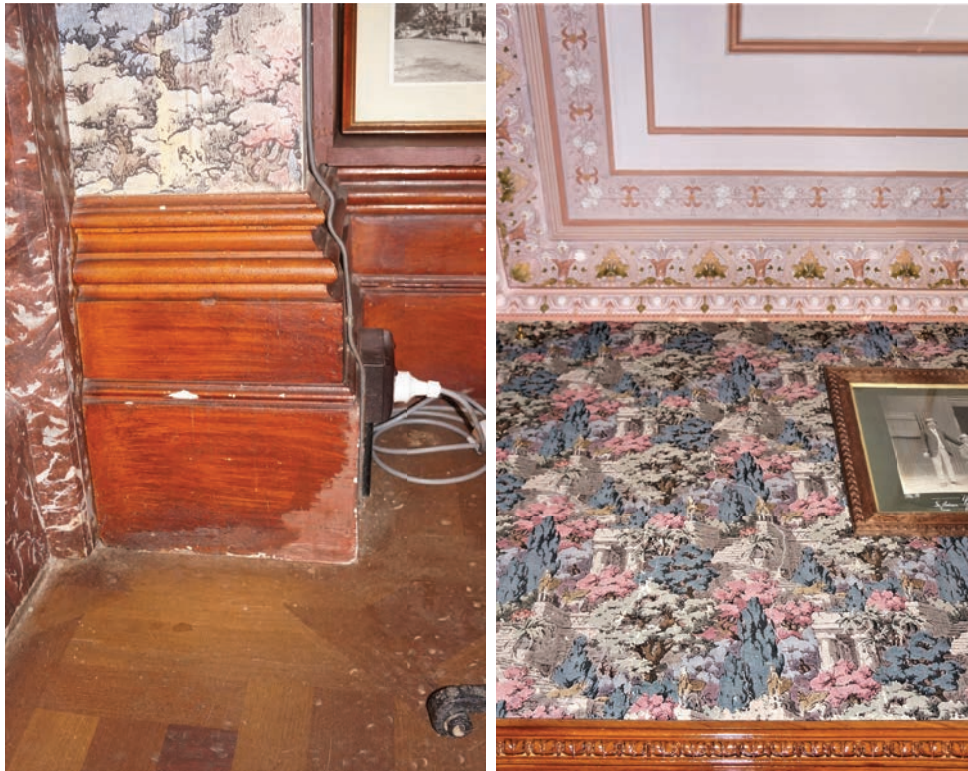
Figure 56: Above left: Poor past repair to moulded and grained skirting to the right of the fireplace.

Figure 57: Above right: Highly decorated green, blue and pink wall paper, possibly original. Highly decorated plaster cornice similar in style to that in the Dining Room. The wall paper shows movement cracks in the underlying plaster.

Room 8. Programmable Works			Priority (Highest priority is 1)		
Era type	A	Bowman	1	2	3
8.1	Repair damage to cement skirtings, rendered walls & cornices			5,000	
8.2	Conserve/ refurbish/ renew decorative finishes throughout, incl walls, ceiling & woodwork, as deemed appropriate			25,000	
8.3	Conserve/ refurbish linoleum floor finish			6,000

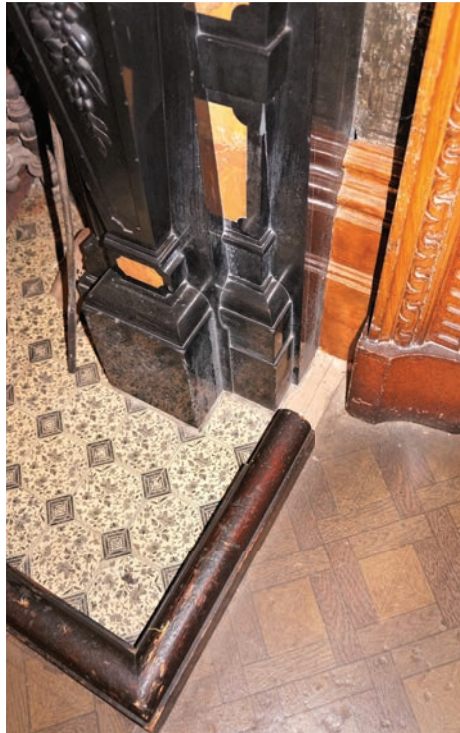
Figure 63: Left: The hearth's timber surround stops short of the skirting at both sides of the mantelpiece.

At the northern end of the room is a black marble mantelpiece inlaid with yellow marble with an ornately moulded black cast iron fire box. For no apparent reason the timber surround to the hearth now stops short of the skirting at both sides of the mantelpiece.

Room 9. Programmable Works			Priority (Highest priority is 1)		
Era type	B	Mortlock	1	2	3
9.1	Repair damage to cement skirtings, rendered walls & cornices			5,000	
9.2	Redecorate throughout incl all walls, ceiling & woodwork			35,000	
9.3	Refurbish linoleum floor finish			6,000	
9.4	Repair timber surround to hearth			1,000

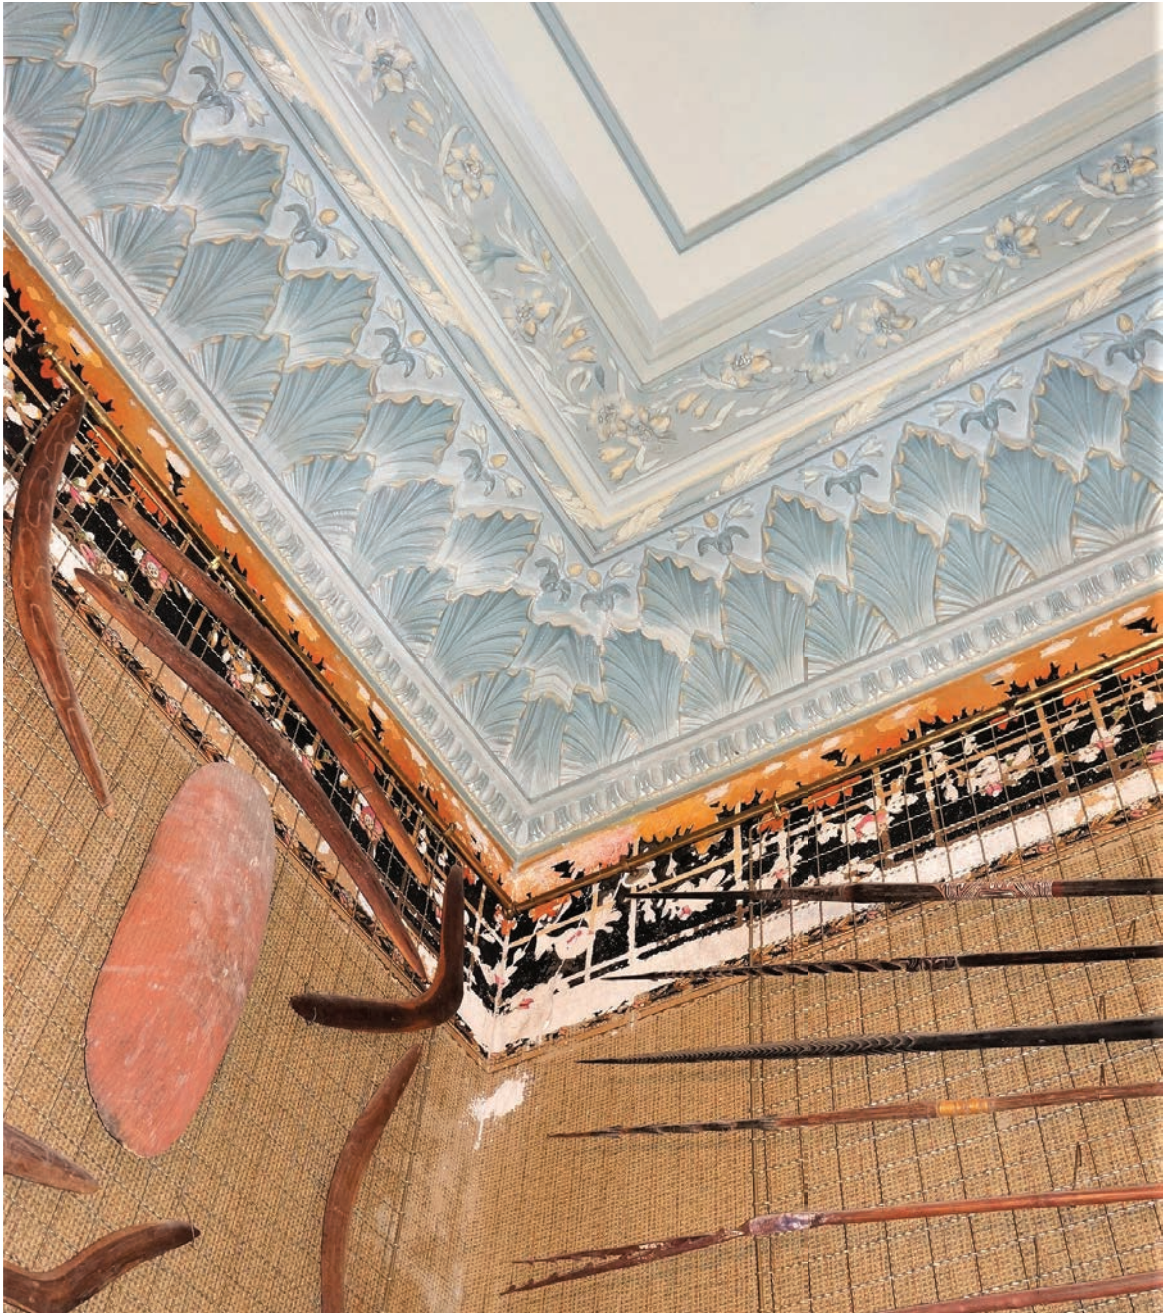
Walls in this room are topped with an Edwardian Art Nouveau style frieze and lined with a paper of woven mat appearance. A timber picture rail surrounds the room at door head height. The walls are lined with brass grid frames upon which are displayed the Mortlock collection of curios and weapons. The decorative frieze in the south east corner is showing signs of deterioration, possibly due to damp that might be traced back to a rainwater pipe that is embedded in the external wall in this corner. Moisture readings taken during the survey showing medium damp readings at 2 metres above floor level suggest that this pipe should be leak-tested.

Figure 64: View of south east corner showing Edwardian Art Nouveau style frieze beneath the decorative plaster cornice. Beneath the frieze are brass grid frames fixed over wall paper that has a woven mat appearance. Note the cracks in the corner plaster within the depth of the frieze, and the deterioration of the painted frieze itself, possibly due to the presence of moisture. There is a rainwater pipe embedded in the external wall in this corner.

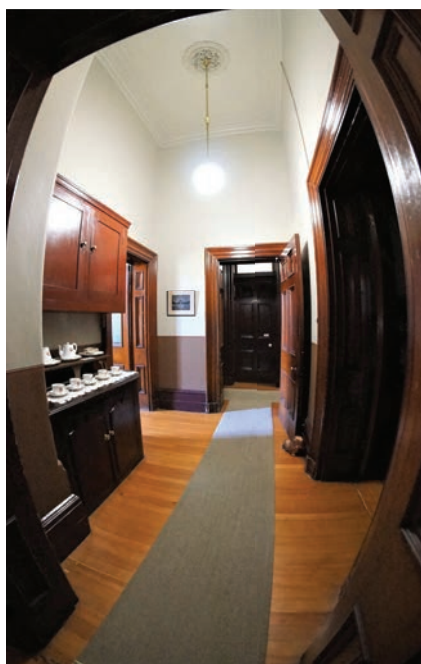
Door frame, door and architraves of the door leading from Dining Room into Servants Hall are damaged from trolley buffeting. For some unknown reason, there is a series of nails sticking out of the top of the architrave of the door to the dining room.

Figure 69: Wide-angled view taken from the doorway of the Dining Room looking towards the Housemaids Scullery. The Butler's Pantry is on the left.

Room 11. Programmable Works			Priority (Highest priority is 1)		
Era type	A	Bowman	1	2	3
11.1	Repair damage to cement skirtings, rendered walls & cornices			1,000	
11.2	Touch up paintwork to repaired render/ plasterwork areas			1,000	
11.3	Clean thoroughly throughout incl all walls, ceiling & woodwork			2,000	
11.4	Refurbish/ repair & redecorate timber flooring			2,000	
11.5	Remove nails from door architrave			100

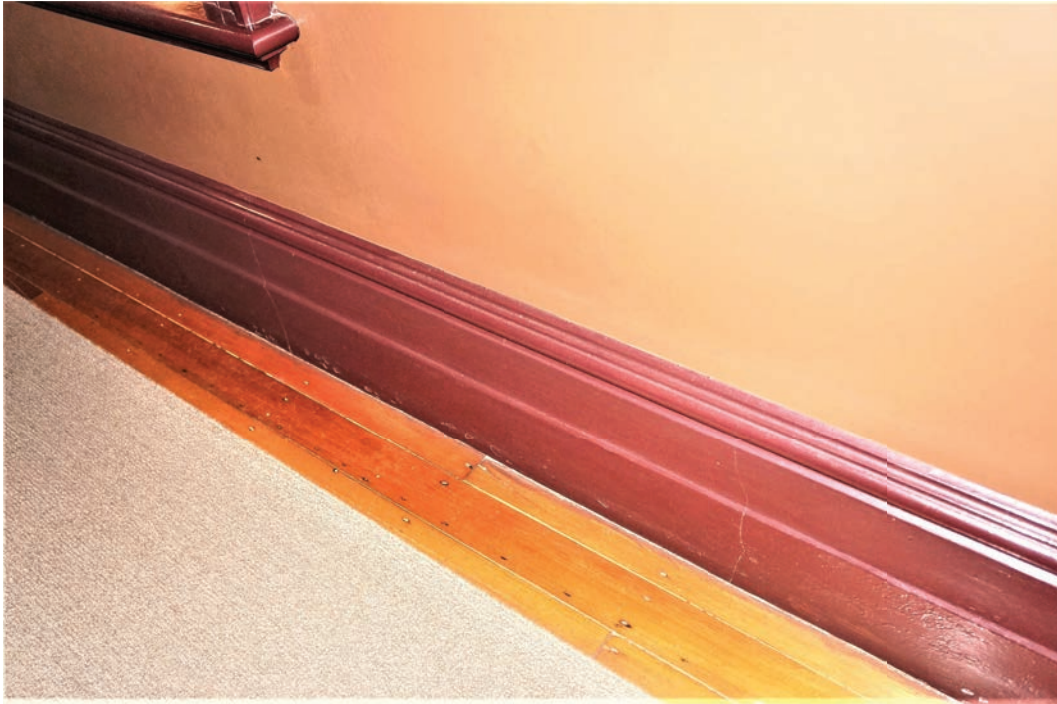
Figure 73: There are a number of cracks throughout the moulded cement skirting. Also, gaps in the timber flooring has been inappropriately filled in the past and is in need of proper refurbishment.

Room 13. Programmable Works			Priority (Highest priority is 1)		
Era type	A	Bowman	1	2	3
13.1	Repair damage to cement skirtings, rendered walls & cornices			1,500	
13.2	Redecorate throughout incl all walls, ceiling & woodwork			6,000	
13.3	Refurbish/ repair & redecorate timber flooring			2,000	
13.4	Provide working pendant light fixed to empty ceiling rose			2,000

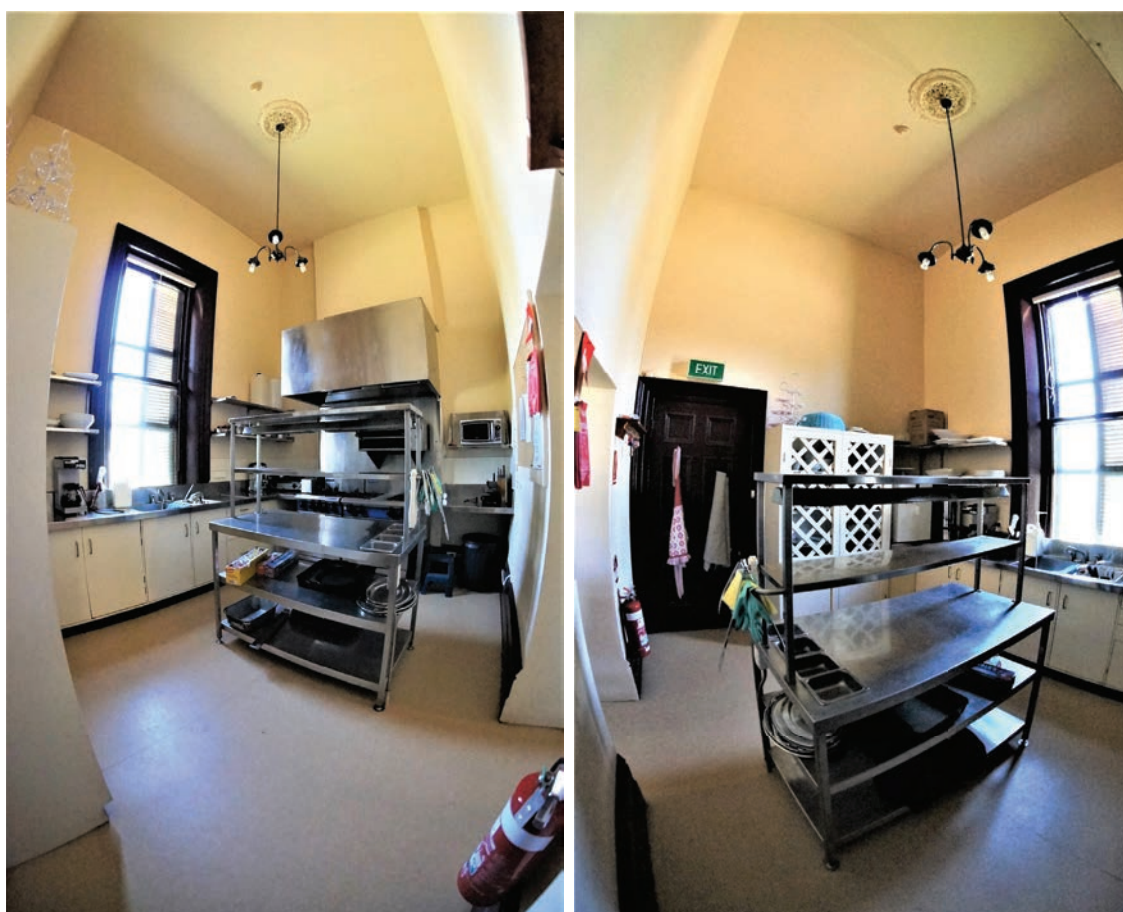
There are no plaster cornices to the walls and there is only a simple small ceiling rose. Walls are plain with a simple moulded plaster skirting (as per Servants Corridor). Arises of wall corners are generally staff moulded. 3 bowl Edwardian pendant light fitting. No hand basin installed. There is a dry chemical fire extinguisher sitting on the floor. There is a non-slip vinyl sheet floor finish. The kitchen base units are old and dilapidated and in need of replacement.

There are minor movement cracks in the plaster wall finish, in particular down the south east corner and running west from that corner just beneath ceiling level.

Figure 75: Above left: New Kitchen. View from doorway to Servants' Corridor.

Figure 76: Above right: New Kitchen. View looking back to doorway to Servants' Corridor.

Room 14. Programmable Works			Priority (Highest priority is 1)		
Era type	C	Post-Mortlock	1	2	3
14.1	Replace all base units		10,000		
14.2	Repair cracks in wall render			500	
14.3	Redecorate throughout incl all walls, ceiling & woodwork			5,000

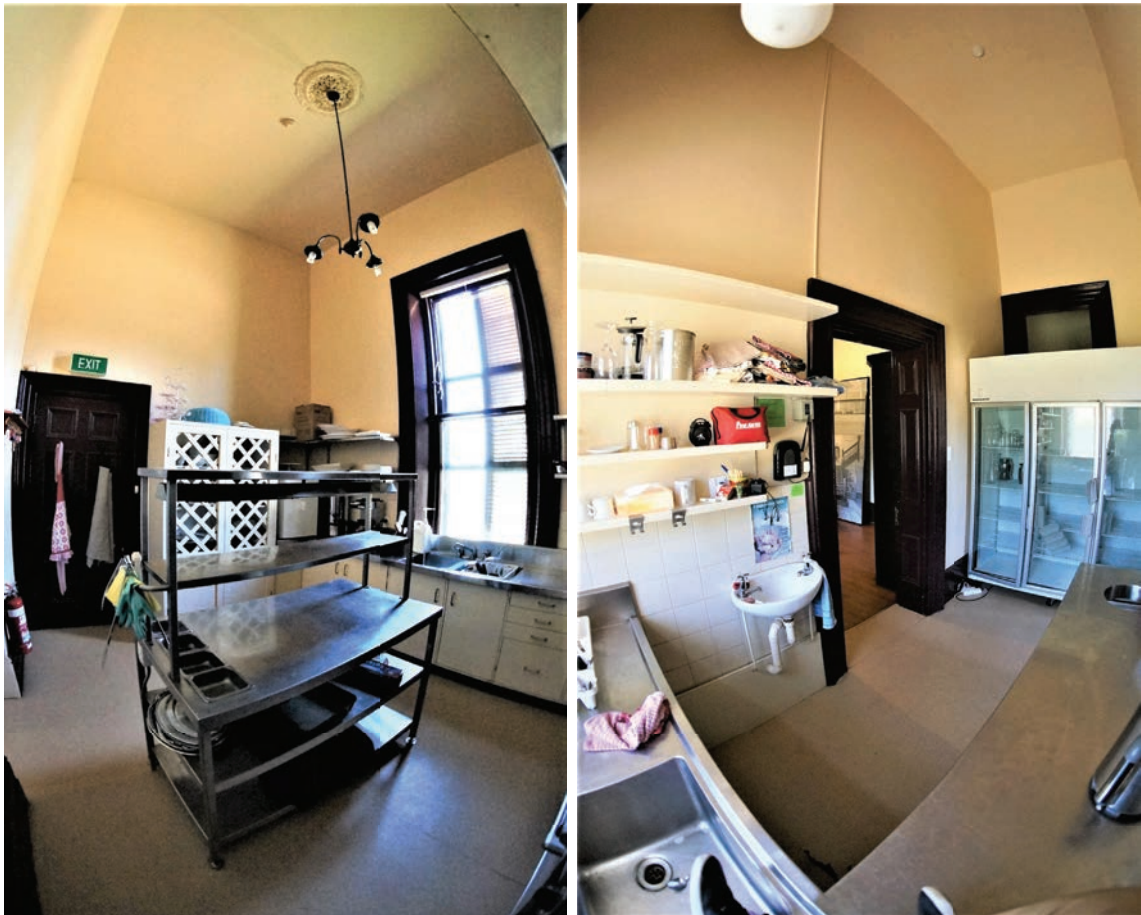
The non-slip vinyl sheet flooring under the sink beneath the window is not stuck down properly and is starting to disintegrate. The area under the sink may also be damp as the paint is peeling off the wall there and the plaster is becoming friable.

Figure 77: Above left: Wide-angled view looking through the doorway to the Old Kitchen.

Figure 78: Above right: Wide-angled view from next to the window looking back to the doorway of the Old Kitchen.

Room 15. Programmable Works			Priority (Highest priority is 1)		
Era type	A & C	Bowman & Post-Mortlock	1	2	3
15.1	Repair wall render under sink		1,000		
15.2	Repair & treat damp-affected timber flooring under sink		2,000		
15.3	Redecorate throughout incl all walls, ceiling & woodwork			3,000	
15.4	Replace sheet flooring		2,000

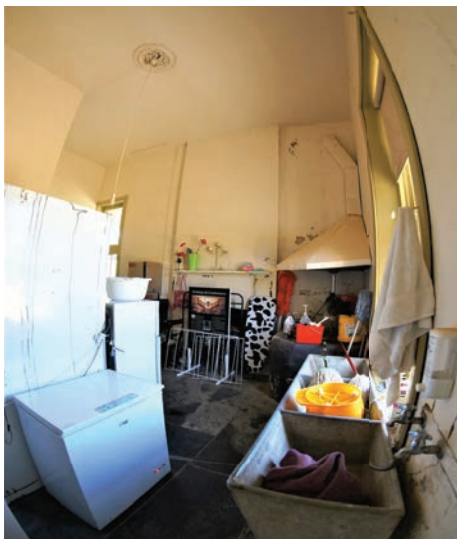
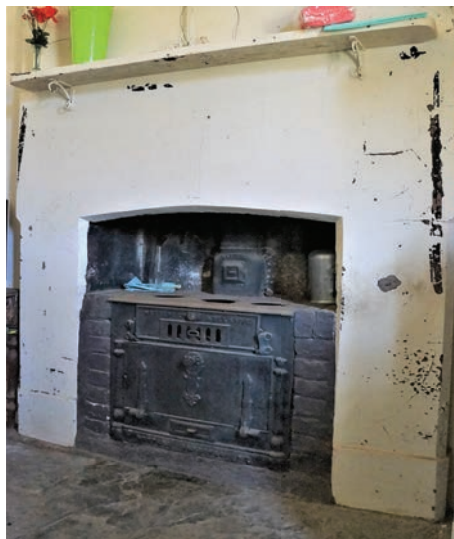
The finishes in the Laundry are in poor condition with much peeling paint and cracked wall and ceiling plaster. There is minor damage to the Metters range top.

Figure 85: Far left: View of Laundry looking west with Belfast sink in the foreground. The “Metters Adelaide” cast iron range to the left of the ventilation hood.

Figure 86: Left: The “Metters Adelaide” cast iron range.

Room 18. Programmable Works			Priority (Highest priority is 1)		
Era type	A & C	Bowman & Post-Mortlock	1	2	3
18.1	Repair laundry wall & ceiling render		2,000

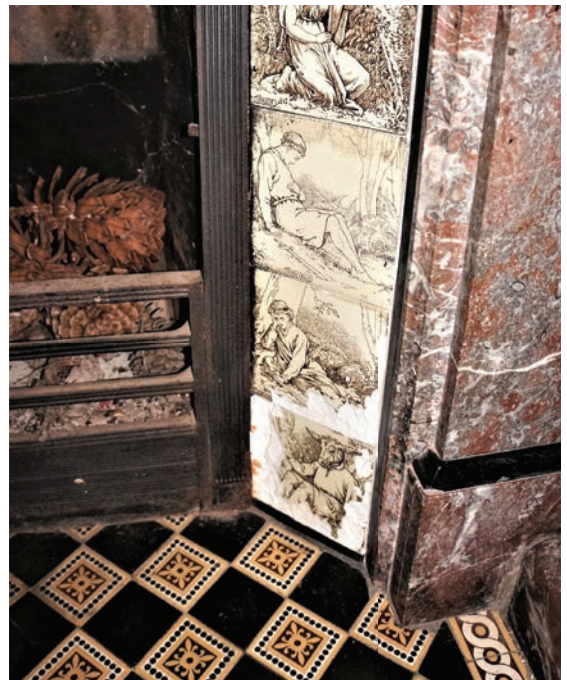
There are missing encaustic tiles to the hearth and the remaining tiles require to be refixed. The marble hearth surround also requires to be refixed. The two bottom tiles on the vertical edge of the fireplace are damaged and require to be repaired or replaced to match.

Figure 91: Above right: Detail of decorative tiles. Note the damage to the surface of the bottom two tiles.

Room 19. Programmable Works			Priority (Highest priority is 1)		
Era type	B	Mortlock	1	2	3
19.1	Repair/ replace vertical tiles to RHS of fireplace		2,500		
19.2	Provide new tiles & fix all tiles to hearth along with marble surround		2,500		
19.3	Repair damage to cement skirtings			500	
19.4	Redecorate throughout incl all walls, ceiling & woodwork			5,000	
19.5	Refurbish/ repair & redecorate timber flooring			2,000

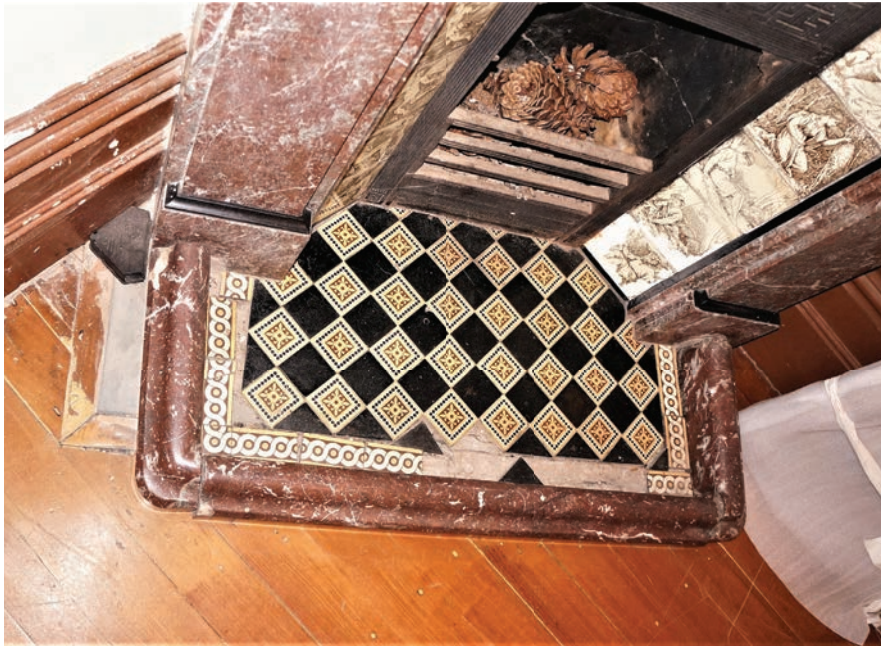
Figure 92: Left: The hearth of the fireplace has damaged and missing encaustic tiles. The marble surround is not fixed.

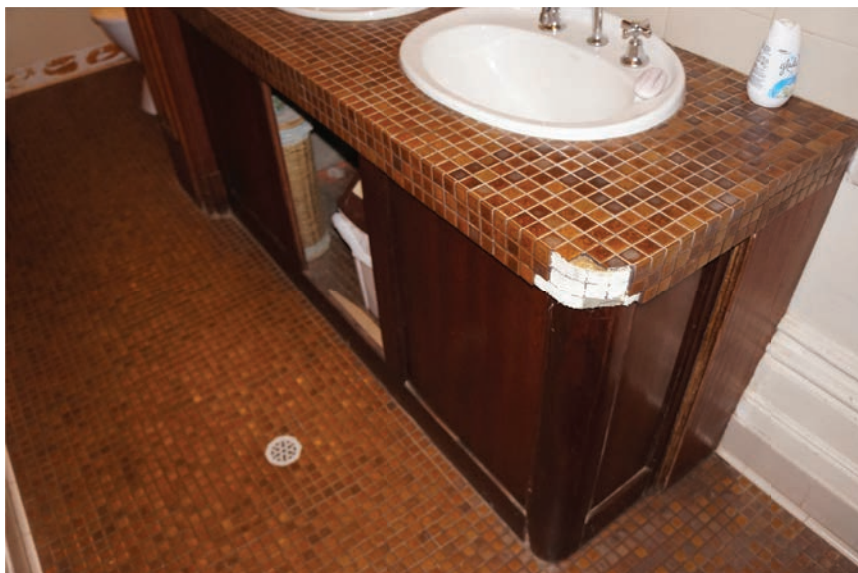
Overall, the finishes within the WC are in need of upgrading. The vanity unit and sinks are dilapidated and need to be replaced, as does the floor tiling and tiled skirtings.

Figure 96: The vanity bench needs to be refurbished. The mosaic tiles on the corner are damaged and there is a missing central panel.

Room 20. Programmable Works			Priority (Highest priority is 1)		
Era type	C	Post-Mortlock	1	2	3
20.1	Replace vanity unit & sinks, plus floor tiling & tiled skirtings		12,000		
20.2	Redecorate throughout incl all walls, ceiling & woodwork			5,000

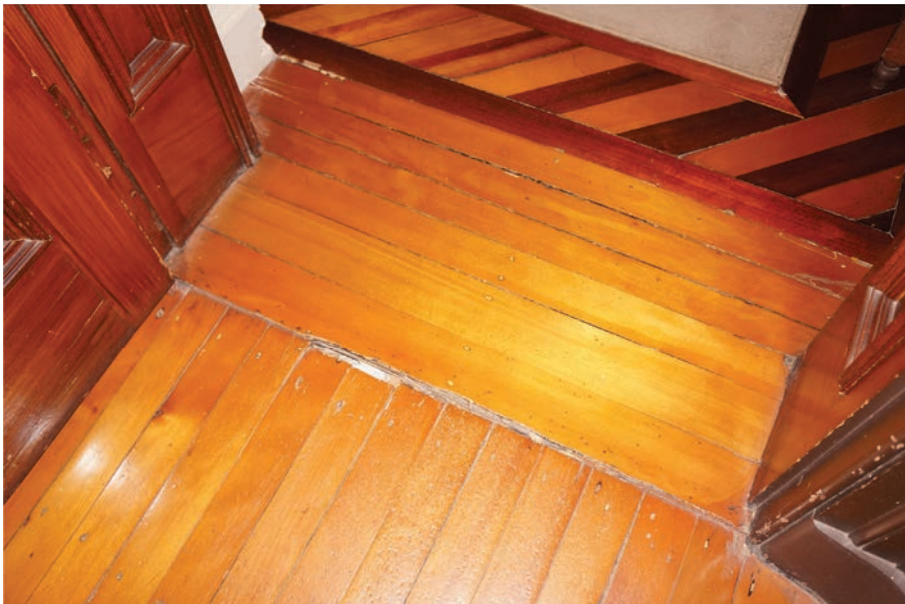
Figure 104: Plain floor boards at doorway to small, southern bedroom. Gaps in boarding have been filled poorly in the past.

Room 22. Programmable Works			Priority (Highest priority is 1)		
Era type	A	Bowman	1	2	3
22.1	Refurbish parquet floor & timber floor boarding throughout			15,000	
22.2	Repair damage to cement skirtings & rendered wall panels			10,000	
22.3	Redecorate throughout incl touching up woodwork			35,000

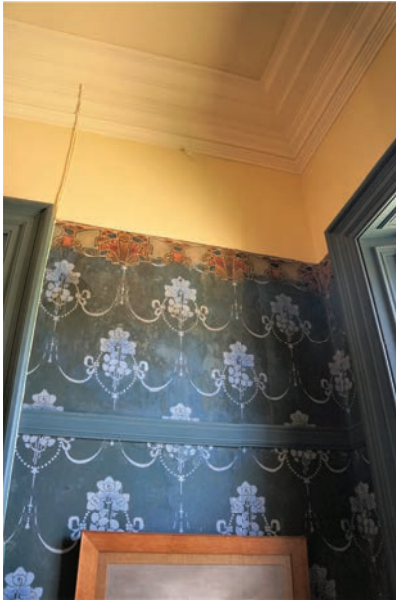
The wallpaper in the south east corner exhibits water staining where there is an adjacent rainwater downpipe embedded within the wall. Although tests for damp during the survey for

this CMP proved negative, suggesting that past leaks from the pipe may have been repaired, the downpipe should still be leak-tested.

Figure 112: Water stains on wall paper in south east corner. There is a downpipe embedded just here in this external wall.

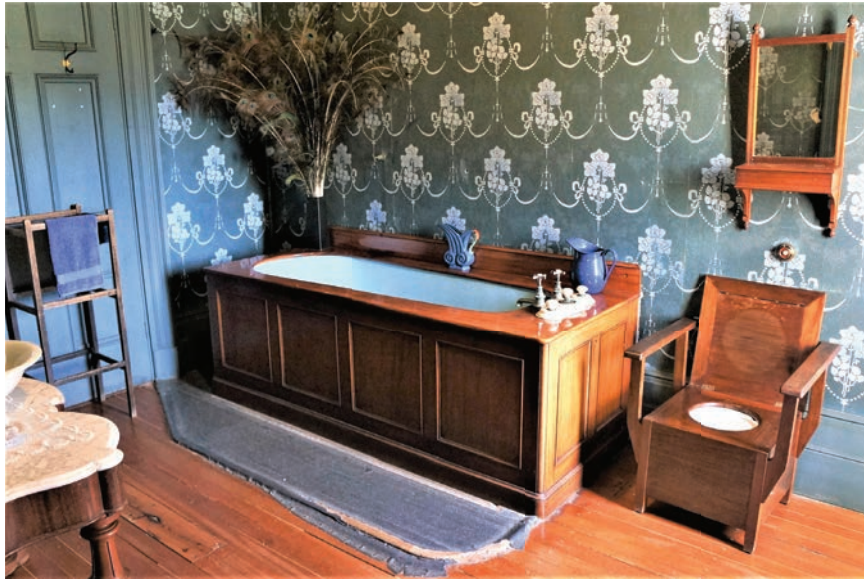
The bathroom contains a built-in metal bath, cased in a Spanish Mahogany surround. The original silver plated and enamel hot and cold-water tapware survives and surrounding the bath, (and presumably extending under it), is a lead tundish over the timber flooring. The lead is suffering from wear and tear, as are the other finishes in the room.

Figure 115: Left: Built-in metal bath with lead tundish over the timber flooring.

Room 24. Programmable Works			Priority (Highest priority is 1)		
Era Type	B	Mortlock	1	2	3
24.1	Stabilise lath & plaster ceiling. Repair all cracks		5,000		
24.2	Repair damage to cement skirtings, rendered walls, cornice & ceiling rose. Touch up decoration		2,000		
24.3	Conserve/ refurbish/ renew decoration throughout incl all walls, ceiling & woodwork			10,000	
24.4	Refurbish/ repair & redecorate timber flooring			5,000	
24.5	Conserve lead tundish to bath			5,000

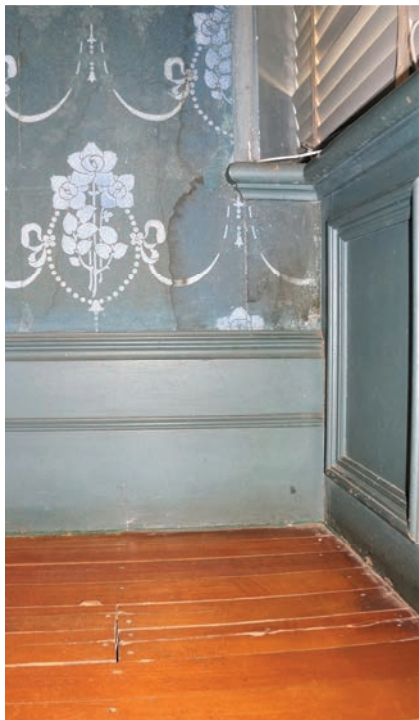
Figure 116: Far left: Water stains and general grime on the finishes. Note the damage to the timber floor.

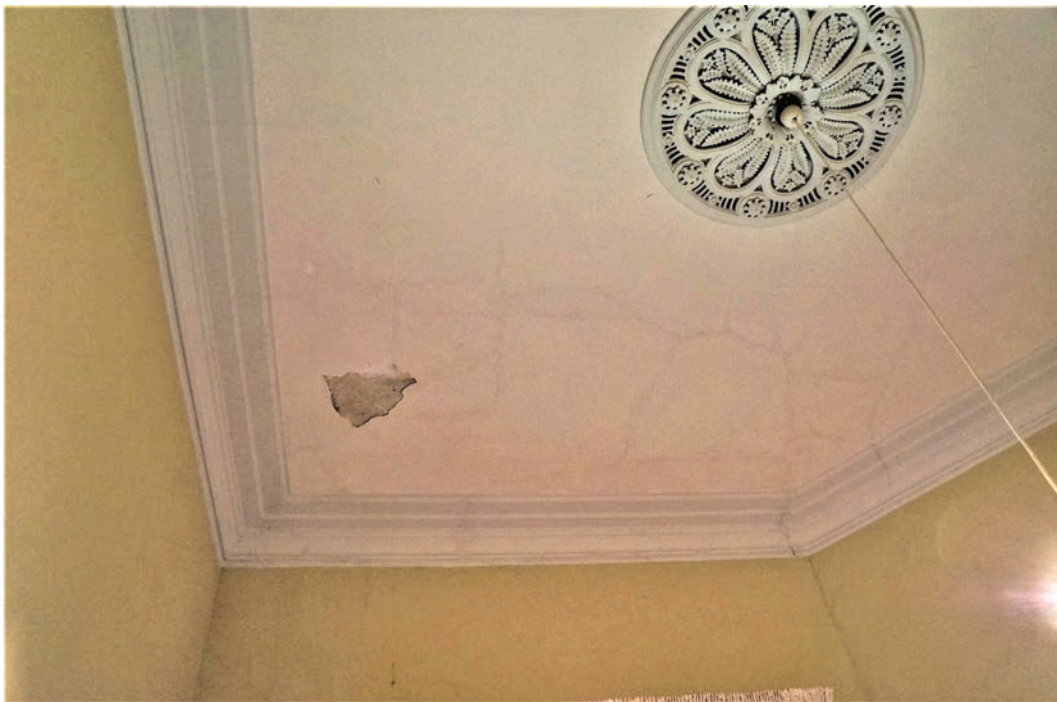
The ceiling has clearly been badly cracked in the past, and although it has been repaired there are still many cracks throughout, especially along the outside wall. In the south east corner, there is some current cracking to the wall plaster where there is an adjacent rainwater downpipe embedded in the wall. Although tests for damp during the survey for this CMP proved negative, suggesting that leaks from the pipe may have been repaired, the downpipe should still be leak-tested.

Figure 122: View of the ceiling along the outside wall. Note the past cracks that have been repaired and the current damage. There is an embedded rainwater pipe near this corner.

Room 26. Programmable Works			Priority (Highest priority is 1)		
Era Type	B	Mortlock	1	2	3
26.1	Stabilise lath & plaster ceiling. Repair all cracks		10,000		
26.2	Repair damage to cement skirtings, rendered walls, cornice & ceiling rose. Touch up decoration		5,000		
26.3	Wash down & refurbish finishes throughout incl all walls, ceiling & woodwork			10,000	
26.4	Refurbish/ repair & redecorate timber flooring			6,500
