MARTINDALE HALL

CONSERVATION MANAGEMENT PLAN

REV. A / NOV 2021

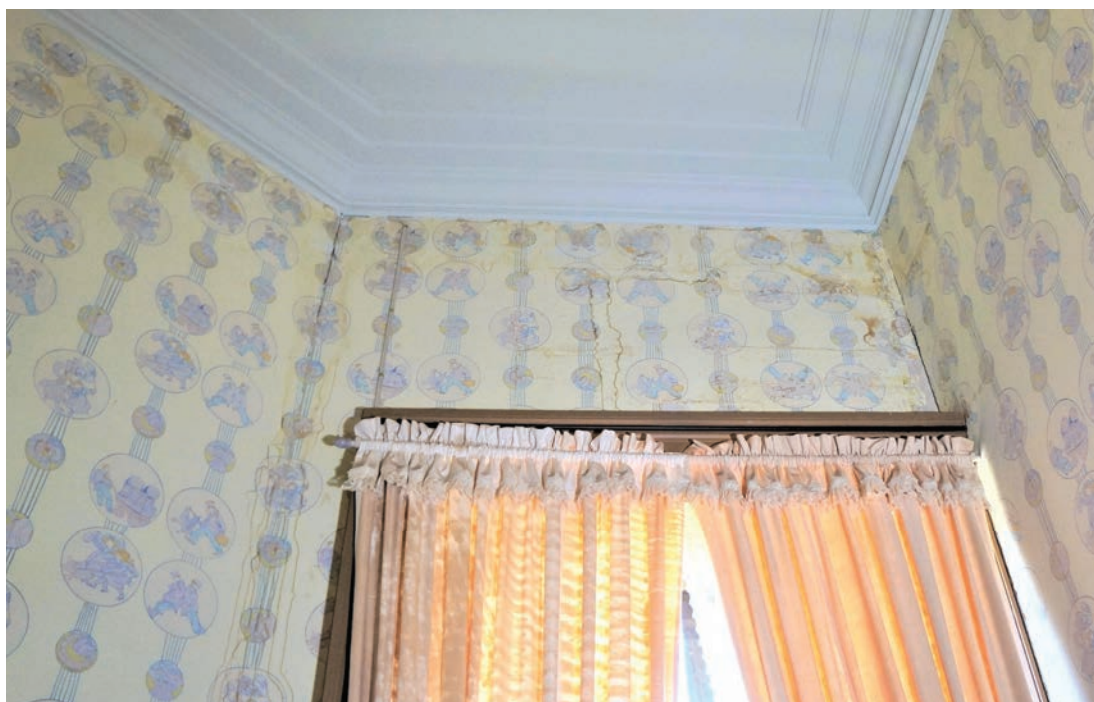
There have clearly been issues of water ingress along the outside wall as the wallpaper above the window is badly water marked. Tests for damp during the survey for this CMP proved negative so leaks, which might have been from a faulty gutter, may have been repaired.

Figure 127: Water staining on wall paper. Former Dressing Room.

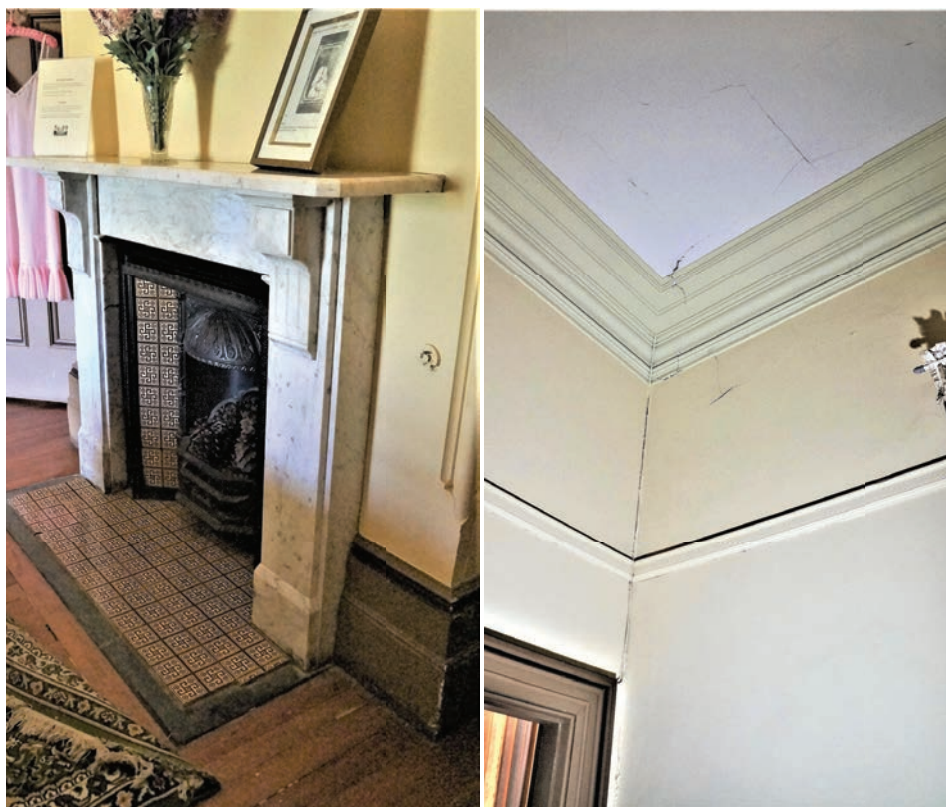
There are cracks in the plaster to the ceiling, cornice and external wall which may have been caused by water ingress. There is a rainwater pipe embedded in the external wall adjacent to this corner. Tests for damp, though, during the survey proved negative so leaks, which might have been from a faulty gutter or the downpipe, may have been repaired. It would still be advisable to water test the downpipe.

Figure 130: Above right: North west corner of room. Note the cracks in the ceiling and down the wall. There is a rainwater pipe embedded in the external wall beyond.

Room 28. Programmable Works			Priority (Highest priority is 1)		
Era Type	B	Mortlock	1	2	3
28.1	Stabilise lath & plaster ceiling. Repair all cracks		10,000		
28.2	Repair damage to cement skirtings, rendered walls, cornice & ceiling rose. Touch up decoration		5,000		
28.3	Wash down & refurbish finishes throughout incl all walls, ceiling & woodwork			10,000	
28.4	Refurbish/ repair & redecorate timber flooring			6,500

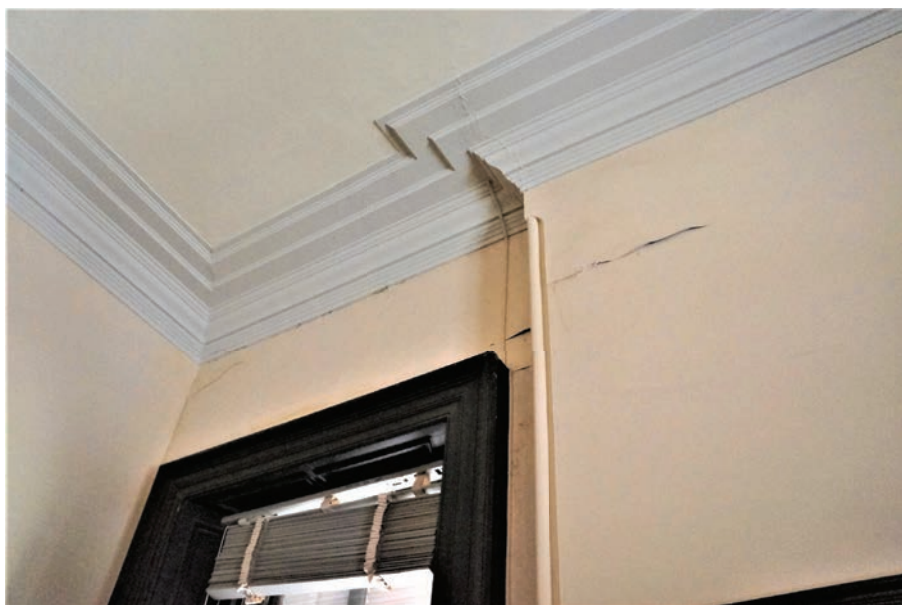
The disjointed mixture of applied finishes is not representative of a particular style or age. The room exhibits significant wear and tear to finishes but it is recommended that the status quo be maintained until the long-term strategy for the coordinated redecoration of the Mansion is determined.

Figure 135: Peeling paper and cracked plasterwork to the chimney breast.

Room 29. Programmable Works			Priority (Highest priority is 1)		
Era Type	B	Mortlock	1	2	3
29.1	Stabilise lath & plaster ceiling. Repair all cracks		10,000		
29.2	Repair damage to cement skirtings, rendered walls, cornice & ceiling rose. Touch up decoration		7,500		
29.3	Repair movement cracking to timber panelling			1,000	
29.4	Conserve/ refurbish/ renew decoration throughout incl all walls, ceiling & woodwork			25,000	
29.5	Refurbish/ repair & redecorate timber flooring			7,500

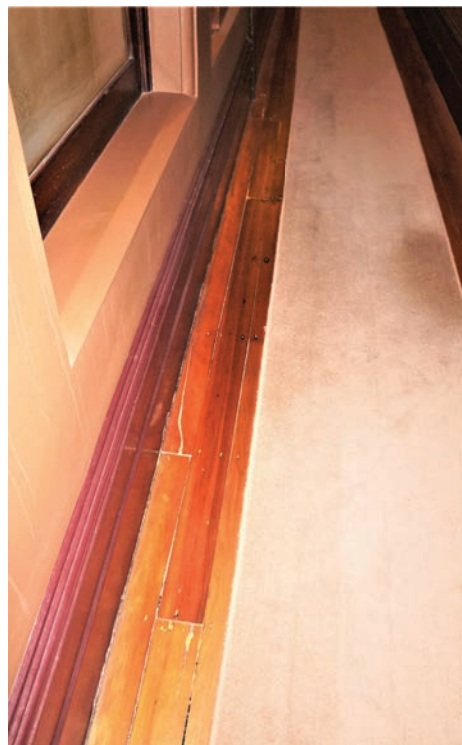
Figure 144: Left: Damaged flooring beneath the aedicule window to the Central Hall staircase.

Room 32. Programmable Works			Priority (Highest priority is 1)		
Era type	A	Bowman	1	2	3
32.1	Repair damage to cement skirtings, rendered walls & cornices			1,500	
32.2	Redecorate throughout incl all walls, ceiling & woodwork			6,000	
32.3	Refurbish/ repair & redecorate timber flooring			5,000

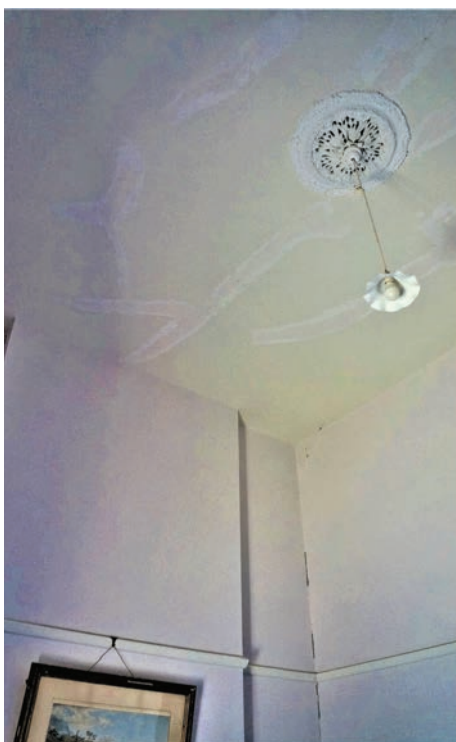
Figure 148: Left: The
ceiling has been badly
damaged in the past
as there is evidence of
many crack repairs.

Room 34. Programmable Works			Priority (Highest priority is 1)		
Era Type	B	Mortlock	1	2	3
34.1	Stabilise lath & plaster ceiling. Repair all cracks		10,000		
34.2	Repair damage to cement skirtings, rendered walls, cornice & ceiling rose. Touch up decoration		3,000		
34.3	Renew finishes throughout incl all walls, ceiling & woodwork			6,000	
34.4	Refurbish/ repair & redecorate timber flooring			4,000

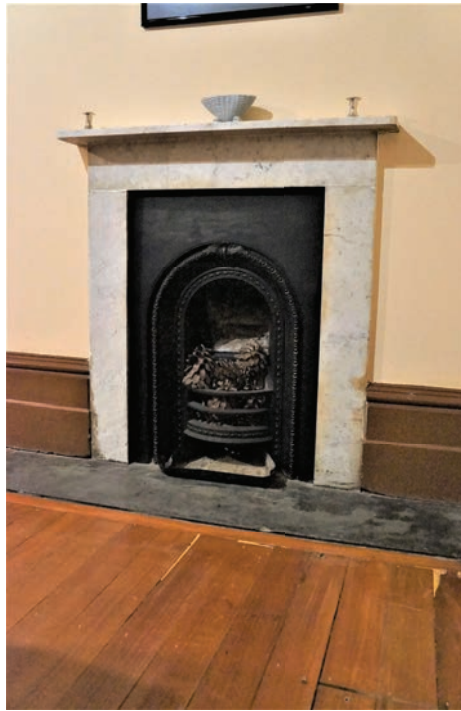
Figure 150: Left: Simple white marble fireplace surround with traditional cast iron fire box. Note damage to the floor boards.

The floor boards have been lifted in the past and poorly repaired afterwards. The space has been modernised to serve as a Boardroom. Apart from the poor condition of the flooring the décor of this room is sound, albeit devoid of original character.

Room 35. Programmable Works			Priority (Highest priority is 1)		
Era Type	C	Post-Mortlock	1	2	3
35.1	Stabilise lath & plaster ceiling. Repair all cracks		10,000		
35.2	Repair damage to cement skirtings, rendered walls, cornice & ceiling rose. Touch up decoration		3,000		
35.3	Remove modern light pendants & provide suitable pendant fitting from ceiling rose			3,000	
35.4	Renew finishes throughout incl all walls, ceiling & woodwork			6,000	
35.5	Refurbish/ repair & redecorate timber flooring			7,500

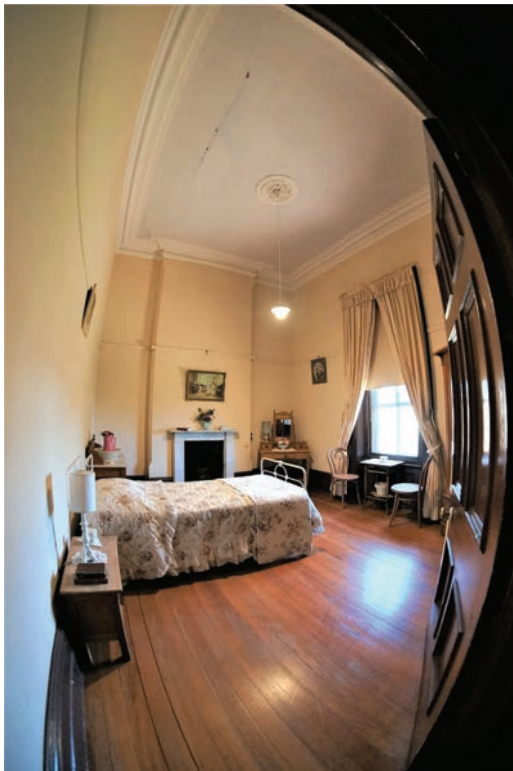
The ceiling is in particularly poor condition, with cracks throughout. Ceiling plaster fell shortly after the survey for this CMP in an area adjacent to the door. Investigations on the roof and inside the roof space above during the survey suggest that damage may have resulted from water ingress due to poor detailing of the 'new' roof, possibly exacerbated by debris from the old, disintegrated water tanks lying on the lath and plaster ceiling. The ceiling needs urgent attention, as do remedial repairs to the roof.

Figure 155: Wide-angled view of the Housekeeper's Bedroom taken from the doorway. Note the crack in the ceiling down the left-hand side. Since this photo was taken part of the ceiling plaster around this crack collapsed.

Room 38. Programmable Works			Priority (Highest priority is 1)		
Era Type	B	Mortlock	1	2	3
38.1	Stabilise lath & plaster ceiling. Repair all cracks		15,000		
38.2	Repair damage to cement skirtings, rendered walls, cornice & ceiling rose. Touch up decoration		3,000		
38.3	Wash down & refurbish finishes throughout incl all walls, ceiling & woodwork			10,000	
38.4	Refurbish/ repair & redecorate timber flooring			5,000

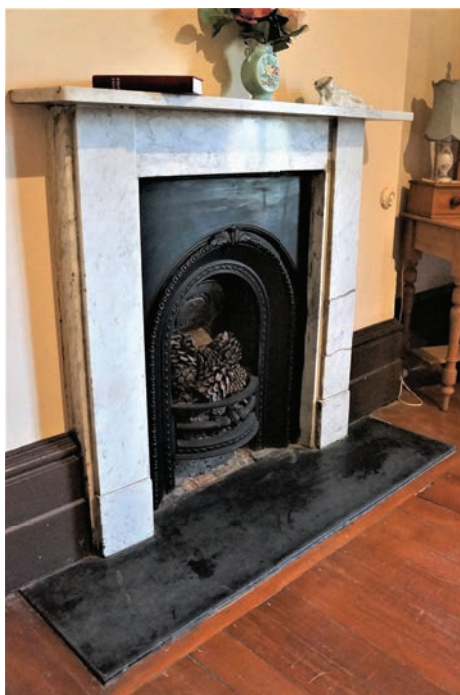
The simple grey marble fireplace surround with traditional arched-head cast iron fire box is only slightly more elaborate than those in the Boardroom and Guest Lounge. There is a crack to the righthand side of the marble surround.

Figure 156: Far left:
Simple white marble
fireplace surround
with traditional cast
iron fire box.

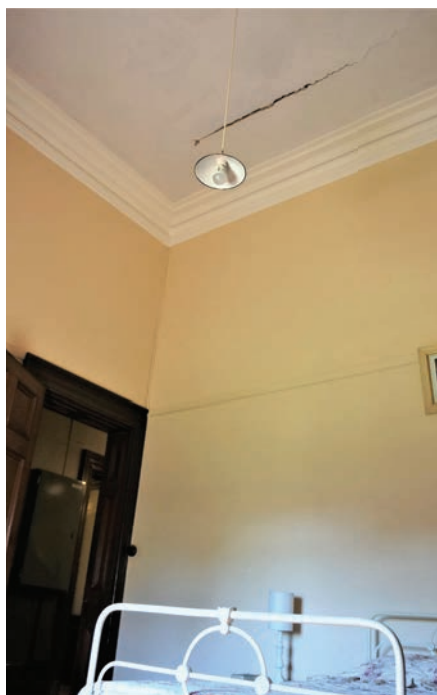
Figure 157: Left:
Serious crack in the
lath and plaster ceiling
above the door. Since
this photo was taken
part of the ceiling plas-
ter around this crack
collapsed.

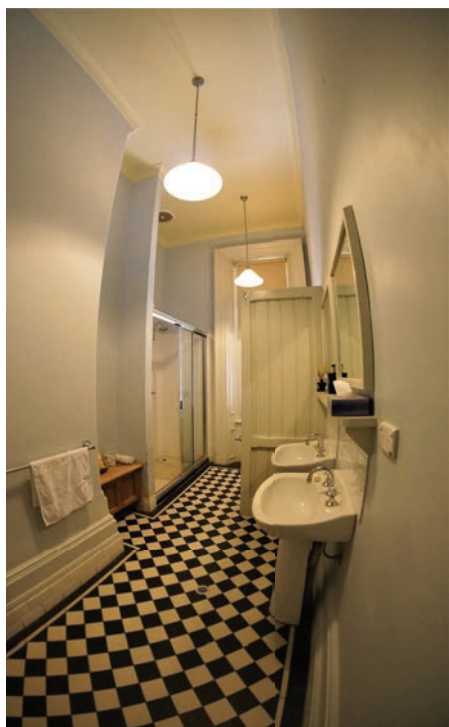
Figure 160: Far left: Wide-angled view of shower room taken near the entrance doorway. Note the remnants of moulded cement skirting.

Room 40. Programmable Works			Priority (Highest priority is 1)		
Era type	C	Post-Mortlock	1	2	3
40.1	Stabilise lath & plaster ceiling. Repair all cracks. Touch up decor		8,000		
40.2	Wash down & refurbish finishes throughout incl all walls, ceiling & woodwork			6,000

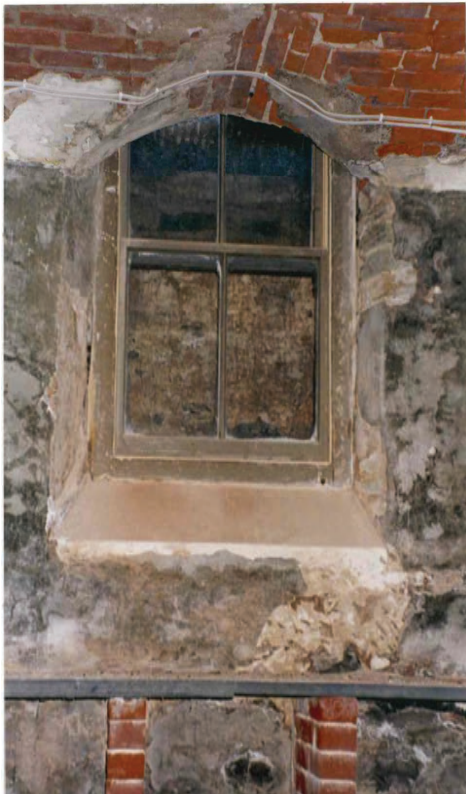
Perimeter and freestanding basement walls are of random rubble. The walls appear originally to have been left unfinished (see figure 164 which was taken around 1991), although Gregg's specification dated June 1878 states: *'To run Portland Cement square skirting 9" high $\frac{3}{4}"$ projection throughout the whole basement excepting larder'.* Although there is no longer any evidence of cement skirtings, these may have been concealed, or removed, when sacrificial lime render was subsequently applied to the walls. This has been during past salt damp repairs to the internal faces of the external walls, at which time silicon injection to internal walls was also apparently undertaken.

Figure 164: Above left: photo inside General Store area taken around 1991. (Photo credit: Conservation Plan by LeMessurier Architects, July 1991)

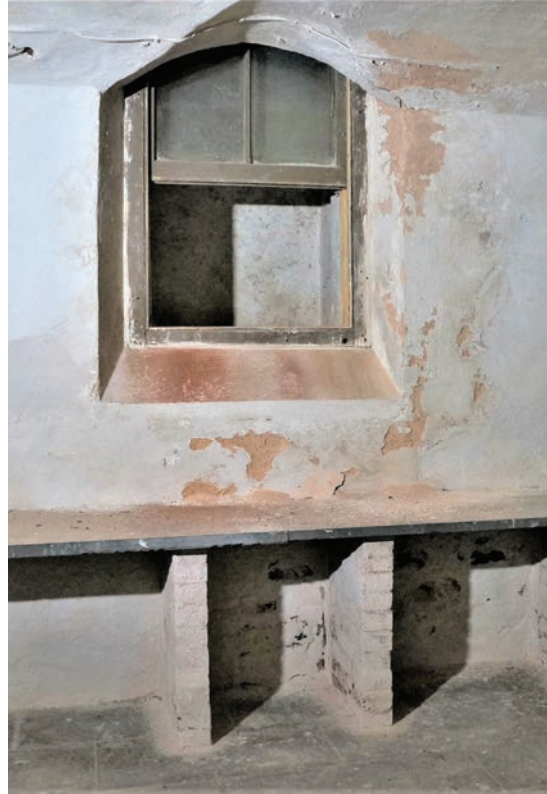
Throughout the basement there are piles of lime where it has spalled off, presumably from having become saturated with salt and moisture.

Figure 165: Above right: the same opening as in Figure 162 but photographed in 2019.

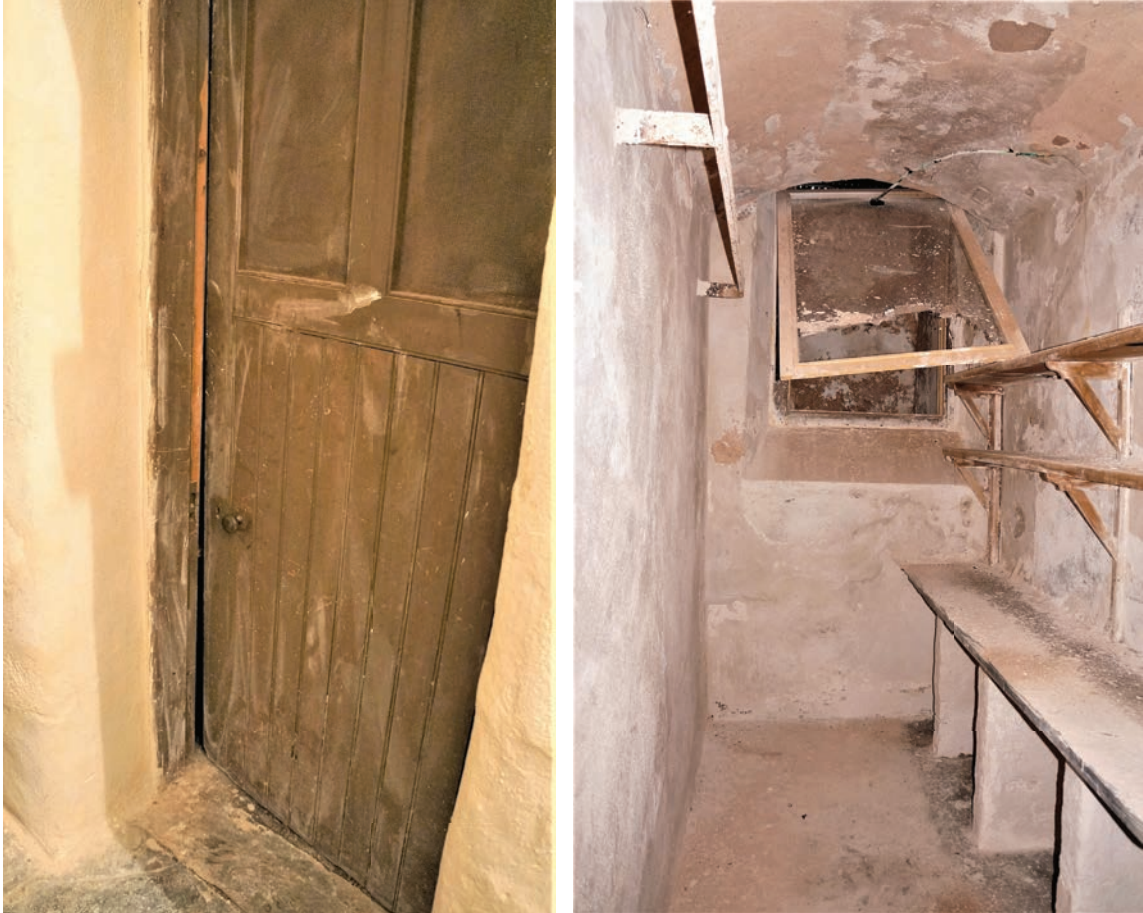
Windows to light/ ventilation wells were generally vertical sliding sashes with two lights per sash, each sash containing fly wire. Only the remnants of a few timber sashes remain, and only one sash, to the Larder for Uncooked Meat, still contains fly wire, albeit it is badly damaged.

Figure 167: Above left: Standard door to basement rooms. The double ventilating panels at the top containing fly wire.

Figure 168: Above right: The only remaining external window sash still containing fly wire, here to the Larder for Uncooked Meat.

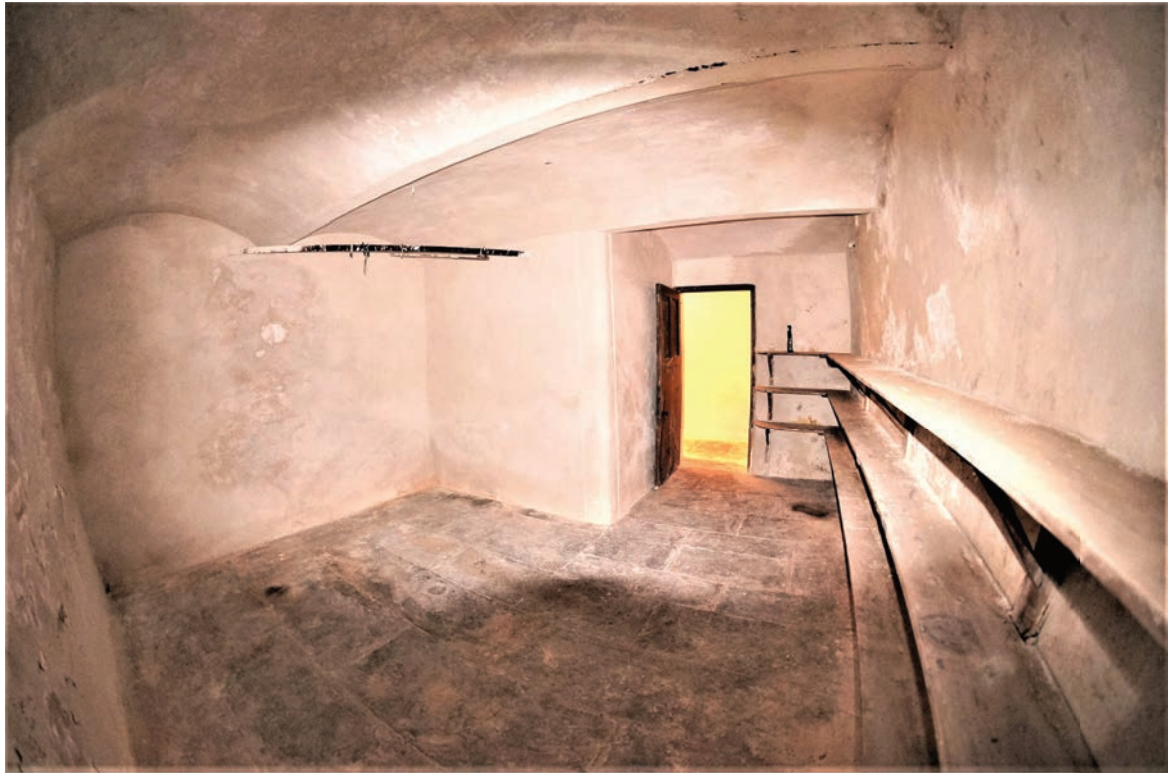
The walls and ceiling are fully rendered with lime plaster which is spalling off the walls. Only the window frame remains in the external opening while the original sashes are missing. The timber two-panel access door and frame appear to be sound.

Figure 171: Wide-angled photograph looking towards access passage.

Room B2. Programmable Works			Priority (Highest priority is 1)		
Era type	A	Bowman	1	2	3
B2.1	Refurbish slate flooring			5,000	
B2.2	Adapt ventilation well to provide natural light & more ventilation			3,000	
B2.3	Renew spalling lime plaster & limewash throughout			7,500	
B2.4	Re-establish timber sashes with insect mesh			2,000	
B2.5	Refurbish/ repair timber shelving			1,000

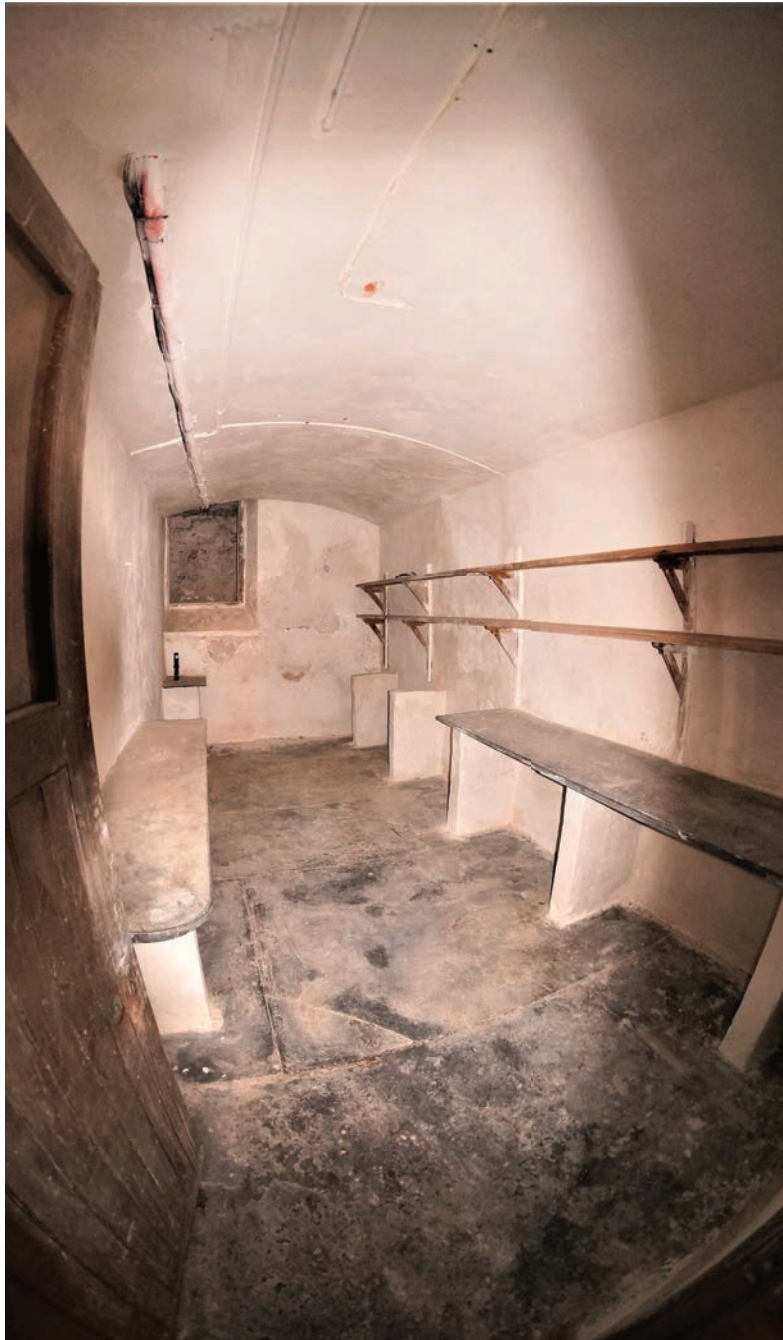
This space has both wall-mounted timber shelving and slate shelving supported on brick stools. Perhaps 40% of the slate shelving is missing. The walls and ceiling are fully rendered with lime plaster which is spalling off the walls. There is no lighting in the room.

Figure 174: Wide-angled view looking to external wall.

Room B3. Programmable Works			Priority (Highest priority is 1)		
Era type	A	Bowman	1	2	3
B3.1	Refurbish slate flooring			2,500	
B3.2	Adapt ventilation well to provide natural light & more ventilation			5,000	
B3.3	Renew spalling lime plaster & limewash throughout			2,500	
B3.4	Re-establish timber window sashes with insect mesh			2,000	
B3.5	Refurbish/ repair timber shelving			1,000

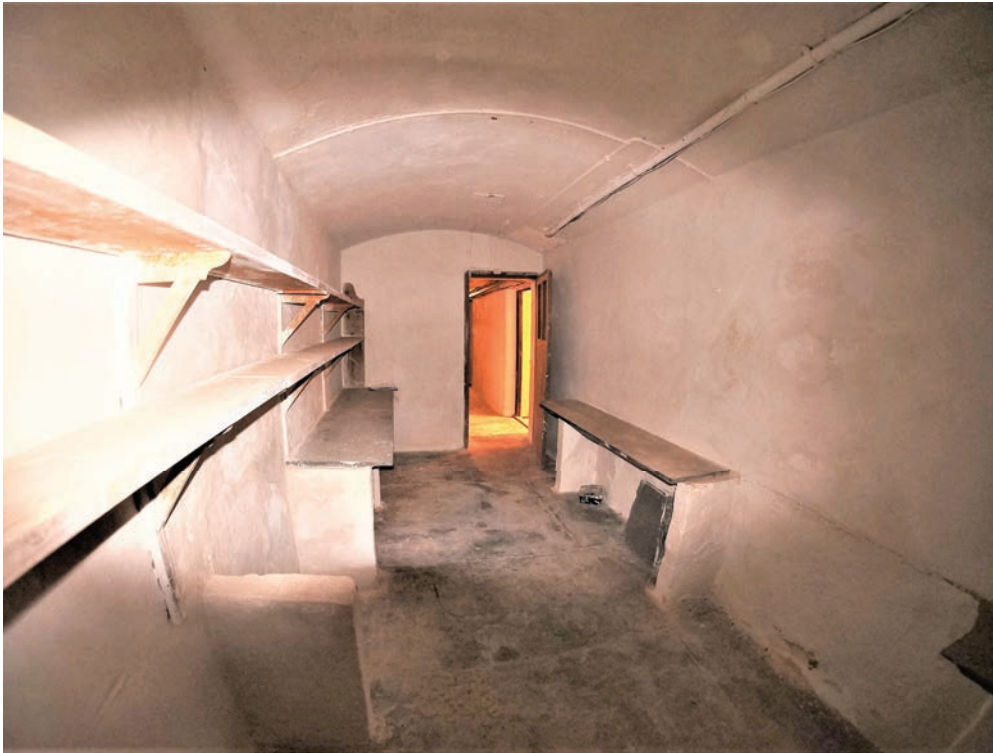
Figure 175:
Wide-
angled
view
looking to
access
passage.

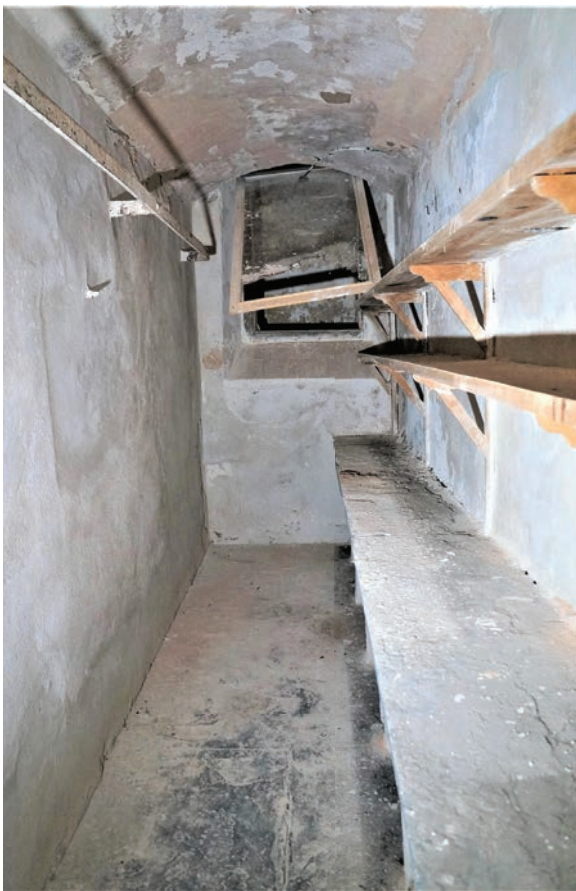
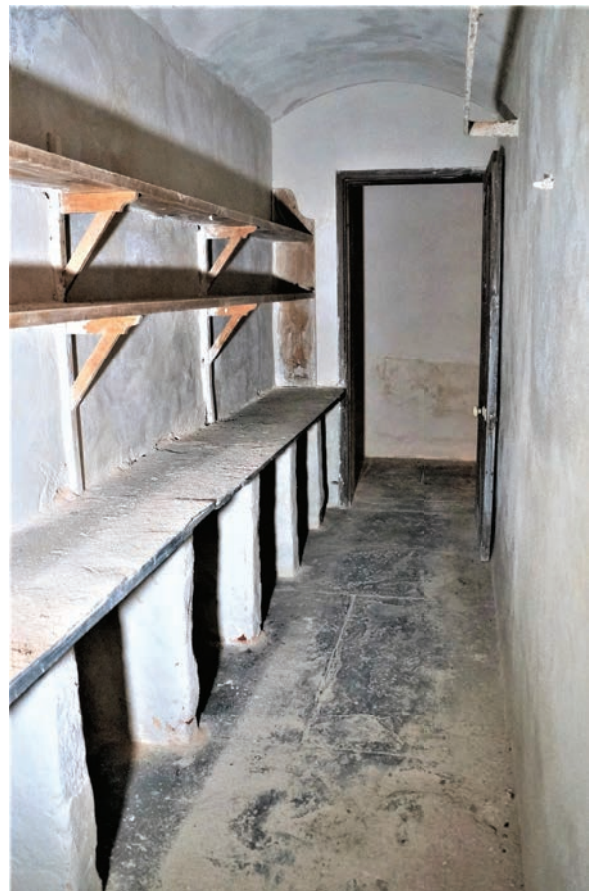
This is a narrow space with a timber two-panel access door at one end and external window at the other end. The room has wall-mounted timber shelving and slate shelving on brick stools to the full length of one side, and an iron flat-bar hanging rail along the opposite wall. Once again, the walls and ceiling are fully rendered with lime plaster which is spalling off.

Figure 176: Above left: View looking to external wall.

Figure 177: Above right: View looking to access passage.

Room B4. Programmable Works			Priority (Highest priority is 1)		
Era type	A	Bowman	1	2	3
B4.1	Refurbish slate flooring			2,000	
B4.2	Adapt ventilation well to provide natural light & more ventilation			3,000	
B4.3	Renew spalling lime plaster & limewash throughout			2,500	
B4.4	Re-establish timber window sashes with insect mesh			2,000	
B4.5	Refurbish/ repair timber shelving			1,000	
B4.6	Reinstate damaged slate shelving			2,000

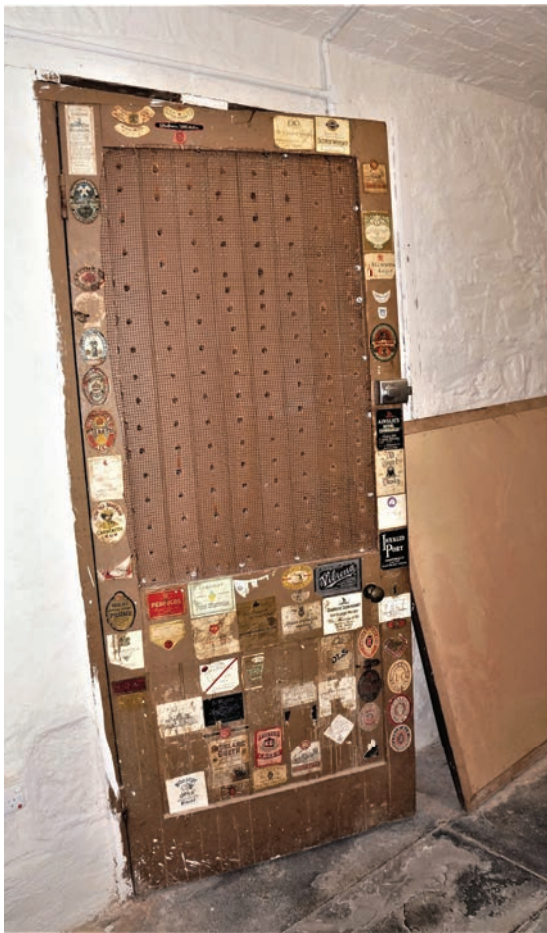
Ventilation has been provided through the solid timber access door by means of a series of holes that have been roughly drilled through the top. These have been covered internally with wire mesh. The door has been decorated internally with various drinks labels, which, judging by their age, were presumably applied during the Mortlock family era.

Figure 183: Above left: Inside face of wine cellar door decorated with drinks labels. Note the ventilation holes covered by wire mesh and the relatively new lock.

Room B6. Programmable Works			Priority (Highest priority is 1)		
Era type	B	Mortlock	1	2	3
B6.1	Refurbish slate flooring			3,000	
B6.2	Renew spalling lime plaster & limewash throughout			4,000	
B6.3	Conserve drinks labels on door			1,000

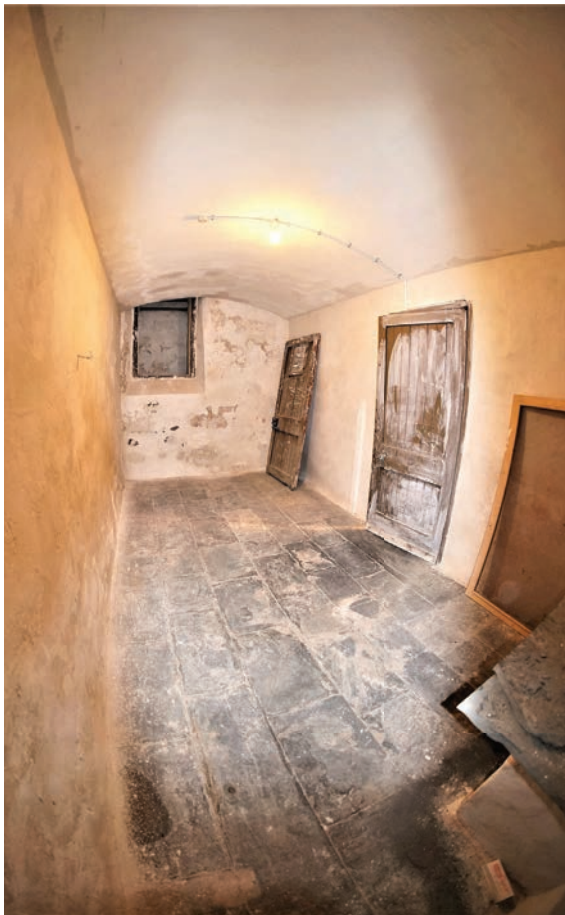
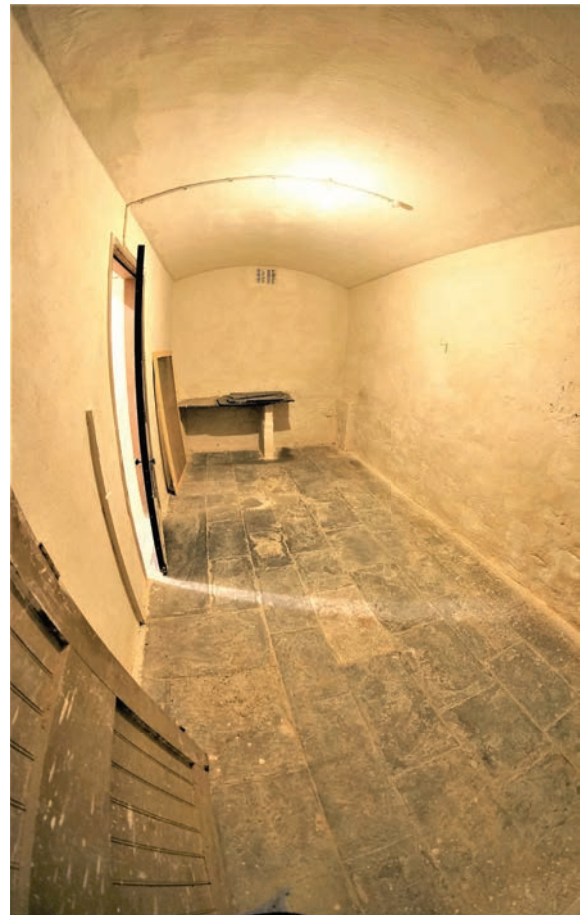
The small store at the south-east end of the main passage has lime render to the walls and ceiling, which, once again is spalling off, particularly around the outside wall. The window frame to the ventilation/ light well remains but without its accompanying sashes.

Figure 186: Above left: Wide-angled view looking south.

Figure 187: Above right: Wide-angled view looking north.

There is slate shelving along the north wall, half of which is broken. The solid timber access door and frame appear sound. Another solid timber door being stored in the space may originally have been fitted at the bottom of the delivery steps where the remnants of a door frame remain.

Room B7. Programmable Works			Priority (Highest priority is 1)		
Era type	A & C	Bowman/ Post-Mortlock	1	2	3
B7.1	Refurbish slate flooring			3,000	
B7.2	Adapt ventilation well to provide natural light & more ventilation			3,000	
B7.3	Renew spalling lime plaster & limewash throughout			3,500	
B7.4	Re-establish timber window sashes with insect mesh			2,000	
B7.5	Repair damaged slate shelving			1,000

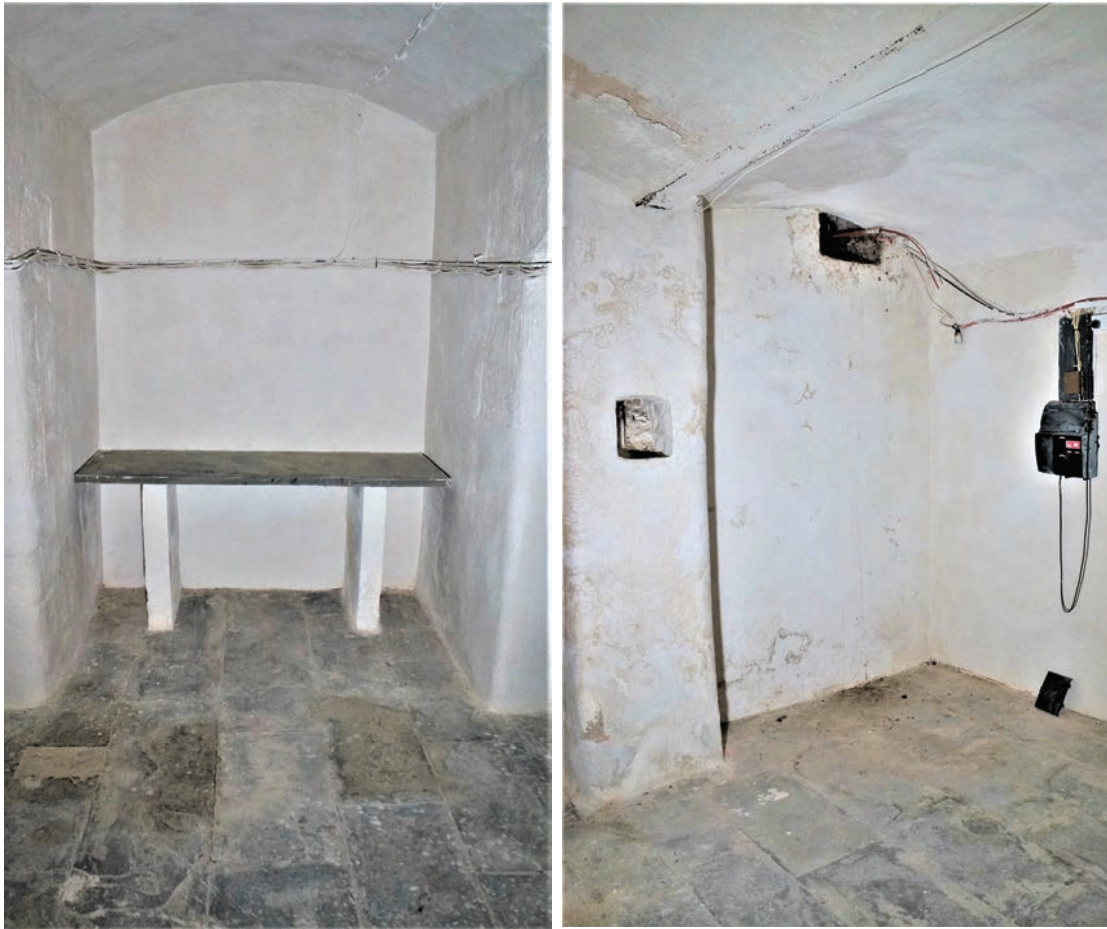
Figure 192: Above right: View inside the largest compartment looking into the north west corner. The hole at ceiling level from which cables are running appears to be one of two ventilators in this compartment that may be linked to ventilation grilles at ground level externally. A third one in the small, central compartment appears to have been covered over.

Room B8. Programmable Works			Priority (Highest priority is 1)		
Era type	B	Mortlock	1	2	3
B8.1	Refurbish slate flooring. Assume replacement of some slate flags			6,000	
B8.2	Adapt ventilation wells to provide natural light & more ventilation			6,000	
B8.3	Renew spalling lime plaster & limewash throughout			6,000	
B8.4	Re-establish timber window sashes with insect mesh			2,000	
B8.5	Reinstate damaged slate shelving			2,000	
B8.6	Conserve newspaper to door			500

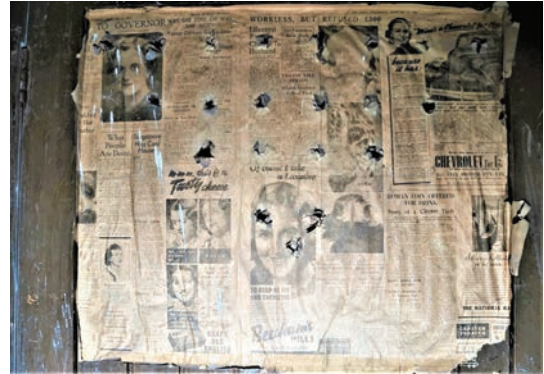
The timber framed and boarded access door has been adapted to provide ventilation, like the door to the small store, by drilling holes in a rough fashion through the boarding. Instead of

metal mesh, though, a page from a newspaper dated 15th February 1939, has been stuck over the inside of the door.

Figure 194: Above right: The solid access door adapted with ventilation holes that have been covered over with newspaper.

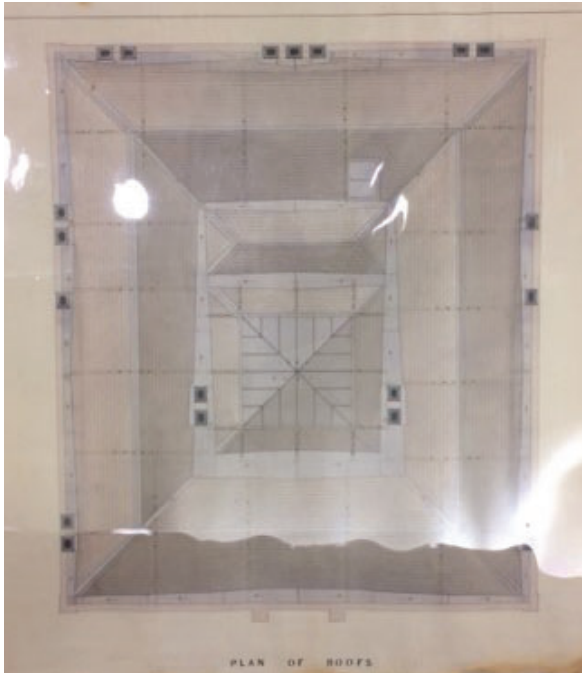
The original roof was constructed, as with a traditional Scottish roof, from timber trusses with butt-jointed timber boards to which slates were nailed using copper nails. Refer to the image of Gregg's original roof plan in Figure 195 below for the layout.

Because of the deep plan, there was a perimeter dual-pitched roof, the lantern to the stair sat centrally, while the Mansion stairhall had its own hipped roof. Gregg's specification called for the use of '7lb milled lead best quality' in gutters, with 6lb lead for ridges, and flashings to be of 5lb lead. From Gregg's drawings it looks as though the roof of the lantern was to be lead-clad also. It is not clear whether lead was ever used as all existing gutters and flashings to the old roof are now galvanised iron sheet.

Figure 195: Gregg's original roof plan (Image photographed in the State Library of SA)

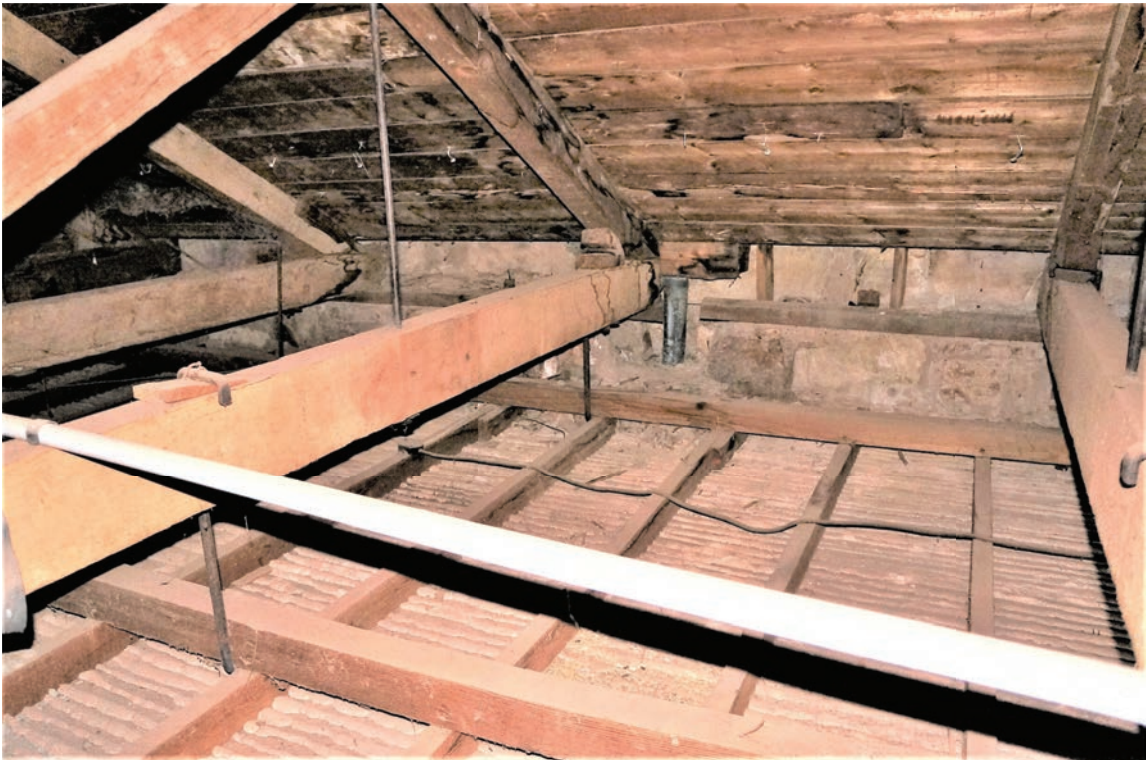
Figure 196: View inside the original roof space. Note the large timber trusses and timber boarded cladding. An original downpipe, which drops within the depth of the external wall, can be seen centre picture. A new conduit for the fire monitoring system is in the foreground.

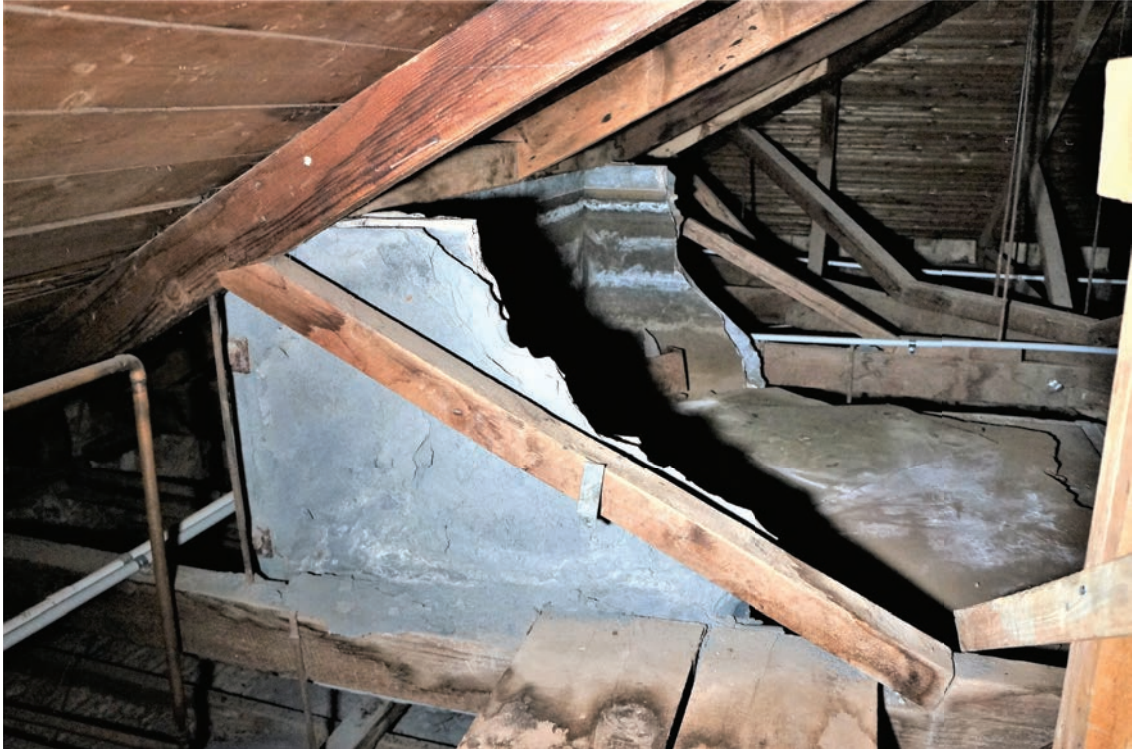
Figure 197: View inside the original roof space. The remnants of one of two large water tanks that sit in the north west corner of the house. This picture was taken at the access door into the roof space off the Servants' Staircase.

Roof Spaces. Programmable Works			Priority (Highest priority is 1)		
Era type	A, B & C	All eras	1	2	3
1	Remove all unnecessary debris, incl remnant water tanks, from all roof spaces prior to stabilising lath & plaster ceilings		5,000

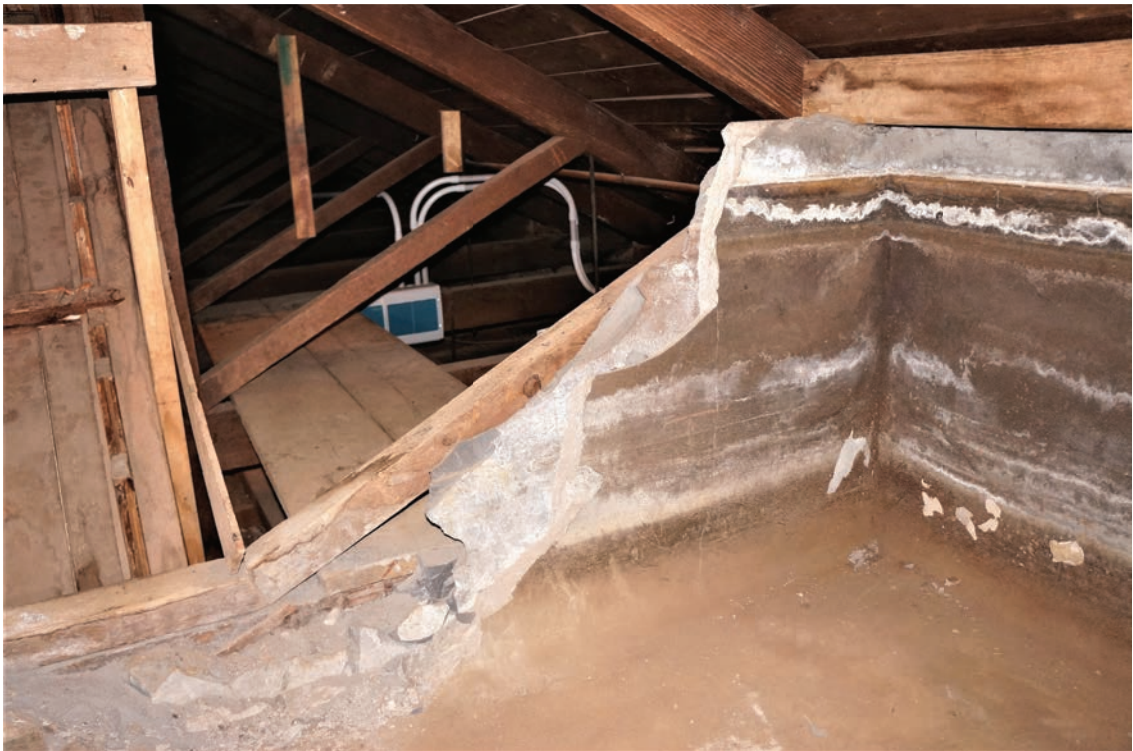
Figure 198: View inside the original roof space. Standing on the remnants of a large water tank looking towards the access into the roof space off the Servants' Staircase which can be seen to the left. Note the fire monitoring system centre left of the picture.

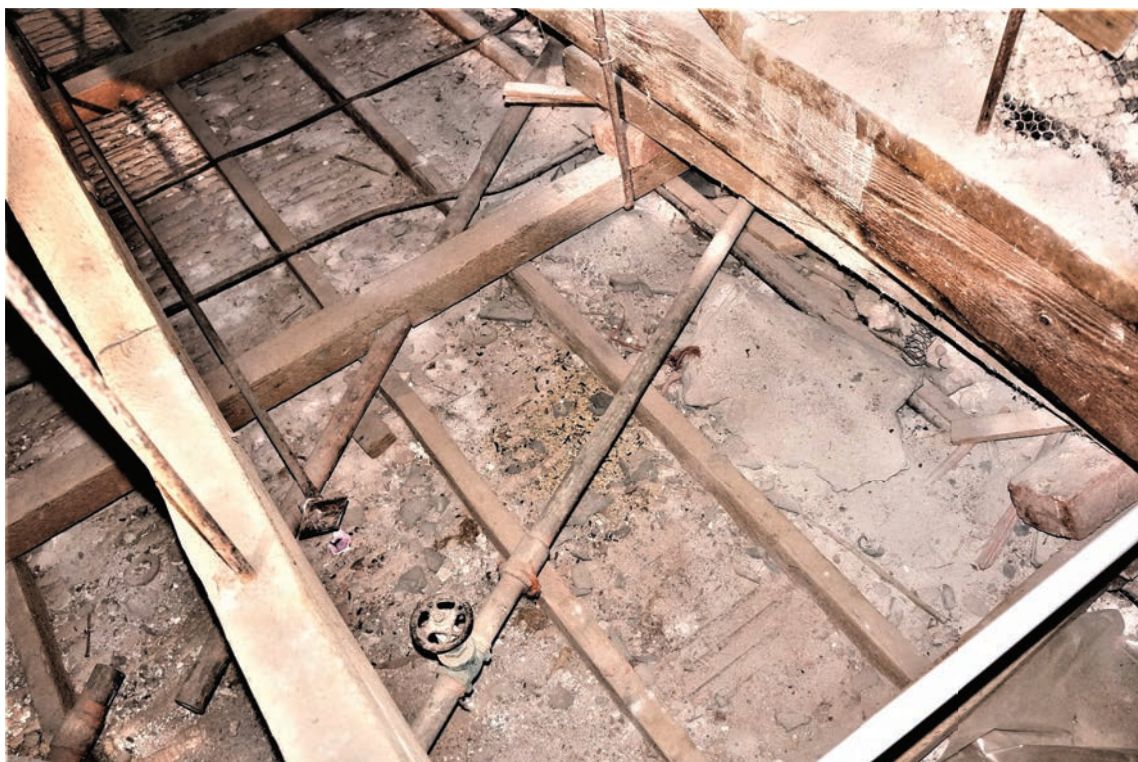
Figure 199: View inside the original roof space. Debris on the lath and plaster ceiling over the Housekeepers room. Note the remnants of a second water tank top right in the picture.

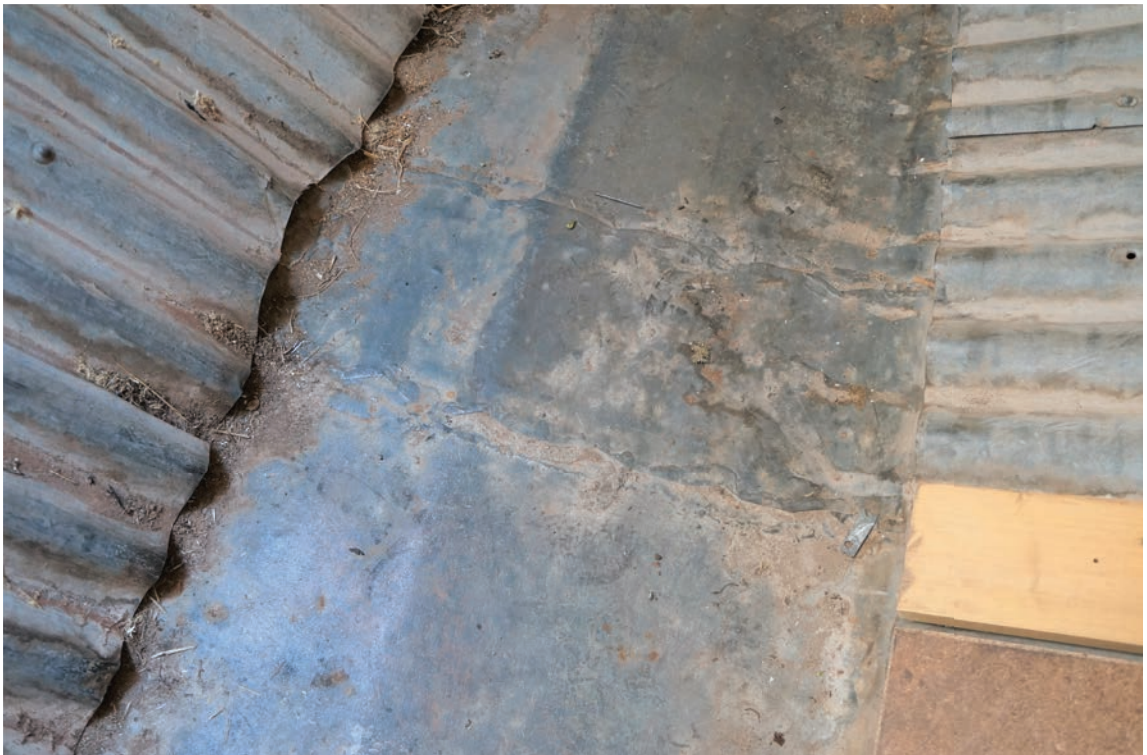
The lead detailing in the original gutters is poor, with lead-welded joints and no steps between junctions in lead sheets. This suggests that the plumber who fitted the original leadwork may have been unfamiliar with standard lead detailing, and that the original gutters may therefore have been prone to leaks where the lead would have split due to thermal stress.

Figure 201: There are no steps in the original lead gutters and joints between sheets are lead-welded.
