MARTINDALE HALL

CONSERVATION MANAGEMENT PLAN

REV. A / NOV 2021

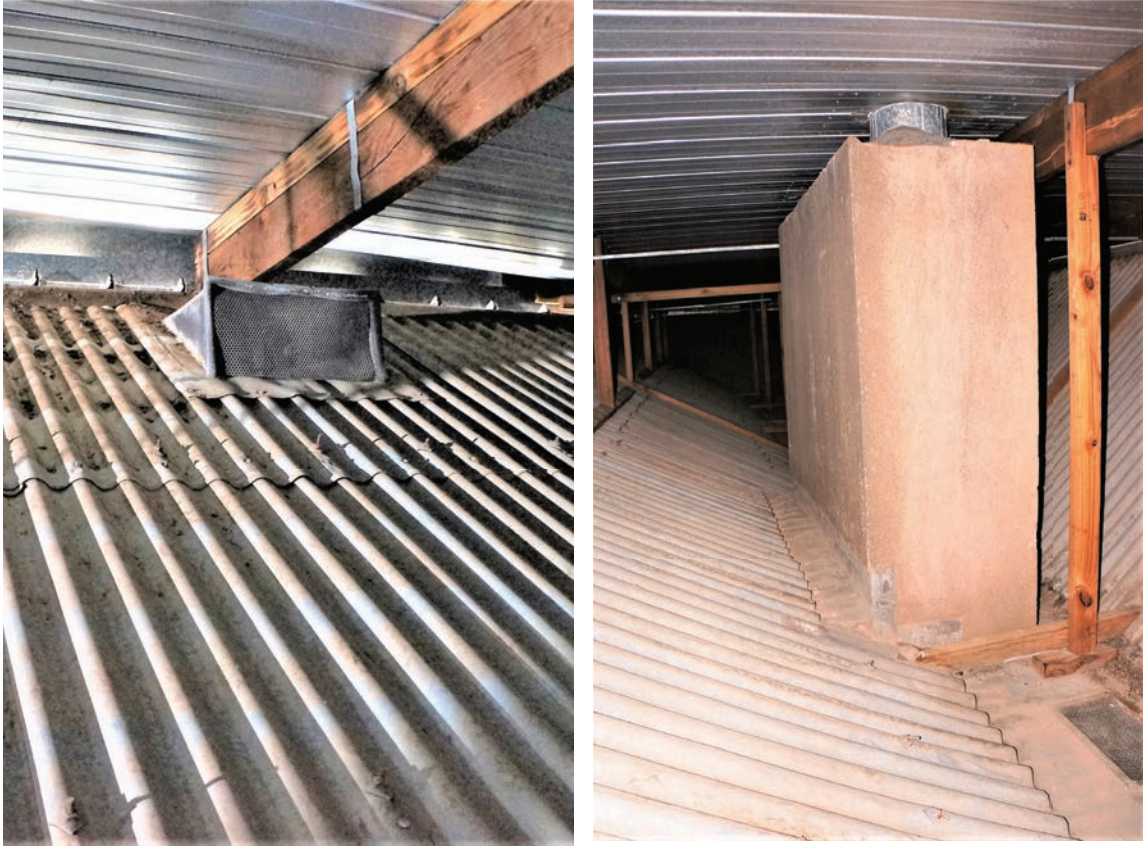
Figure 202: Above left: View of the original roof from inside the new roof space. Note the lead vent which may have been on the original slate roof. Judging by the fixings the corrugated galvanised roofing looks to have been installed in the 1930s.

Figure 203: Above right: View inside the new roof space. Note that the chimney in the foreground has been cut down to fit under the new roof. Note also the gutter outlet in the bottom right of the picture.

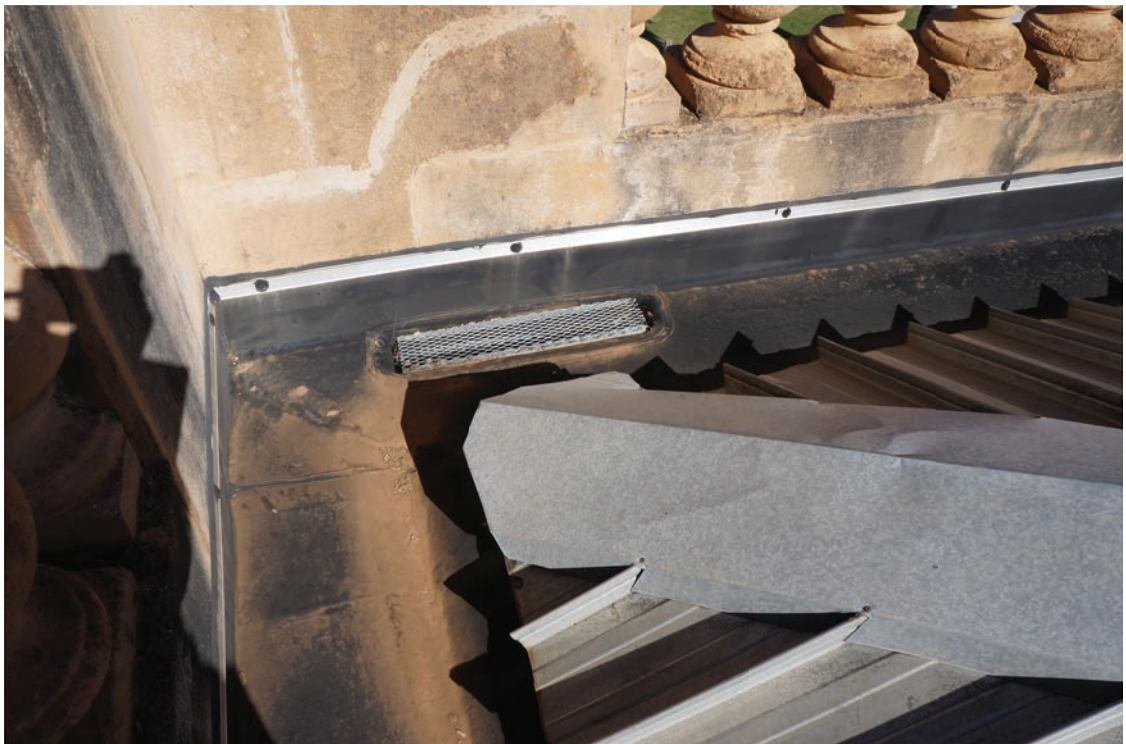
There is only a perimeter box gutter which was lined with a rubberised membrane over 20 years ago. This membrane has been repaired many times, and in many places, it is loose and failing to adhere to the substrate. Also, the lining is secured against the external masonry parapet by means of a pressure seal, rather than being dressed into a chase in the wall. This type of seal is not good practice and is likely to be permitting water to seep in along its top edge and down behind the gutter.

Figure 207: View of membrane-lined box gutter. Note the roof outlet and the pressure seal at the junction between the membrane upstand and the wall.

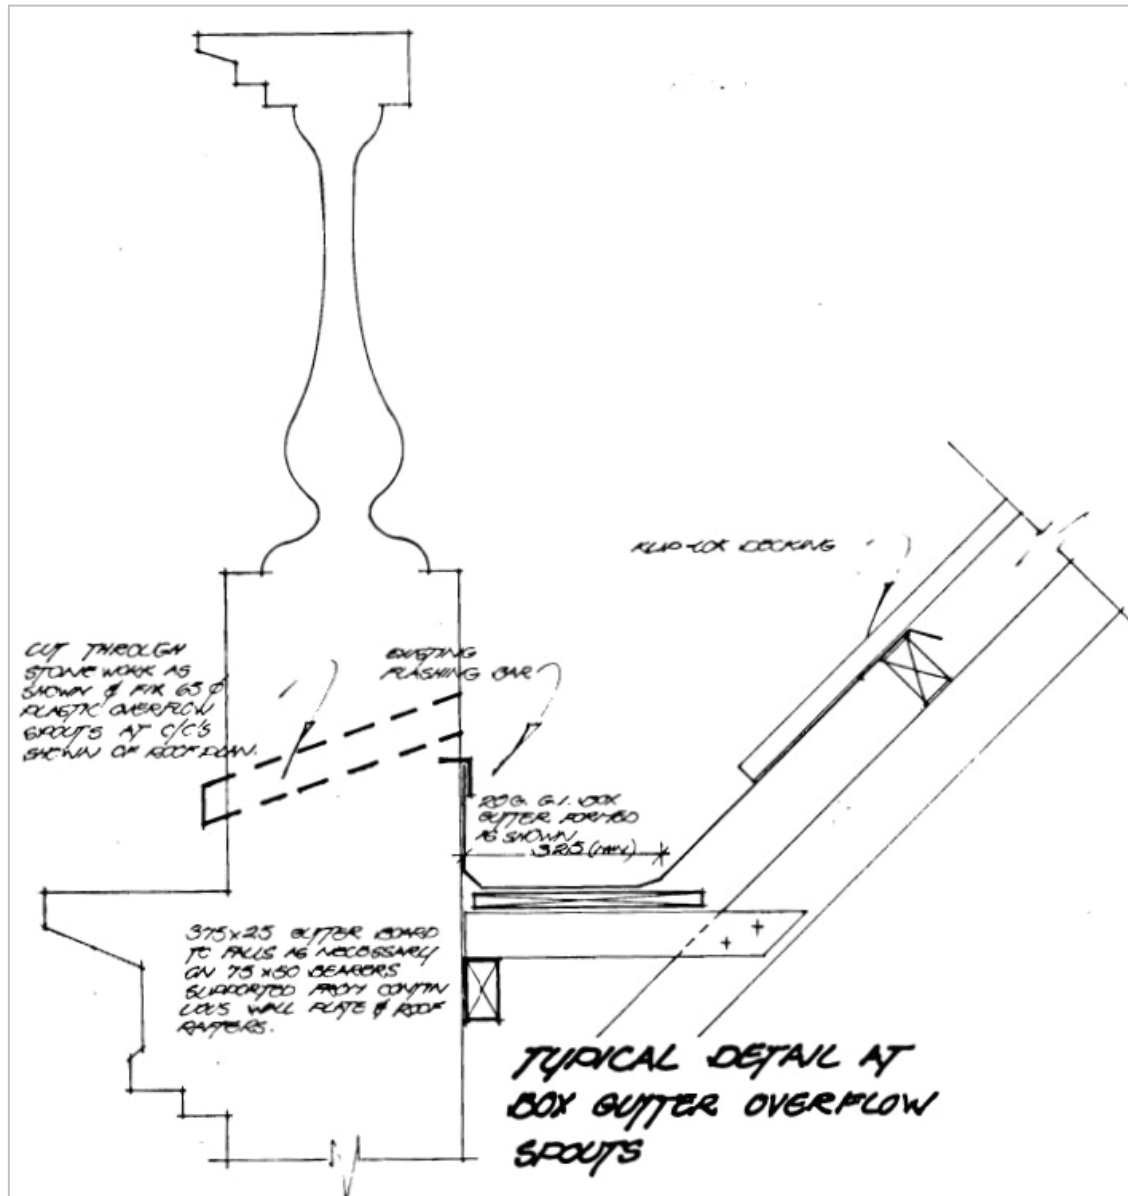
There are no overflows from the perimeter box gutter, although a drawing dated May 1974 by the University of Adelaide Architect's Office clearly showed an intention to install them.

Figure 213: Detail from a drawing of the proposed mansard roof by the University of Adelaide Architect's Office dated May 1974. They clearly intended to install overflows to the parapet gutters, although this never happened. Note the references to Klip-Lok Decking and G.I. (galvanised iron) gutters.

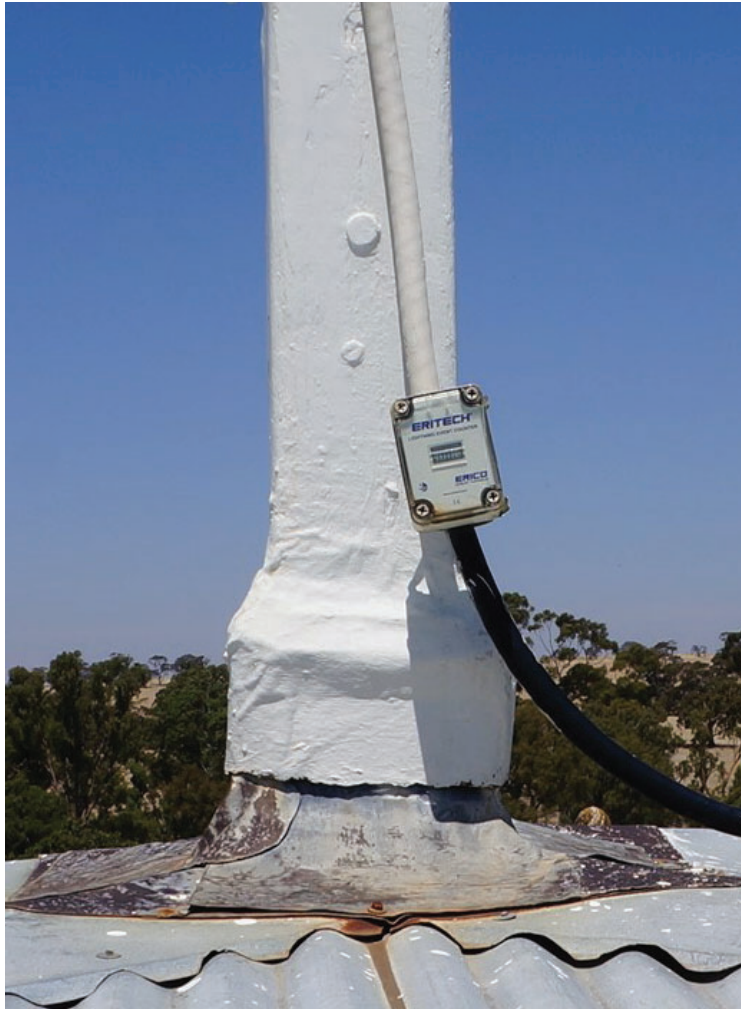
There is a lightning protection system fitted to the flagpole over the lantern roof with a large earthing cable that runs over the parapet wall and down the west rear elevation. This cable is

Figure 215: Lightning protection on the base of the flagpole. Note the old lead flashing and the large cable.

rather clumsily fixed and a more sensitive solution to incorporating a down conductor should be sought during future works.

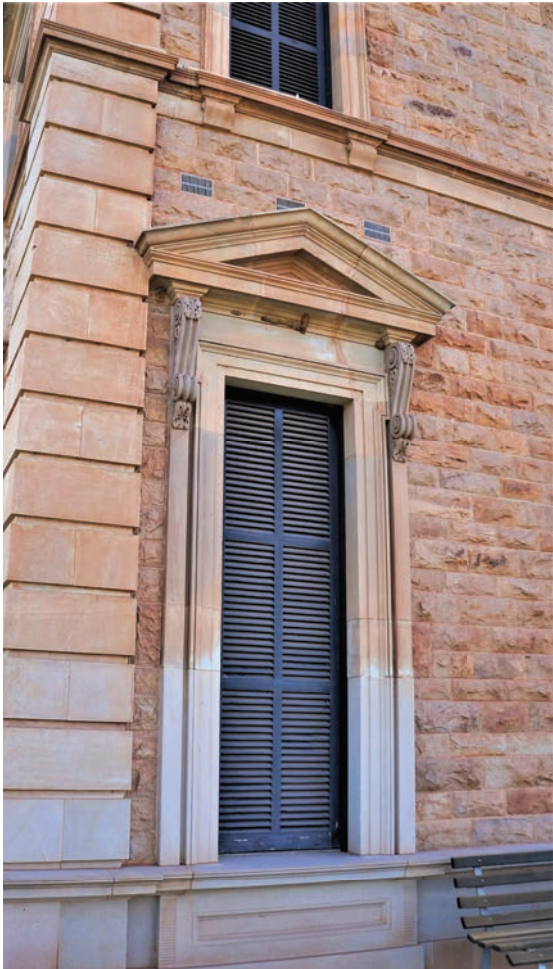
Figure 224: Above left: Window to corner of the Trophy Room. The variety of different colours to the stonework suggest a range of stones and / or a number of alternative applied coatings.

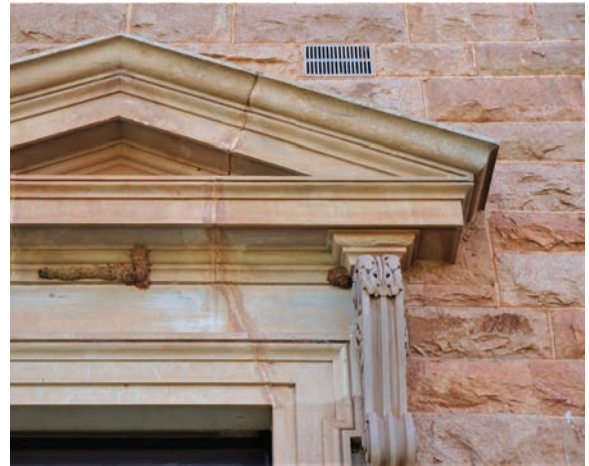
Figure 225: Above right: Close up of the same window. Note the mismatch in the colour of the replacement stone scroll bracket from any other stonework around. Also note the crude epoxy repair to the lintel and pediment hood.

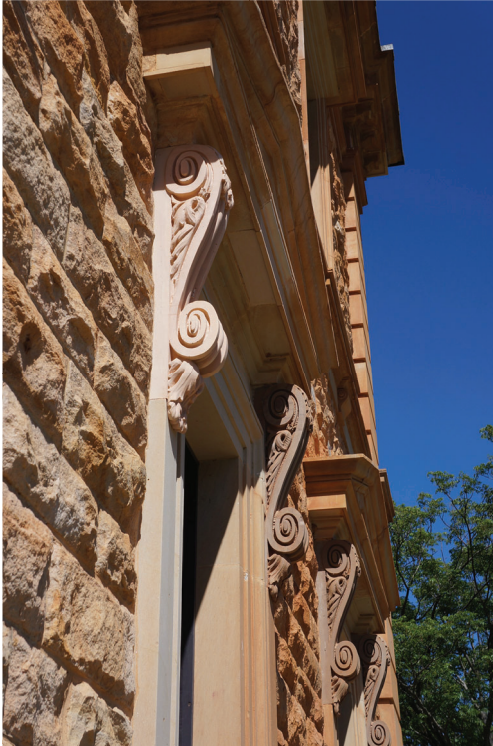
Figure 226: Above left: A row of decorative scroll brackets which are all very homogenous in colour and surface texture, The lighter coloured brackets appear to be cast from resin, as blow holes are visible on their surface. The darker coloured brackets may be carved from stone that has been artificially coloured.

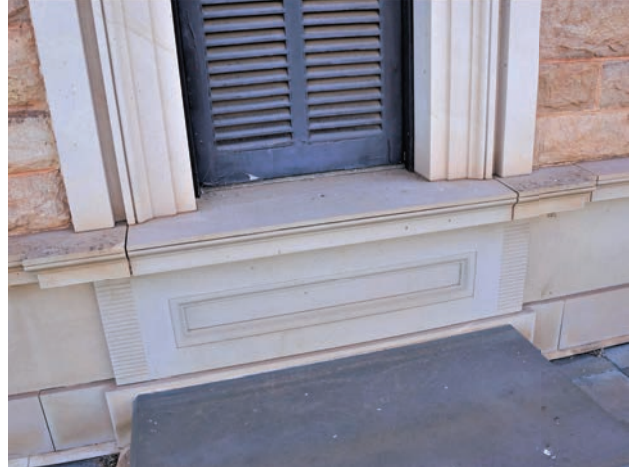
Figure 227: Above right: Replacement spandrel panel beneath ground floor window. Note the large number of open vertical joints in need of repointing. The slate capping of the basement vent is above the level of the DPC and will be allowing moisture to track to the inside.

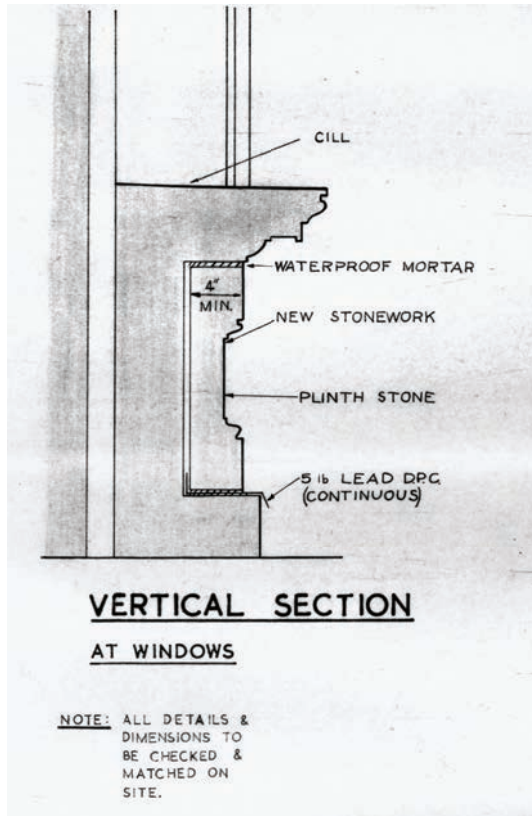
Figure 228: Left: A detail proposed in 1965 by Philip Fagher & Partners for the University of Adelaide for the replacement of stone spandrel panels beneath ground floor windows. If new plinth stones were fixed at the time using this methodology the detail has since failed as the plinth stones have been replaced again in recent times.

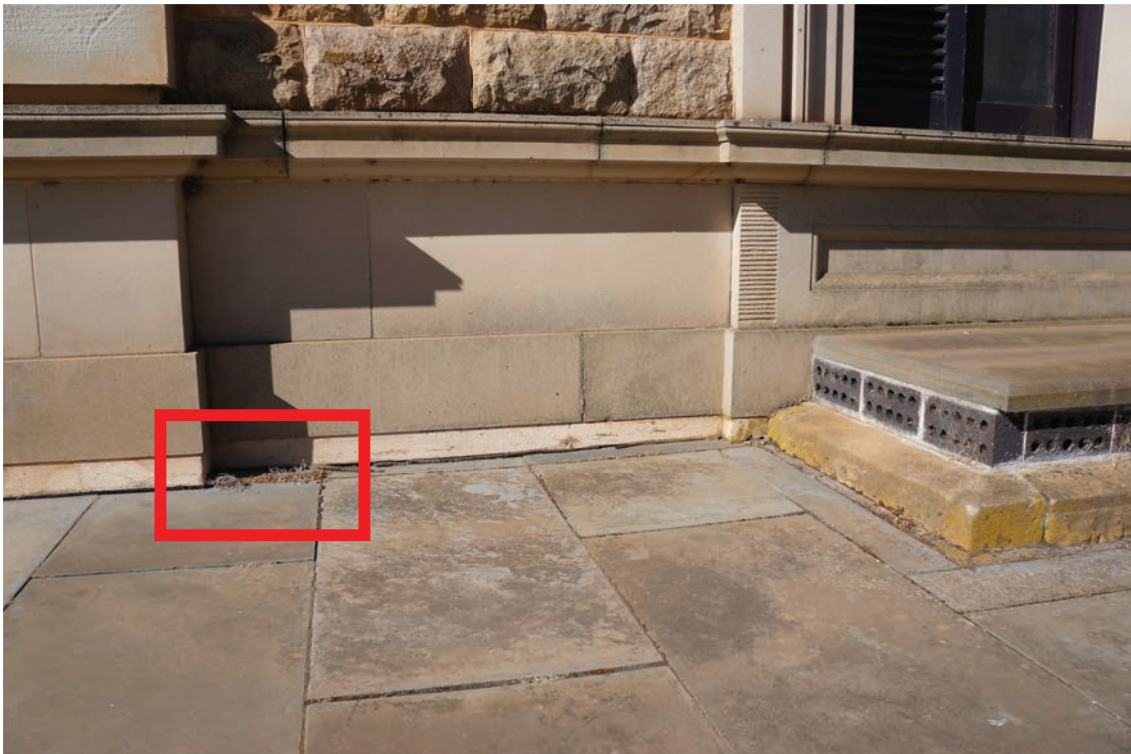
Figure 234: The band of render along the bottom of the stone plinth sits onto a strip of black foam which is disintegrating in the area of the red square.

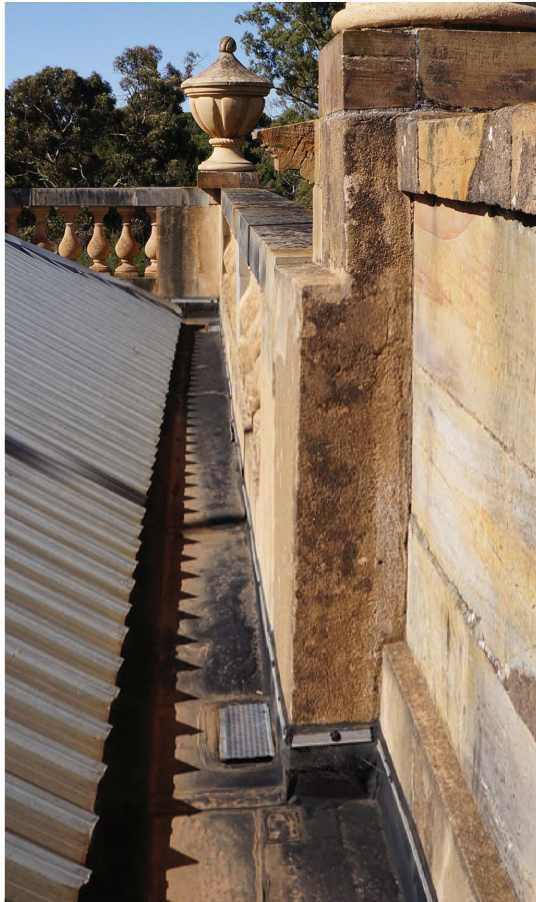
Figure 242: Left: Panel of dressed ashlar wall directly above the main entrance. Plastic repairs are visible from middle the right-hand side of the photo.

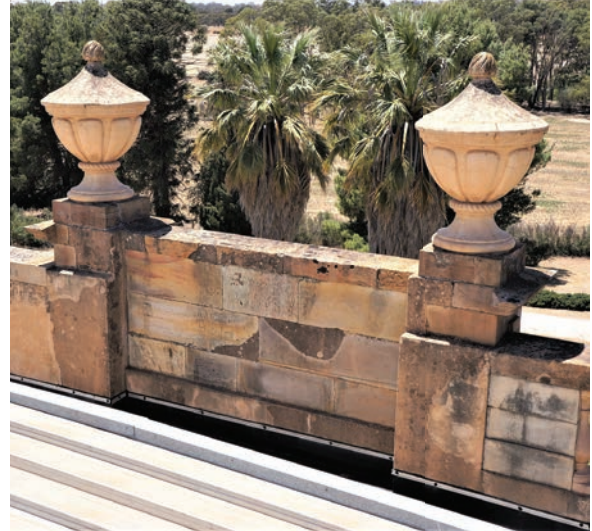
All of the render at roof level appears to be cement-based and if so, will not be good for the stonework against which it is applied. Many of the rendered areas are cracked, while others have cracks that have been repaired in the past. Consideration should be given to removing all cement-based renders and applying lime-rich renders in their place.

Figure 243: Above: The walling directly under each of the urns is rendered, and the render continues in bands beneath the balusters.

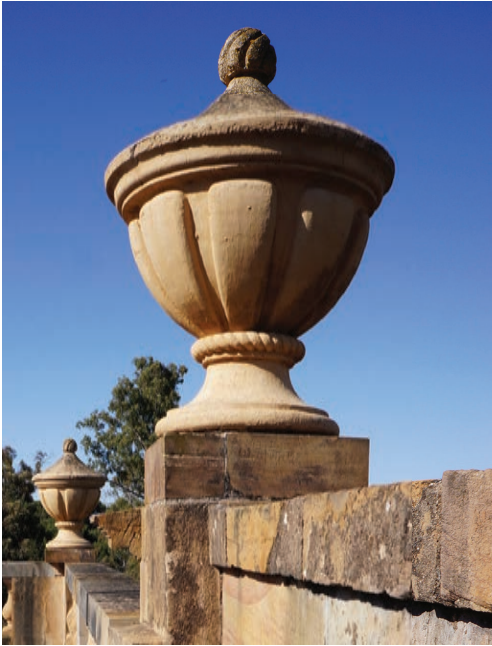
Figure 244: The urns are substantial original features that may have been cast from mass concrete. They appear to be in reasonable condition and have been recently coated to their bodies and bases, but not on top, with a paint, or some other consolidant.

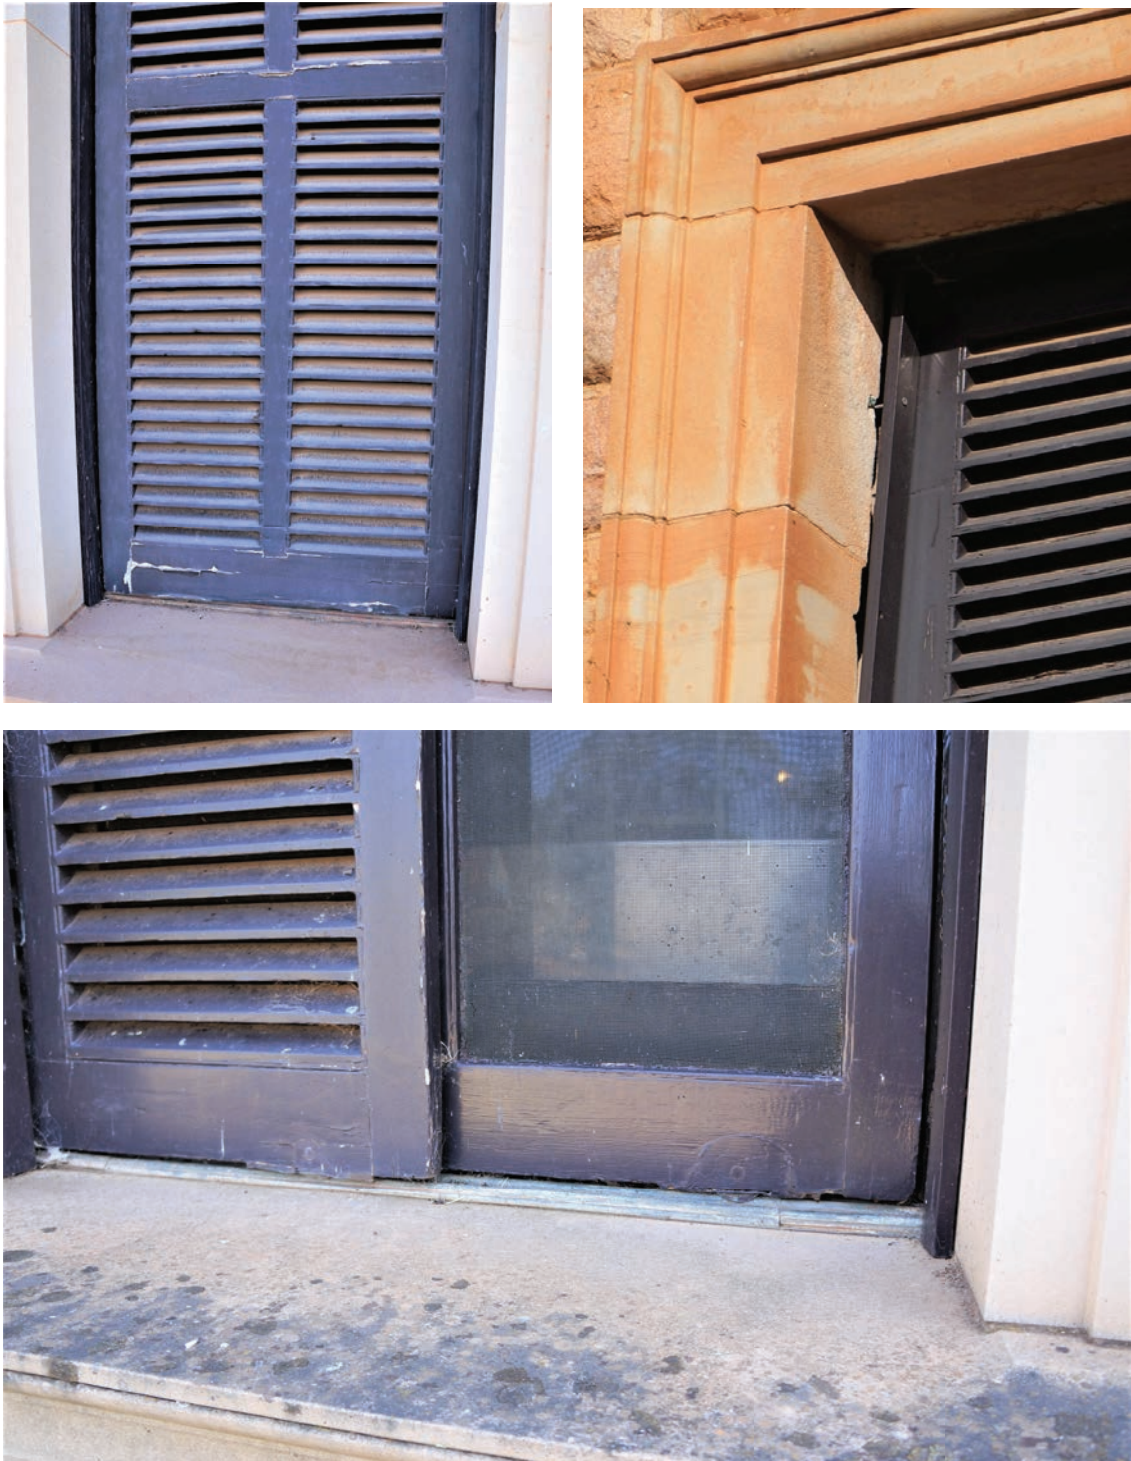
Figure 250: Top right: Louvre shutter on an upstairs west facing window. The stone into which the timber bead is fixed has crumbled away leaving a screw fixing exposed.

Figure 251: Bottom: The two different horizontal-sliding window sashes – the outside one louvered, the inside one with insect mesh. Note the peeling paint and signs of timber rot in the bottom rail.

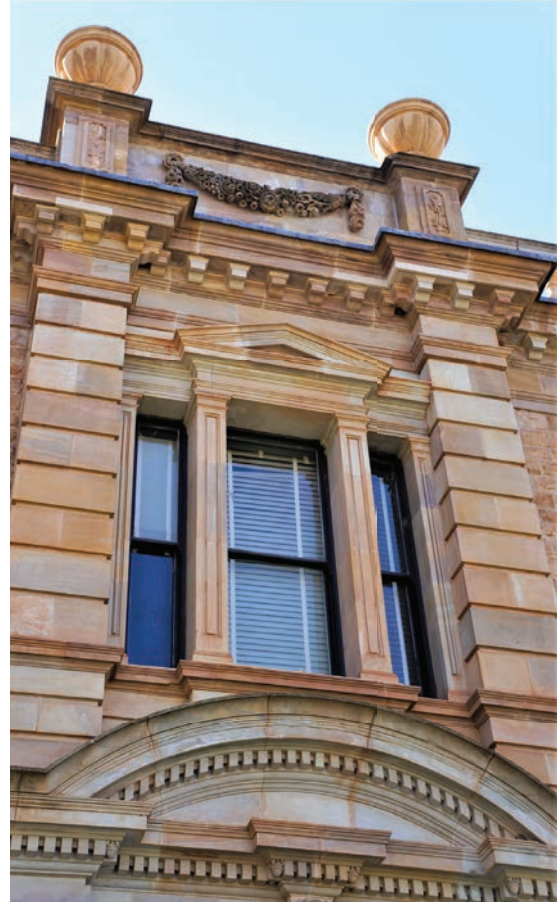
Figure 253: Above right: The three windows above east main entrance have neither external timber sashes nor fly mesh sashes.

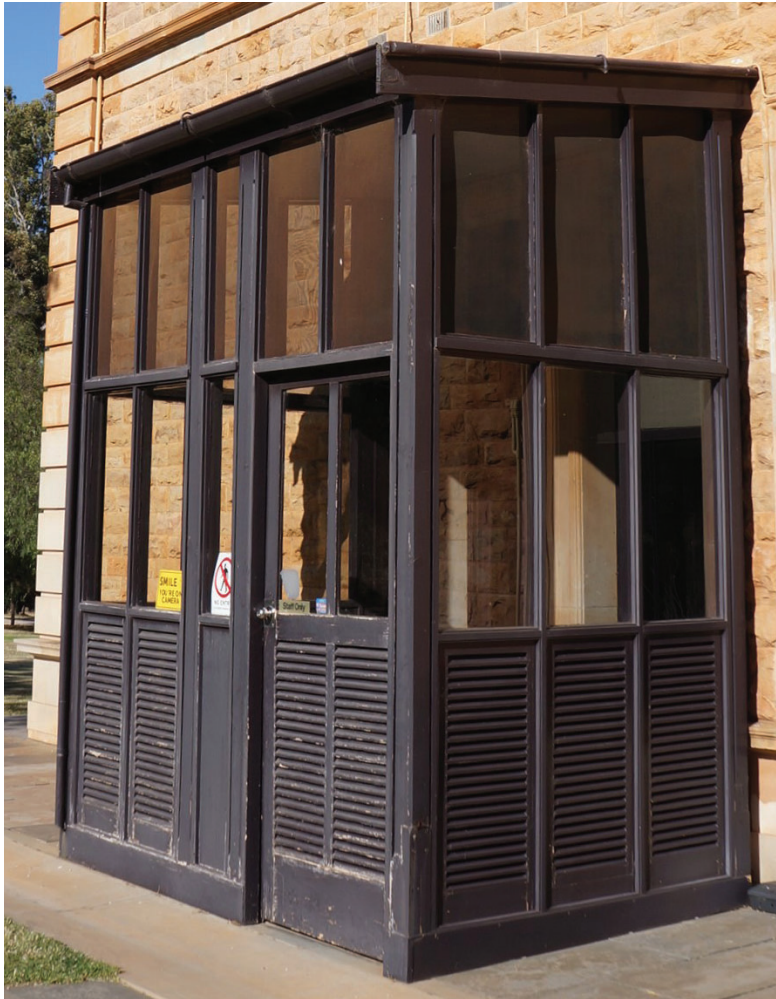
Figure 257: West Porch.

The West Porch is in need of external redecoration throughout and may require some piece-in timber repairs, especially to the bottom timber rails that are in close contact with the slate paving.

The detailing and finish are the same as the timber louvre sashes on most windows suggesting that they were all renewed at the same time, possibly in the 1970s.

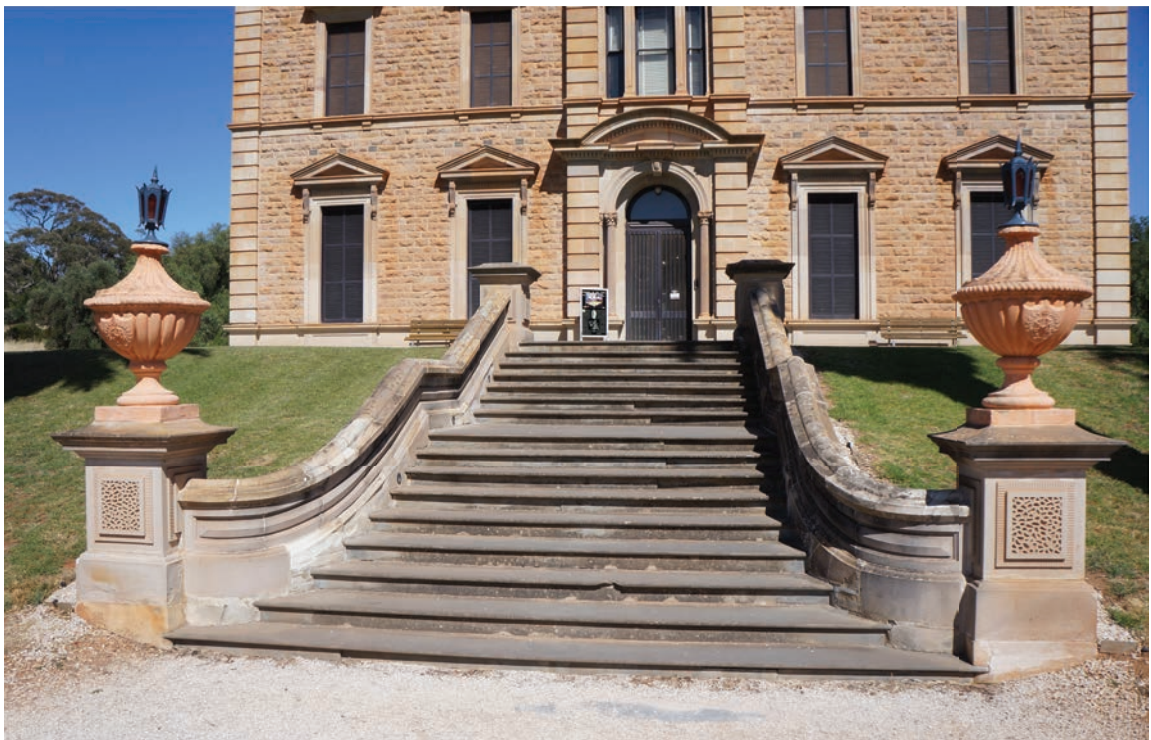
The front steps leading to the main, east elevation appear to be in reasonable condition. The bases that terminate the tops and bottoms of the stone flanking walls, and much of the stone to the side walls themselves, has been replaced in new stone over the years, although there is still stonework that requires renewal. There are small spotlights set into the walls on both sides to light the steps, and decorative metal lamps sit on top of urns, although it is not clear whether these are all working.

The decorative urns flanking the base of the steps, which are more elaborate in detail than those on the rooftop parapet of the Mansion, have a coating over them which is an inappropriate colour.

Figure 259: Current front steps.

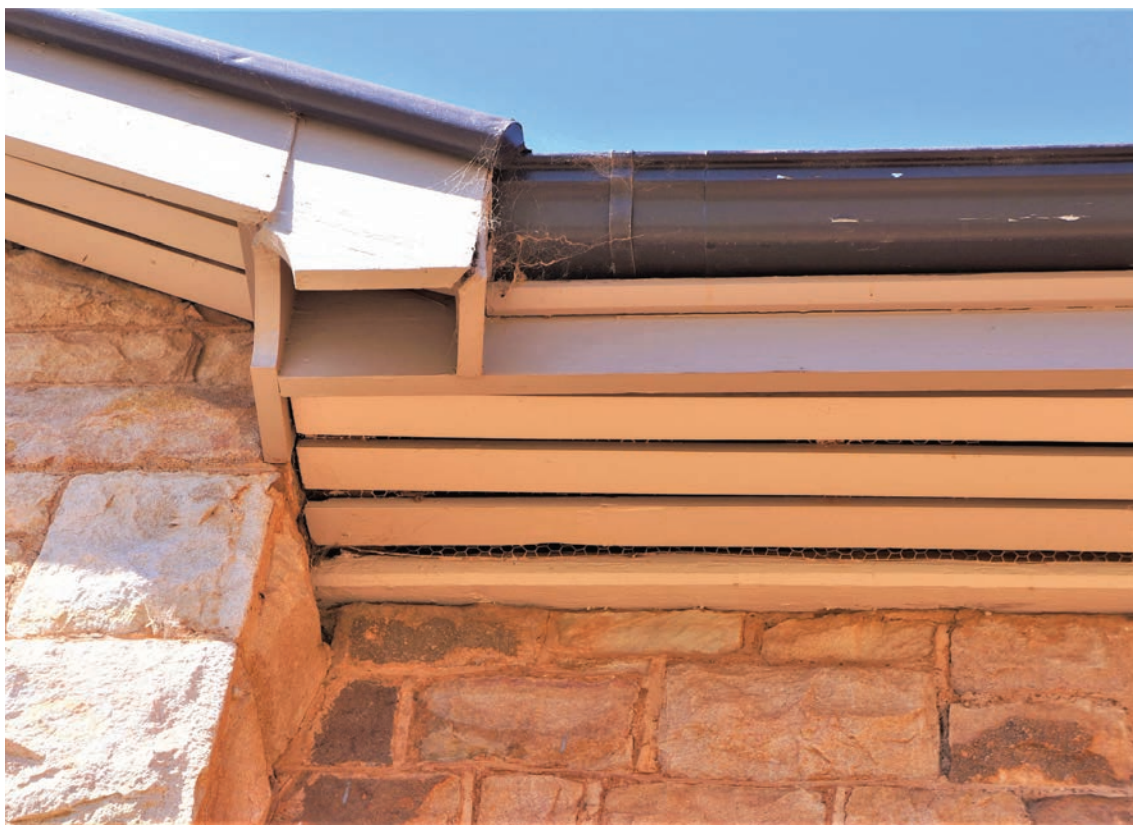
Figure 268: Grey painted galvanised steel gutter and barge flashing. Note the galvanised steel showing through the paint on the gutter.

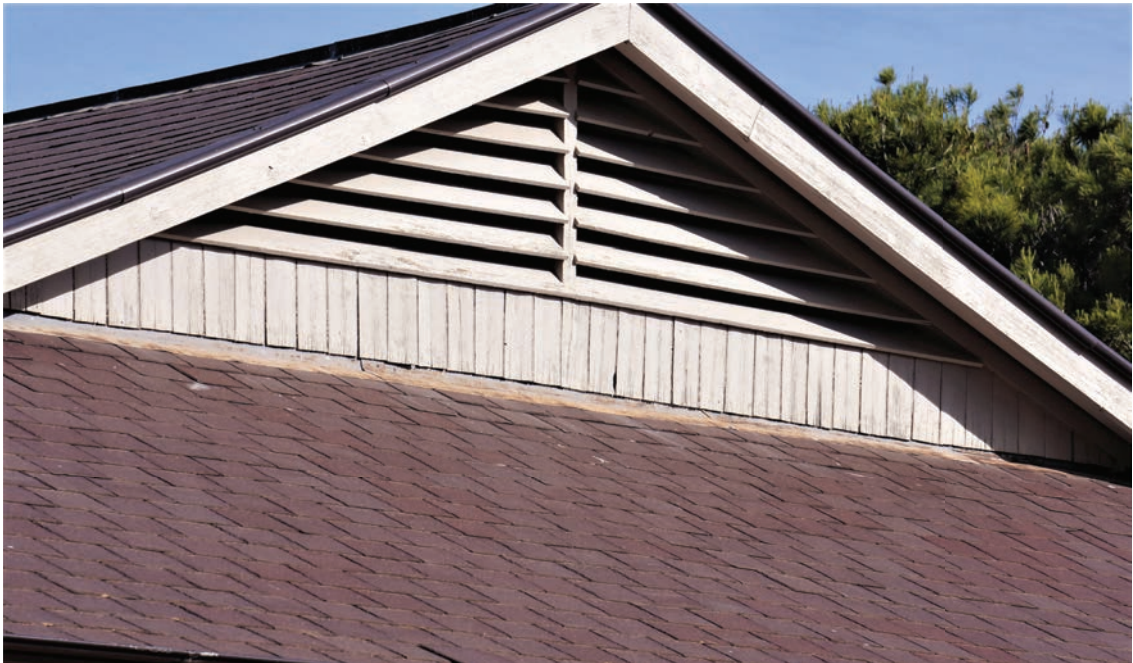
There are a handful of slipped and broken slates that should be repaired quickly. It was not possible to inspect the box gutters beneath the clerestory windows of the main pavilion.

Figure 272: View of roof along west elevation. Note the loose slate lying in the gutter.

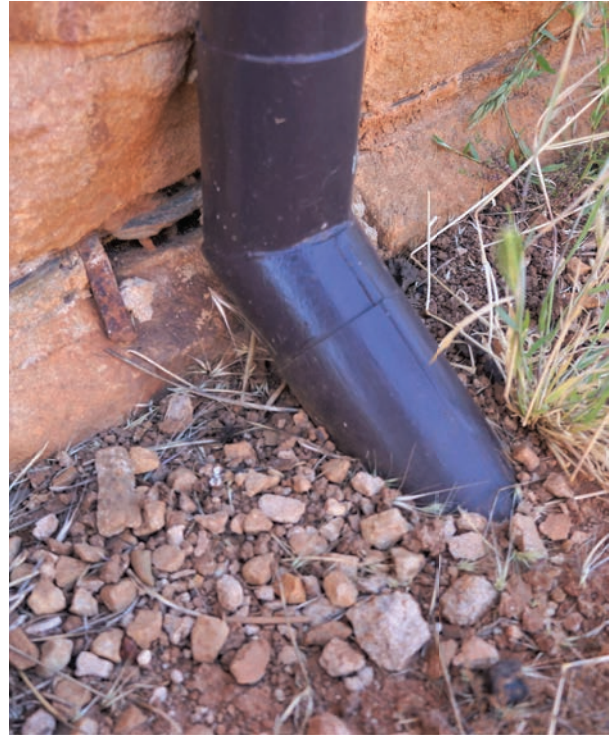
Figure 278: Above right: Galvanised steel downpipe at ground level along west elevation. This pipe is likely to last long where exposed to ground moisture. Note the slate DPC and the rusted remnant of the former iron holderbat.

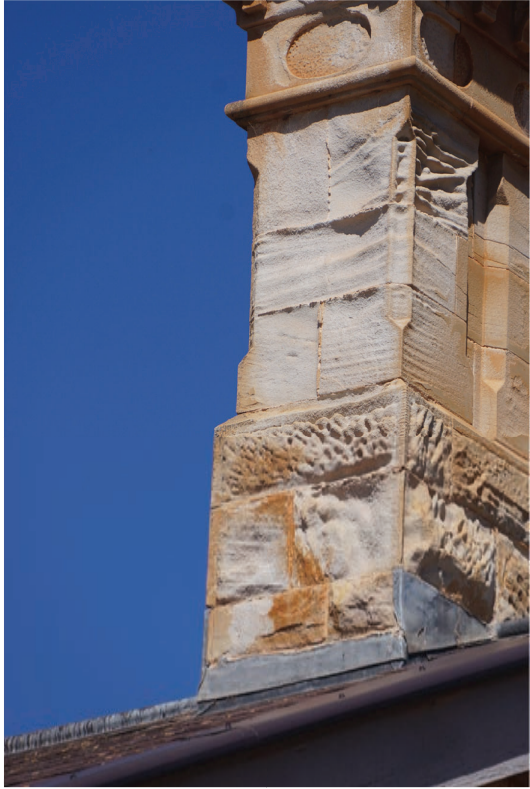
Figure 281: Above left: Erosion of the soft sandstone on the chimney on the north east corner. These chimneys should be structurally strengthened against earthquakes.

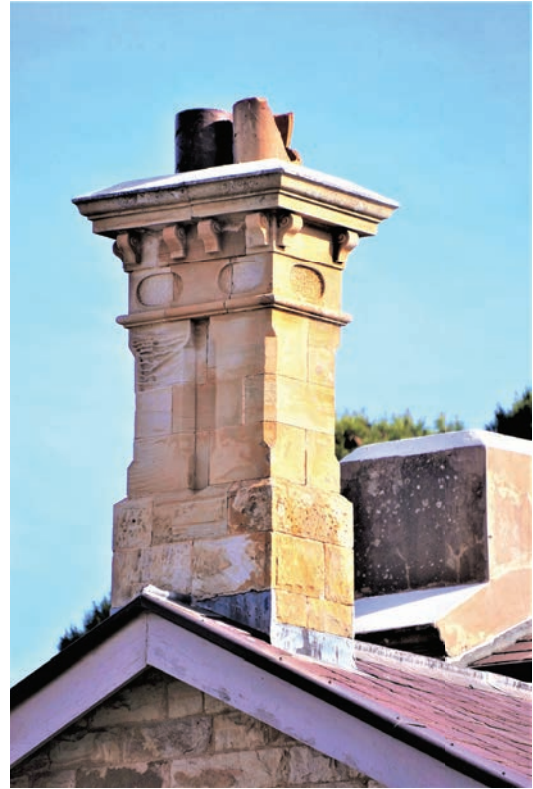
Figure 282: Above right: Erosion of the soft sandstone on the chimney on the south west corner. Note the broken chimney pot.

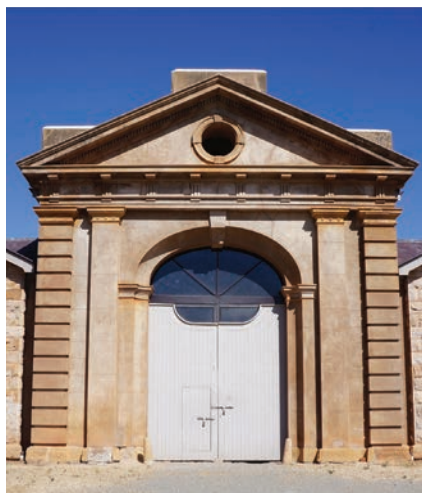
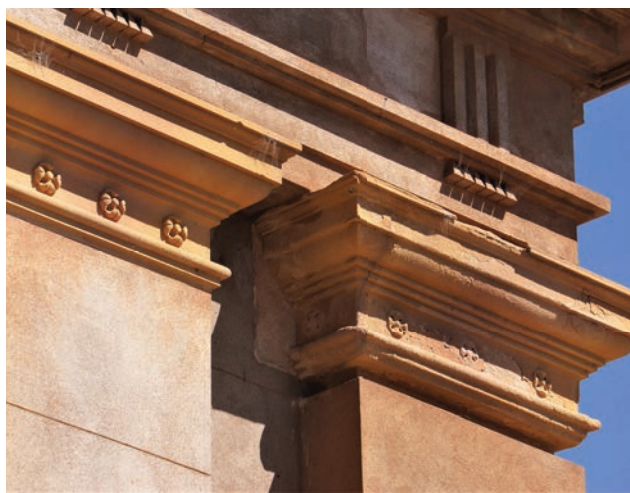
Except for the stone base plinth, the pedimented east entrance is stucco which has been cracked in places and repaired. Some of the stucco detailing has eroded away and there are other areas where the fine details have been repaired.

Figure 284: Above left: All but the base plinth of the pedimented east entrance is stucco.

Figure 285: Above right: The stucco capital on the left of picture has been repaired recently. The one on the right has worn badly.

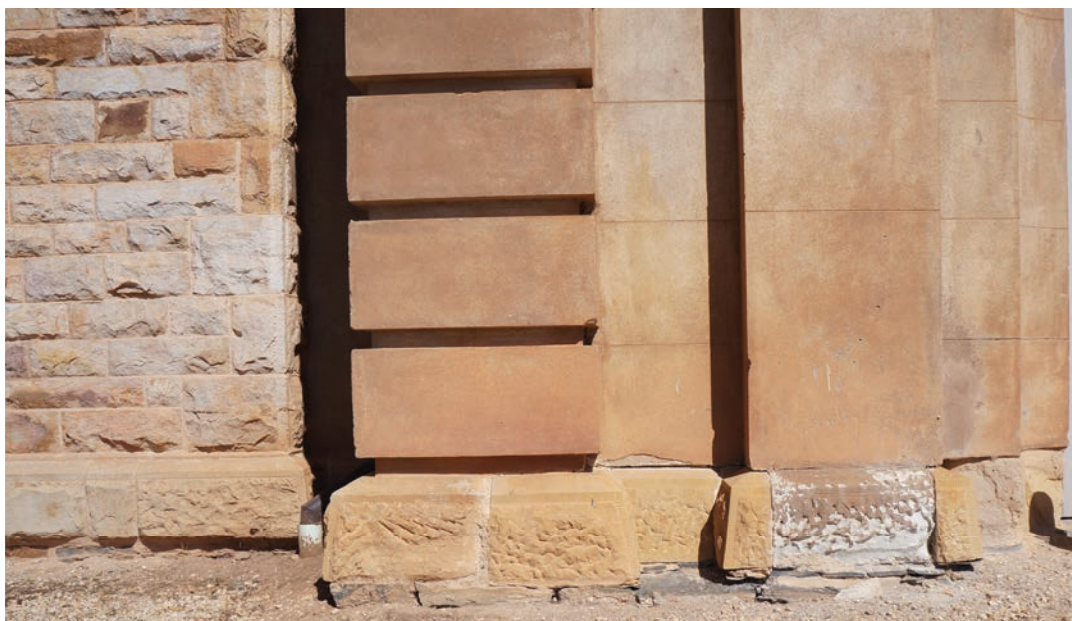
Figure 286: Base of east elevation at junction between main and side pavilion. Most of the original stonework has been replaced. The few original stones that remain are badly fretted by moisture. Note the slate packed under the original stone to act as a DPC.

Stonework to the base of the pilasters to the main pediment has lost some case hardening at ground level due to rising damp. At high level, moisture penetration through the tops of stucco capitals is leading to breakdown of the detailing.

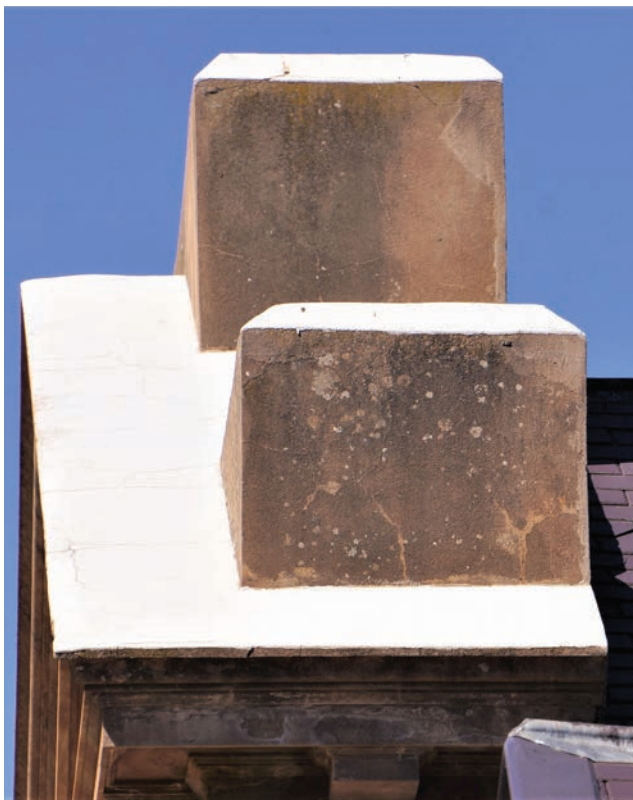
The top surface of the pediment and parapet appears to have a thin render that has prevented mosses and lichens from growing, but which has many fine surface cracks. The tops of all the chimneys appear to have the same coating, albeit thinner.

Figure 287: Above left: Thin render on top of main entrance pediment and parapet. This has many fine cracks on its surface.

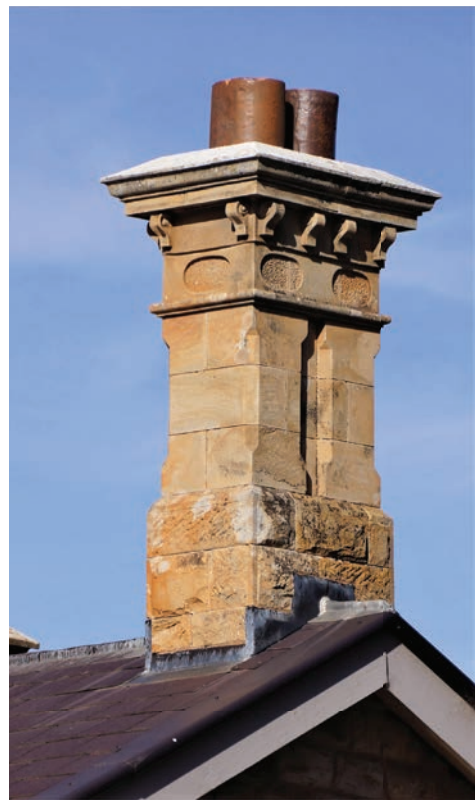
Figure 288: Above right: The top of this chimney appears to have the same coating as the top of the pediment and parapet.

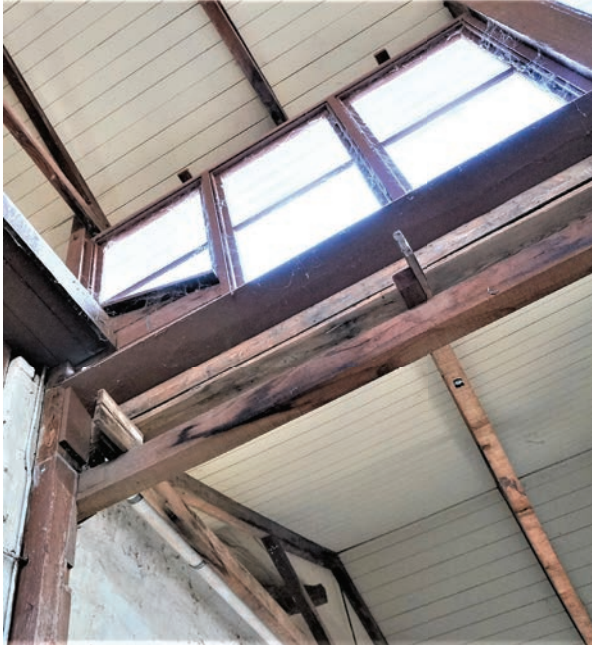
Although the high-level timber clerestory windows lighting the central space appear to be sound when viewed internally, it was not possible to inspect them from outside. Most likely they will need to be redecorated.

Figure 294: Timber clerestory windows lighting central space. The internal paint appears sound. Inspection externally was not possible.

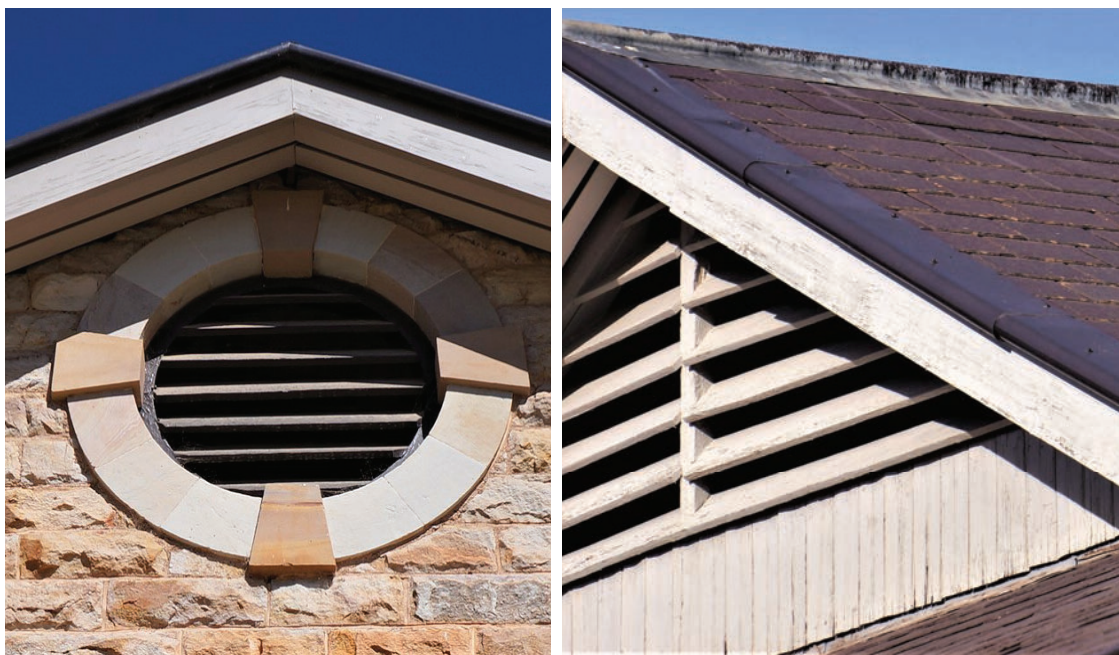
The four circular timber louvre vents at the apex of gables on the north, south and west elevations are in need of redecoration.

Figure 297: Above left: Four circular timber louvre features are in need of redecoration.

Figure 298: Above right: Timber louvres on west elevation are in need of refurbishment and repainting. There are signs of timber rot in the vertical boarding.

Paintwork to the rooftop timber louvre vent to the western gable is in poor condition and there are signs of timber rot, especially in the vertical boarding.

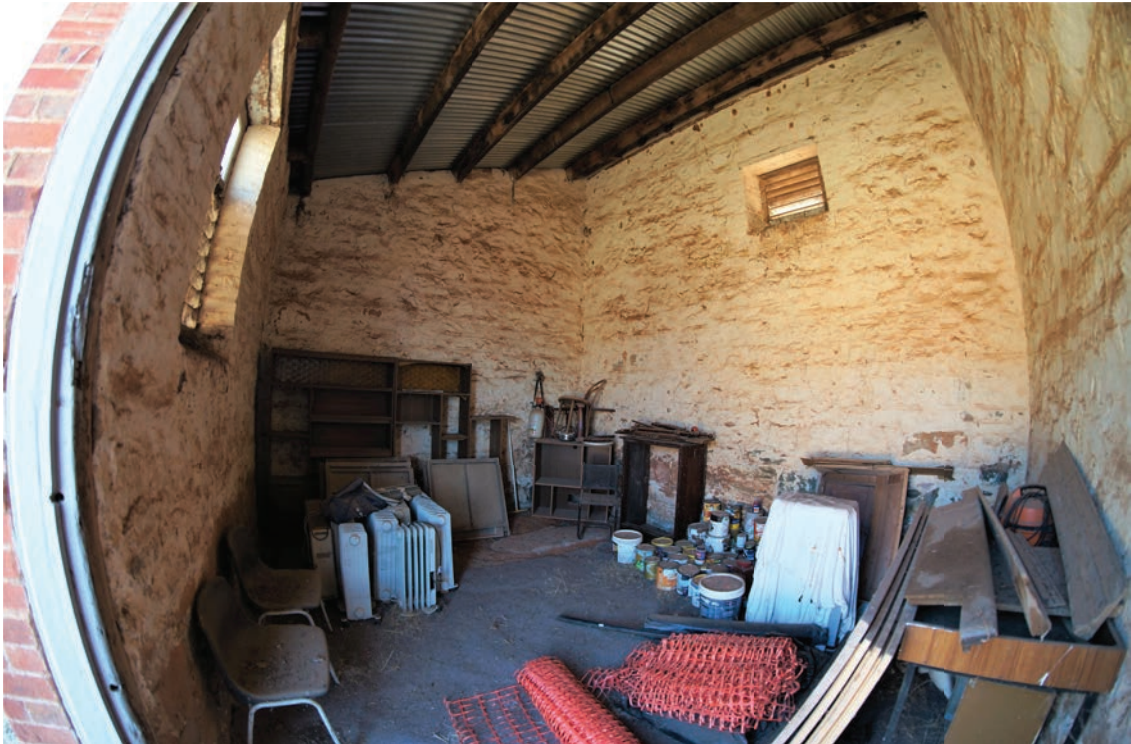
Figure 312: Wide-angled view of south stable interior.

The enclosed stables are currently being used to store a variety of items and the spaces appear to be weathertight and in reasonable condition. The roof finishes and rainwater goods appear sound and the stonework and brickwork has been reasonably well maintained, which has included works to repoint with cement mortar around the base of the stables, store and

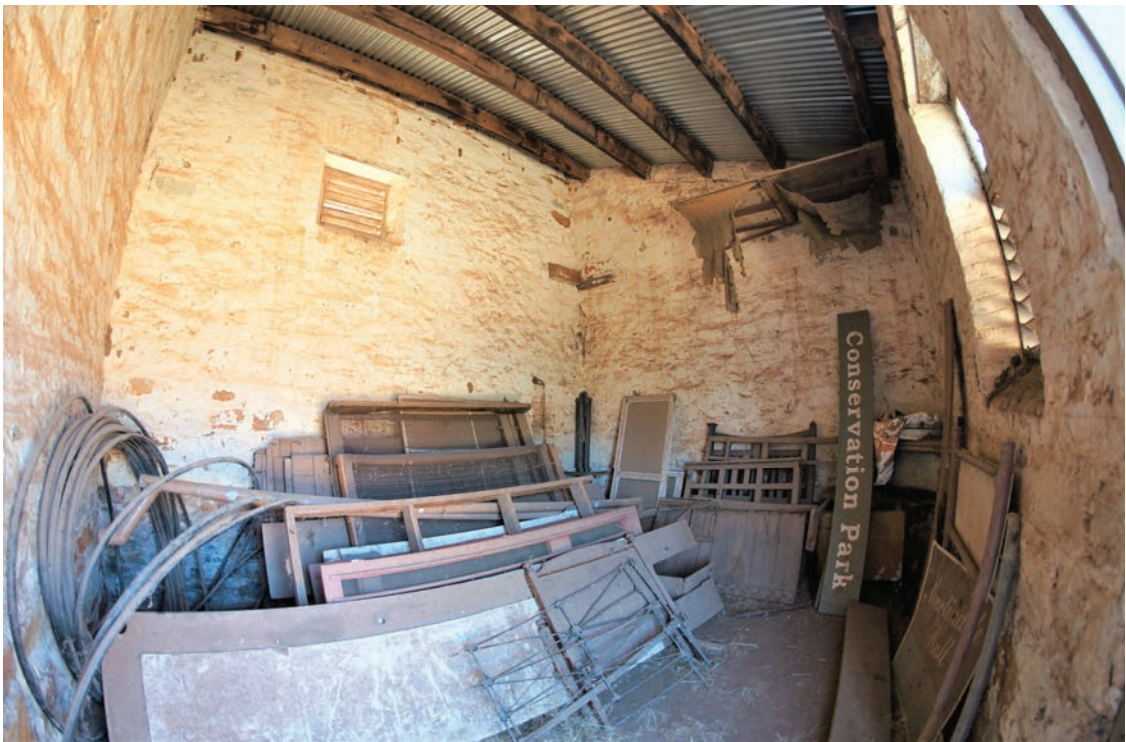
Figure 313: Wide-angled view of north stable interior.

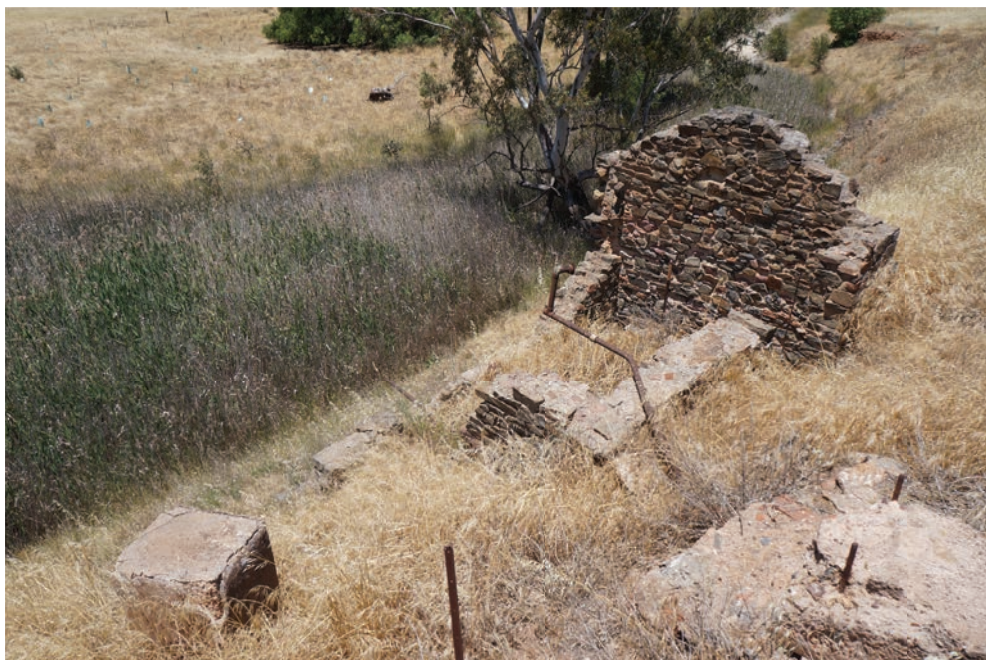
Figure 317: Existing ruin of the former Pump House

Needless to say, the Pump House is in ruinous condition. It would be worth clearing the immediate surrounds of debris and consolidating the stonework so as to ensure the remaining gable and walls will not collapse further. It is disappointing that the machinery shown in the 1970s photograph is no longer on site although it would be interesting to understand where it has gone and whether it might be restored and brought back to site.

The original Pump House is in such ruinous condition that there seems little point in attempting to reconstruct it. Access to the ruins should be provided by cutting back the grass around it and interpretive signage should be provided. The original pumping equipment, that is shown in a 1970s photograph in Figure 316, is no longer on site and it may be worthwhile researching where it has gone, in case it could be restored and reinstated.
