MARTINDALE HALL

CONSERVATION MANAGEMENT PLAN

REV. A / NOV 2021

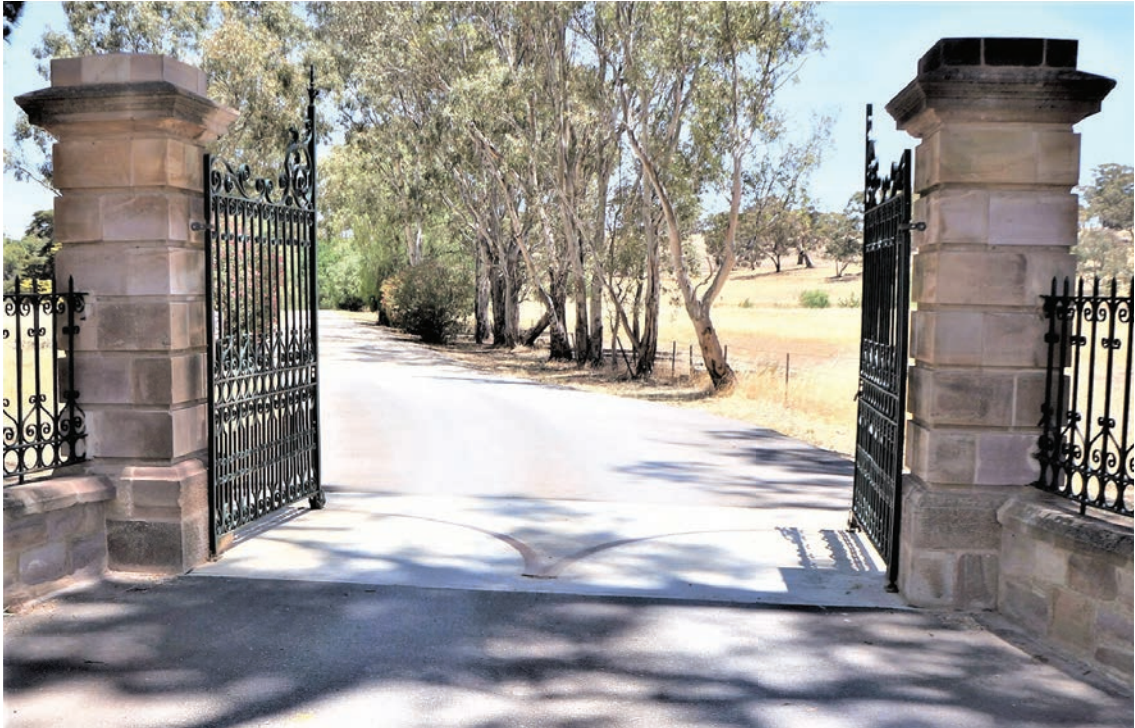
Figure 320: Main Gates today looking from the road.

The stone work has been repaired and repointed recently using a hard mortar mix. The soft stonework to the walls facing the road is exfoliating.

The wrought ironwork is generally in sound condition.

The Entrance Gateway still retains its architectural integrity and is generally in sound condition. It would be desirable restore the arch with Mortlock family crest which is currently stored in the Coach House, although doing so may limit access for coaches bringing visitors. Once again, extensive cement pointing should be replaced with lime mortar reasonably urgently, given the dilapidated condition of stonework.

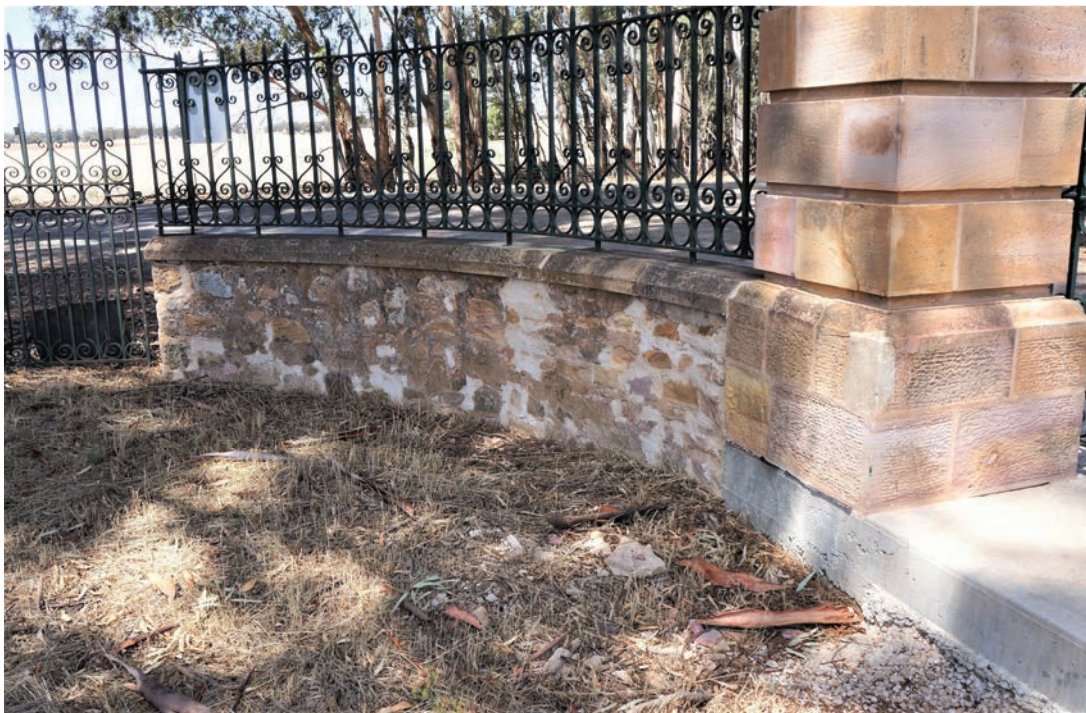
Figure 322: Recent patching to the back of the walls.
