# Native Vegetation Clearance

## Dry Plains Road

### Data Report

Clearance under the *Native Vegetation Regulations 2017*

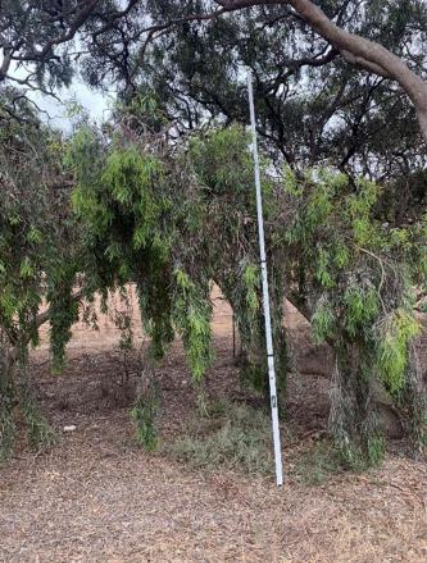
Tree ID – Tree 2	Representative photo	
Tree spp. <i>Eucalyptus largiflorens</i>

Photo direction - West Waypoint 158
Number of trees – 1		
Height (m) –3		
Hollows –0		
Diameter (cm) –21cm		
Canopy dieback (%) –5%		
Total Biodiversity Score –0.19		
This is a small tree with a low habitat value

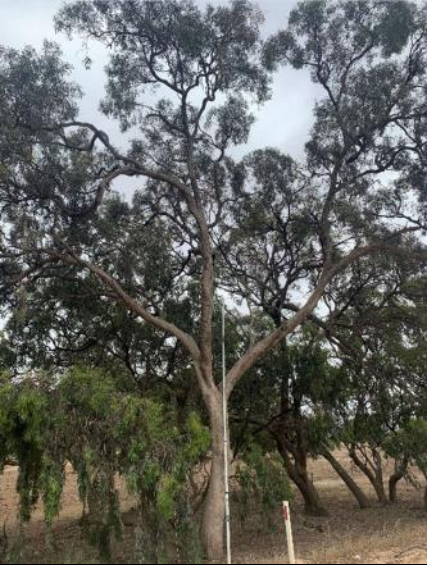
Tree ID – Tree 3	Representative photo	
Tree spp. <i>Eucalyptus largiflorens</i>

Photo direction - West
Number of trees – 1		Waypoint 159
Height (m) –11		
Hollows –1		
Diameter (cm) –40cm		
Canopy dieback (%) –5%		
Total Biodiversity Score –1.98		
Excellent solid tree as part of a clump of the same species. Hollows present which may provide habitat for numerous species including NP&W Act species.

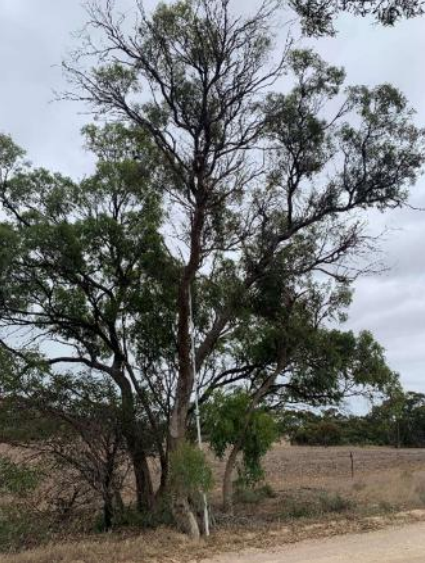
Tree ID – Tree 7	Representative photo(s)	
Tree spp. <i>Eucalyptus largiflorens</i>

Photo direction - West Waypoint 163
Number of trees – 1		
Height (m) –9		
Hollows –1		
Diameter (cm) –55cm		
Canopy dieback (%) –60%		
Total Biodiversity Score –0.18		
Tree in poor health. Hollows present which may provide habitat for numerous species including NP&W Act species.

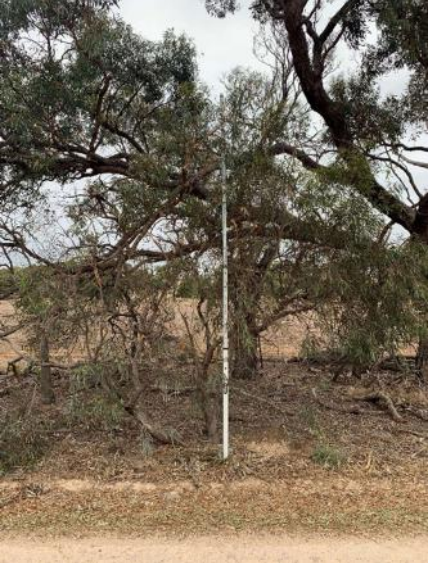
Tree ID – Tree 8	Representative photo	
Tree spp. <i>Eucalyptus largiflorens</i>

Photo direction - West Waypoint 164
Number of trees – 1		
Height (m) –3		
Hollows –0		
Diameter (cm) –21cm		
Canopy dieback (%) –20%		
Total Biodiversity Score –0.15		
This is a small tree with a low habitat value

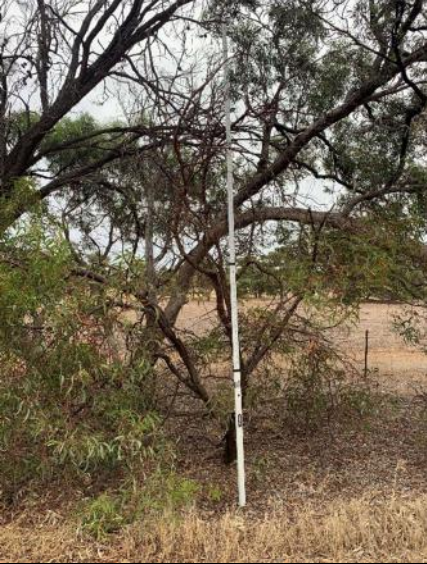
Tree ID – Tree 9	Representative photo	
Tree spp. <i>Acacia pycnantha</i>

Photo direction - West
Number of trees – 1		Waypoint 165
Height (m) –3		
Hollows –0		
Diameter (cm) –11cm		
Canopy dieback (%) –60%		
Total Biodiversity Score –0.12		
This is a small tree with a low habitat value

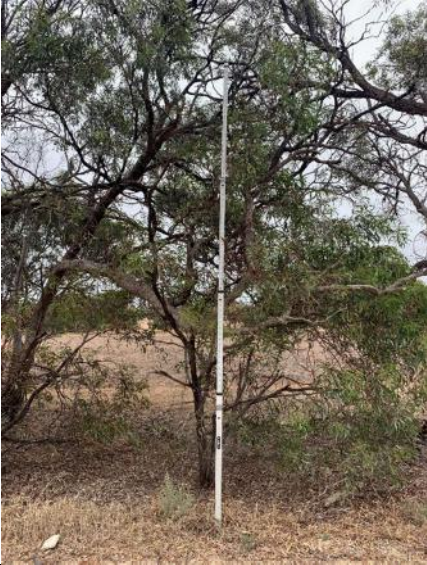
Tree ID – Tree 10	Representative photo	
Tree spp. <i>Acacia pycnantha</i>

Photo direction - West
Number of trees – 1		Waypoint 166
Height (m) –4		
Hollows –0		
Diameter (cm) – 11cm		
Canopy dieback (%) –50%		
Total Biodiversity Score –0.19		
This is a small tree with a low habitat value. Looks to be dying.

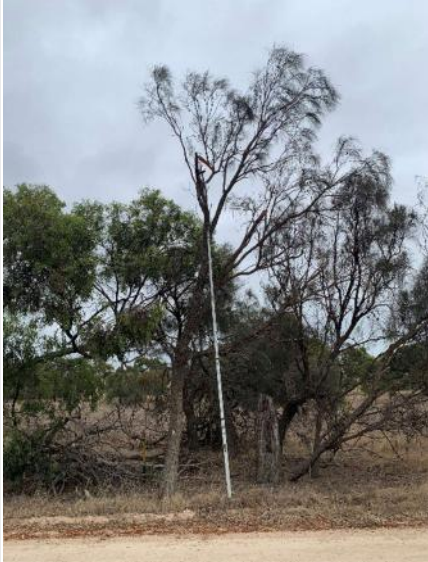
Tree ID – Tree 11	Representative photo	
Tree spp. <i>Allocasuarina verticillata</i>

Photo direction - West Waypoint 167
Number of trees – 1		
Height (m) –8		
Hollows –0		
Diameter (cm) –21cm		
Canopy dieback (%) –40%		
Total Biodiversity Score –0.33		
<p>This is a small tree with a low habitat value. Large branch has fallen off.</p>

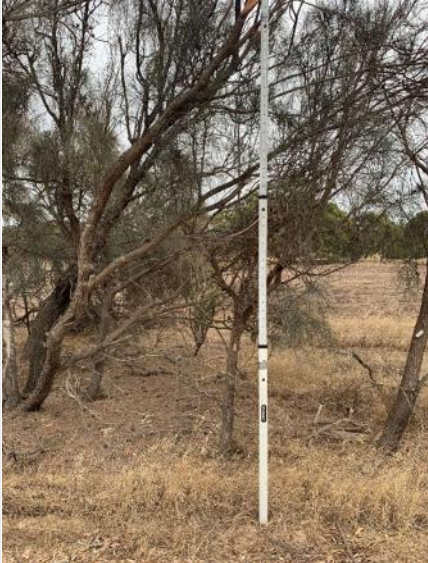
Tree ID – Tree 12	Representative photo	
Tree spp. <i>Allocasuarina verticillata</i>

Photo direction - West Waypoint 168
Number of trees – 1		
Height (m) –3		
Hollows –0		
Diameter (cm) –7cm		
Canopy dieback (%) –30%		
Total Biodiversity Score –0.10		
<p>This is a small tree with a low habitat value</p>

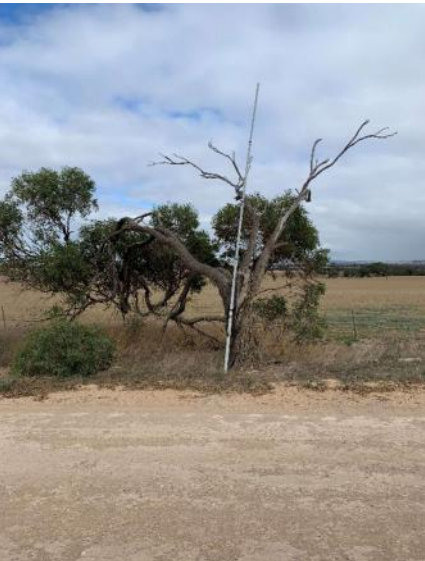
Tree ID – Tree 30	Representative photo(s)	
Tree spp. <i>Eucalyptus largiflorens</i>

Photo direction West
Number of trees – 1		Waypoint 186
Height (m) –3		
Hollows –0		
Diameter (cm) –55cm		
Canopy dieback (%) –80%		
Total Biodiversity Score –0.18		
<p>Large old tree with significant dieback</p>

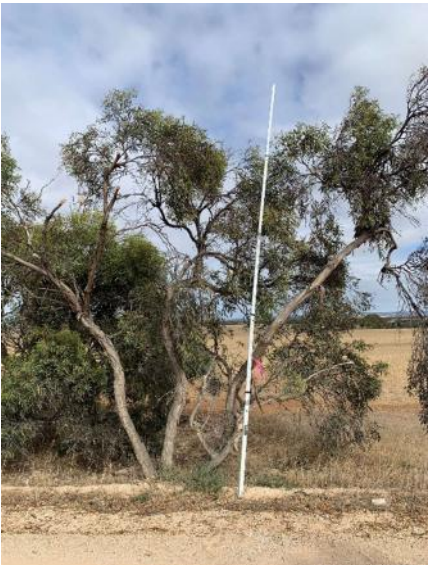
Tree ID – Tree 31	Representative photo(s)	
Tree spp. <i>Eucalyptus largiflorens</i>

Photo direction West
Number of trees – 1		Waypoint 187
Height (m) –4		
Hollows –0		
Diameter (cm) –25 cm		
Canopy dieback (%) –20%		
Total Biodiversity Score –0.20		
This is a small tree, multi trunked with signs of dieback.

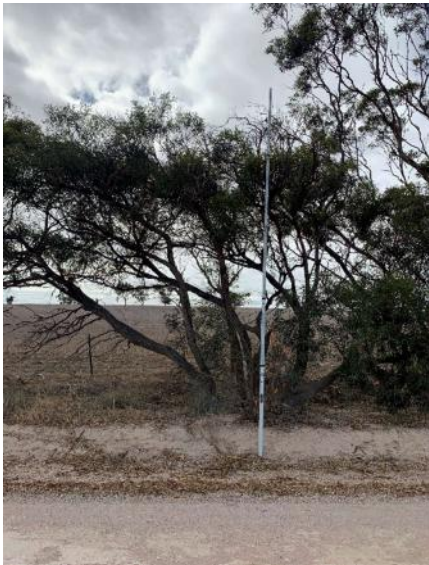
Tree ID – Tree 32	Representative photo(s)	
Tree spp. <i>Eucalyptus largiflorens</i>

Photo direction East
Number of trees – 1		Waypoint 188
Height (m) –4		
Hollows –0		
Diameter (cm) –26cm		
Canopy dieback (%) –50%		
Total Biodiversity Score –0.14		
This is a small tree, multi trunked with signs of dieback.

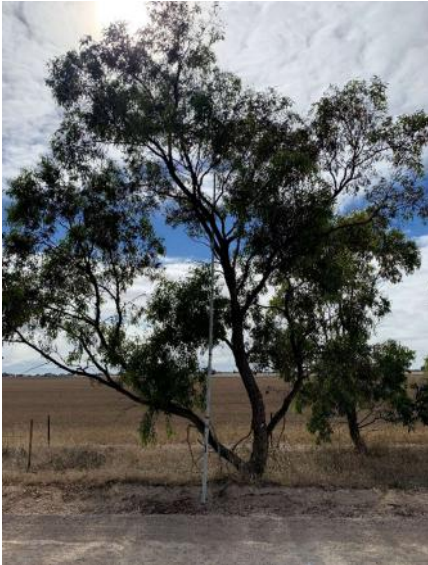
Tree ID – Tree 34	Representative photo	
Tree spp. <i>Eucalyptus largiflorens</i>

Photo direction East
Number of trees – 1		Waypoint 190
Height (m) –6		
Hollows –0		
Diameter (cm) –19cm		
Canopy dieback (%) –5%		
Total Biodiversity Score –0.23		
This is a small tree with a low habitat value

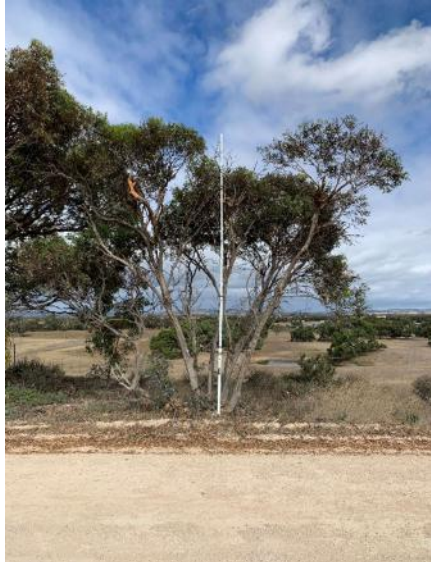
Tree ID – Tree 35	Representative photo	
Tree spp. <i>Eucalyptus odorata</i>

Photo direction west
Number of trees – 1		Waypoint 191
Height (m) –5		
Hollows –0		
Diameter (cm) –18cm		
Canopy dieback (%) –20%		
Total Biodiversity Score –0.22		
Multi trunked small tree with a low habitat value.

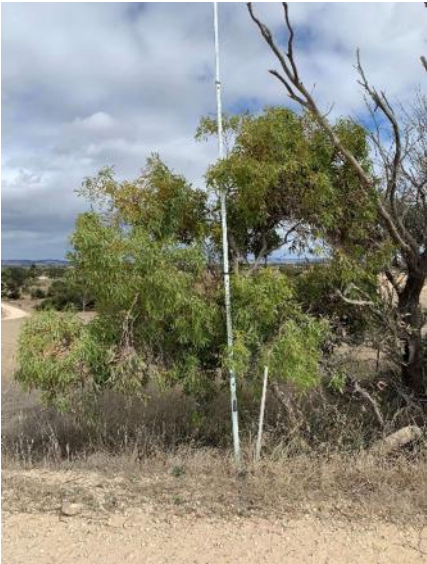
Tree ID – Tree 36	Representative photo	
Tree spp. <i>Eucalyptus odorata</i>

Photo direction West
Number of trees – 1		Waypoint 192
Height (m) –3		
Hollows –0		
Diameter (cm) –9cm		
Canopy dieback (%) –20%		
Total Biodiversity Score –0.11		
This is a small tree with a low habitat value

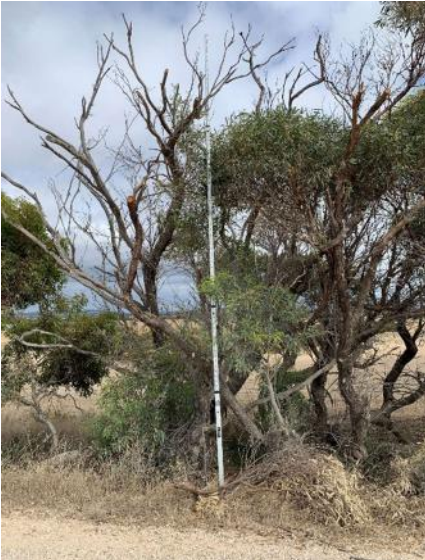
Tree ID – Tree 37	Representative photo	
Tree spp. <i>Eucalyptus odorata</i>

Photo direction West
Number of trees – 1		Waypoint 193
Height (m) –5		
Hollows –0		
Diameter (cm) –13cm		
Canopy dieback (%) –95%		
Total Biodiversity Score –0.06		
This is a small tree with a low habitat value

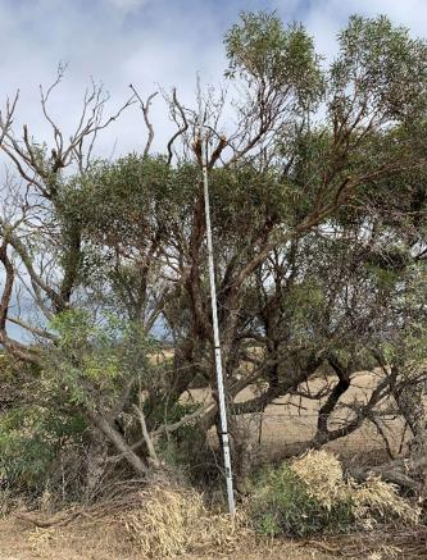
Tree ID – Tree 38	Representative photo	
Tree spp. <i>Eucalyptus Odorata</i>

Photo direction West
Number of trees – 1		Waypoint 194
Height (m) –5		
Hollows –0		
Diameter (cm) –14cm		
Canopy dieback (%) –50%		
Total Biodiversity Score –0.13		
This is a small tree with a low habitat value

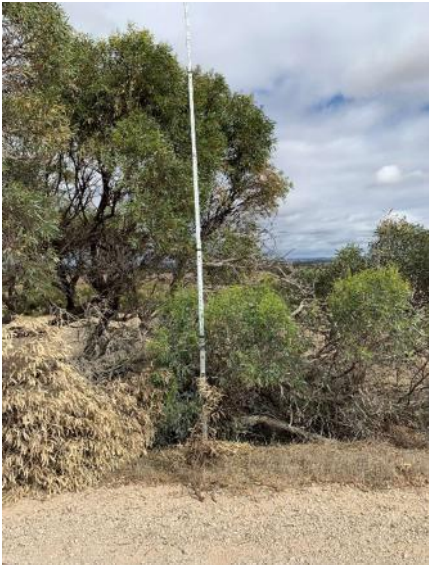
Tree ID – Tree 39	Representative photo	
Tree spp. <i>Eucalyptus odorata</i>

Photo direction West
Number of trees – 1		Waypoint 195
Height (m) –1.5		
Hollows –0		
Diameter (cm) –14cm		
Canopy dieback (%) –90%		
Total Biodiversity Score –0.02		
Tree is nearly dead

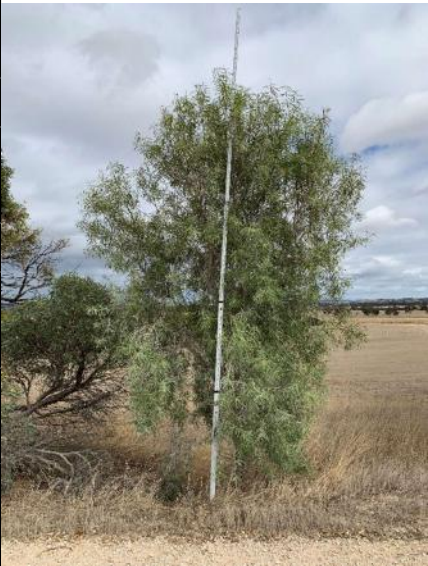
Tree ID – Tree 40	Representative photo	
Tree spp. <i>Pittosporum angustifolium</i>

Photo direction West
Number of trees – 1		Waypoint 196
Height (m) –4		
Hollows –0		
Diameter (cm) –22cm		
Canopy dieback (%) – 0%		
Total Biodiversity Score –0.25		
This is a small tree with a low habitat value

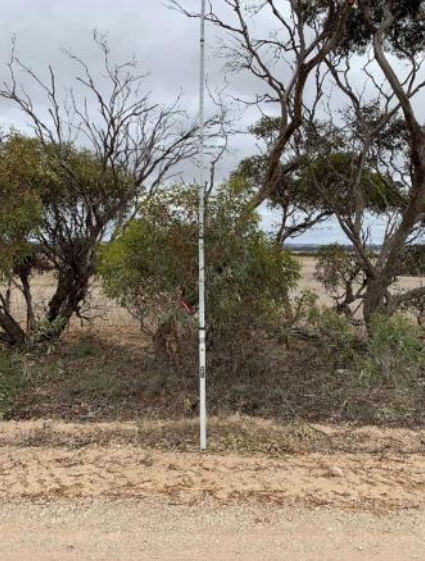
Tree ID – Tree 43	Representative photo	
Tree spp. <i>Eucalyptus odorata</i>

Photo direction West Waypoint 199
Number of trees – 1		
Height (m) –2		
Hollows –0		
Diameter (cm) –14cm		
Canopy dieback (%) –70%		
Total Biodiversity Score –0.04		
This is a small tree with a low habitat value

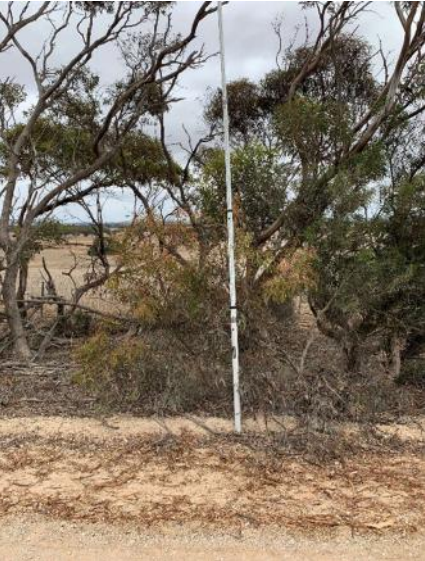
Tree ID – Tree 44	Representative photo	
Tree spp. <i>Eucalyptus odorata</i>

Photo direction West Waypoint 200
Number of trees – 1		
Height (m) –2		
Hollows –0		
Diameter (cm) –14cm		
Canopy dieback (%) –70%		
Total Biodiversity Score –0.04		
This is a small tree with a low habitat value

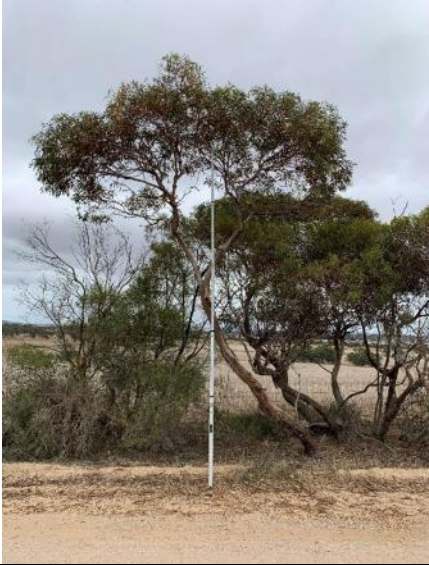
Tree ID – Tree 45	Representative photo	
Tree spp. <i>Eucalyptus socialis</i>

Photo direction West
Number of trees – 1		Waypoint 201
Height (m) –5		
Hollows –0		
Diameter (cm) –15cm		
Canopy dieback (%) –25%		
Total Biodiversity Score –0.30		
This is a small tree on the edge of the alignment

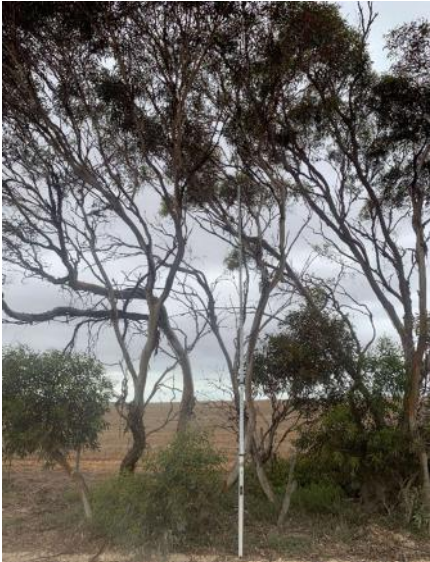
Tree ID – Tree 55	Representative photo	
Tree spp. <i>Eucalyptus socialis</i>

Photo direction East
Number of trees – 1		Waypoint 211
Height (m) –6		
Hollows –0		
Diameter (cm) – 12cm		
Canopy dieback (%) –40 %		
Total Biodiversity Score –0.29		
Multi stemmed tree as part of a group of trees close to the roadside verg

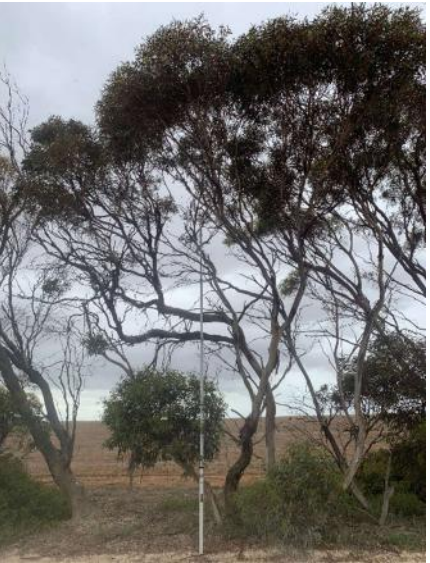
Tree ID – Tree 56	Representative photo	
Tree spp. <i>Eucalyptus socialis</i>

Photo direction East
Number of trees – 1		Waypoint 212
Height (m) – 6		
Hollows –0		
Diameter (cm) – 28cm		
Canopy dieback (%) – 30%		
Total Biodiversity Score – 0.50		
Multi stemmed tree as part of a group of trees close to the roadside verg

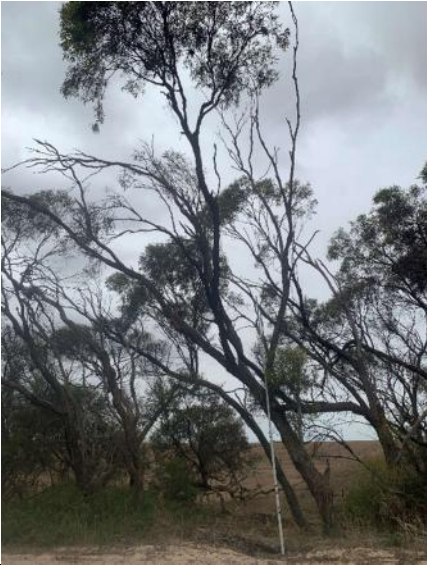
Tree ID – Tree 65	Representative photo	
Tree spp. <i>Eucalyptus largiflorens</i>

Photo direction East
Number of trees – 1		Waypoint 221
Height (m) –9		
Hollows –0		
Diameter (cm) –23cm		
Canopy dieback (%) –30%		
Total Biodiversity Score –0.14		
Multi stemmed tree as part of a group of trees close to the roadside verg in poor health

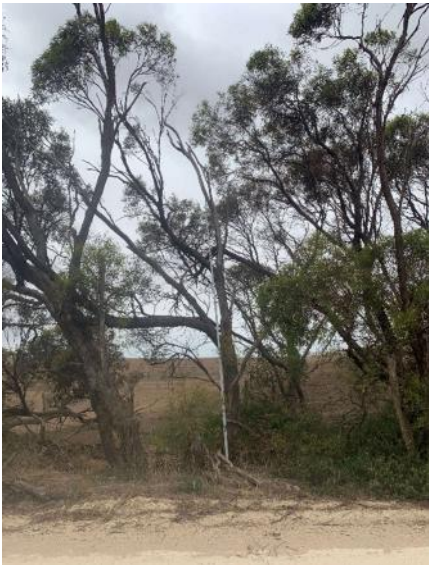
Tree ID – Tree 66	Representative photo(s)	
Tree spp. <i>Eucalyptus largiflorens</i>

Photo direction East
Number of trees – 1		Waypoint 222
Height (m) –8		
Hollows –0		
Diameter (cm) –34cm		
Canopy dieback (%) –60%		
Total Biodiversity Score –0.21		
Multi stemmed tree as part of a group of trees close to the roadside verg with greater than 50% dieback overhanging road

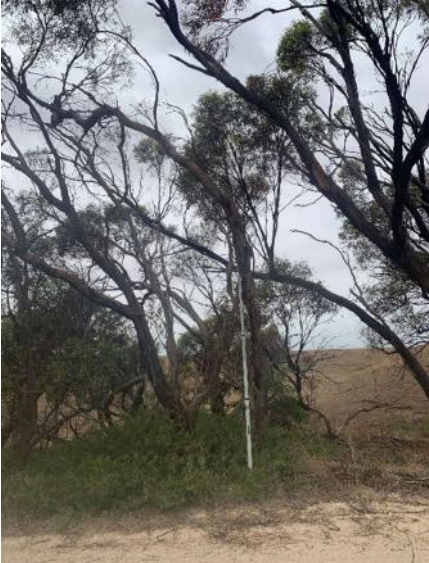
Tree ID – Tree 67	Representative photo	
Tree spp. <i>Eucalyptus largiflorens</i>

Photo direction East
Number of trees – 1		Waypoint 223
Height (m) –6		
Hollows –0		
Diameter (cm) –19cm		
Canopy dieback (%) –70%		
Total Biodiversity Score –0.09		
Multi stemmed tree as part of a group of trees close to the roadside verg with significant dieback overhanging road

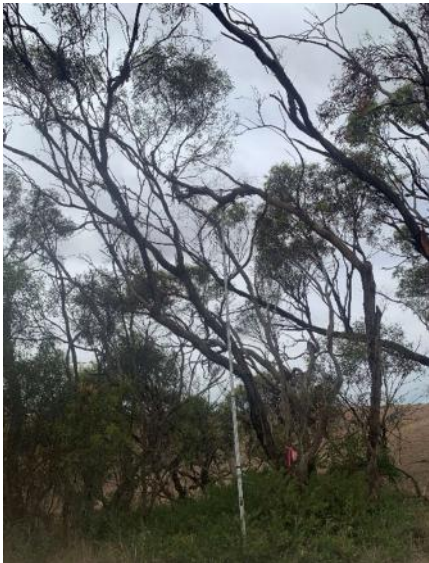
Tree ID – Tree 68	Representative photo	
Tree spp. <i>Eucalyptus largiflorens</i>

Photo direction East
Number of trees – 1		Waypoint 224
Height (m) –6		
Hollows –0		
Diameter (cm) –24cm		
Canopy dieback (%) –50%		
Total Biodiversity Score –0.15		
Multi stemmed tree as part of a group of trees close to the roadside verg with significant dieback overhanging road

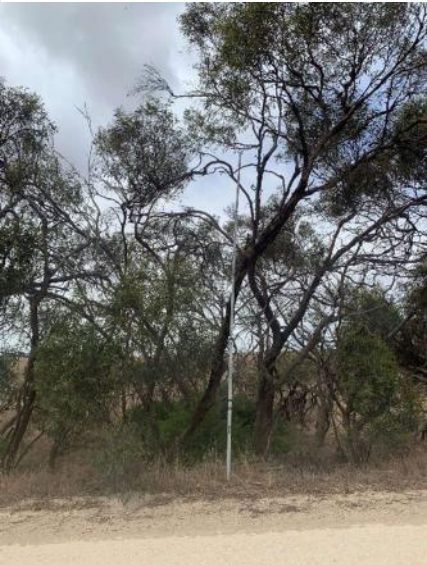
Tree ID – Tree 71	<p>Representative photo</p>

<p>Photo direction East Waypoint 227</p>
Tree spp. <i>Eucalyptus largiflorens</i>		
Number of trees – 1		
Height (m) –7		
Hollows –0		
Diameter (cm) –26cm		
Canopy dieback (%) –30%		
Total Biodiversity Score –0.24		
Multi stemmed tree as part of a group of trees close to the roadside verg

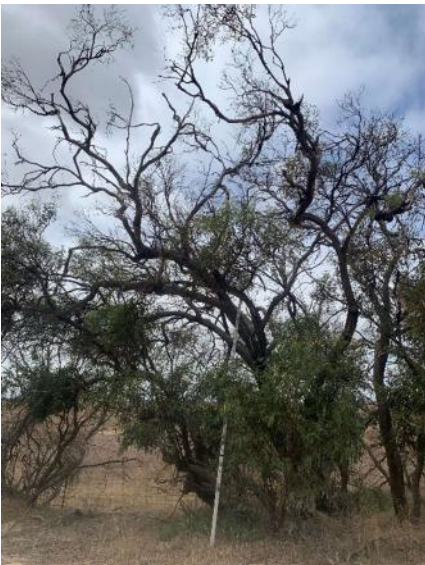
Tree ID – Tree 72	<p>Representative photo</p>

<p>Photo direction East Waypoint 228</p>
Tree spp. <i>Eucalyptus largiflorens</i>		
Number of trees – 1		
Height (m) –7		
Hollows – 2		
Diameter (cm) –85cm		
Canopy dieback (%) –80%		
Total Biodiversity Score –0.48		
Larger tree for the area however has significant dieback and has 2 hollows

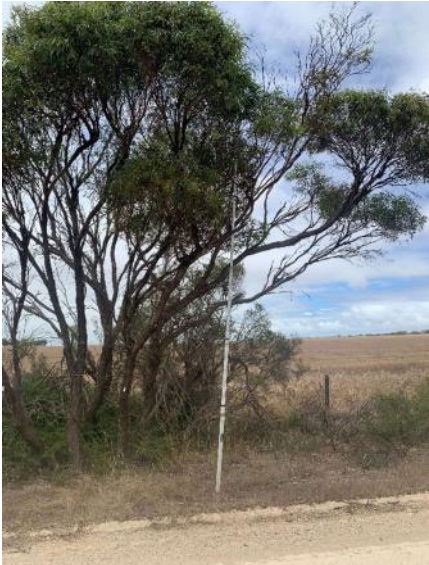
Tree ID – Tree 73	Representative photo	
Tree spp. <i>Eucalyptus largiflorens</i>

Photo direction East
Number of trees – 1		Waypoint 229
Height (m) –6		
Hollows –0		
Diameter (cm) – 18cm		
Canopy dieback (%) –25%		
Total Biodiversity Score –0.28		
Multi stemmed tree as part of a group of trees close to the roadside verg

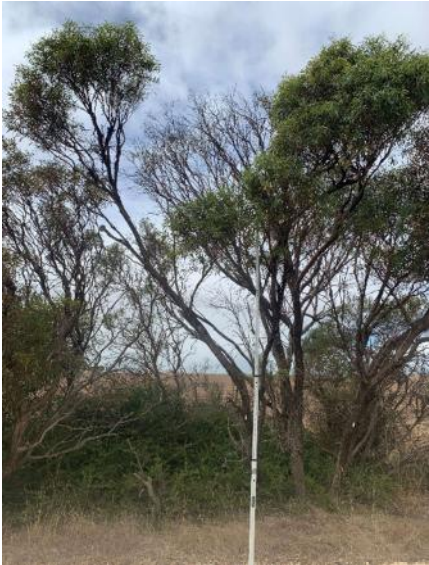
Tree ID – Tree 74	Representative photo	
Tree spp. <i>Eucalyptus largiflorens</i>

Photo direction East
Number of trees – 1		Waypoint 230
Height (m) – 6		
Hollows –0		
Diameter (cm) –15cm		
Canopy dieback (%) –30%		
Total Biodiversity Score –0.15		
Multi stemmed tree as part of a group of trees close to the roadside verg

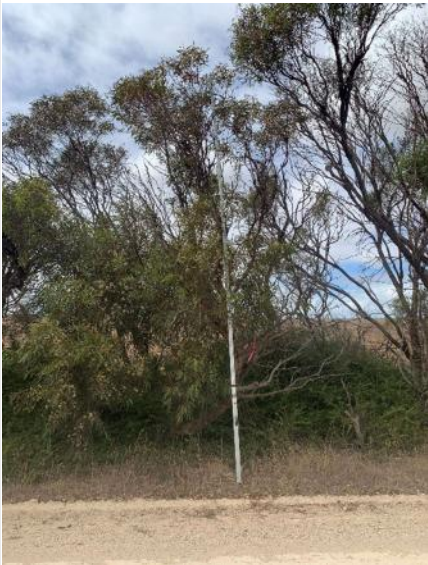
Tree ID – Tree 75	Representative photo	
Tree spp. <i>Eucalyptus socialis</i>

Photo direction East
Number of trees – 1		Waypoint 231
Height (m) –5		
Hollows –0		
Diameter (cm) –28cm		
Canopy dieback (%) –40%		
Total Biodiversity Score –0.37		
This is a small tree with significant dieback

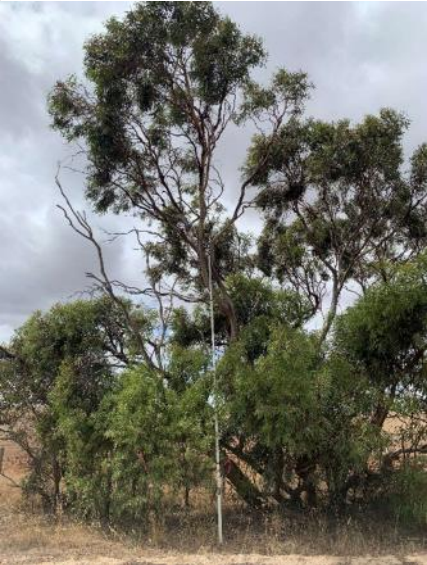
Tree ID – Tree 77	Representative photo	
Tree spp. <i>Eucalyptus phenax ssp</i>

Photo direction East
Number of trees – 1		Waypoint 233 and 234
Height (m) – 8		
Hollows –0		
Diameter (cm) – 64cm		
Canopy dieback (%) –40%		
Total Biodiversity Score –2.19		
Tallest tree in the group in good health

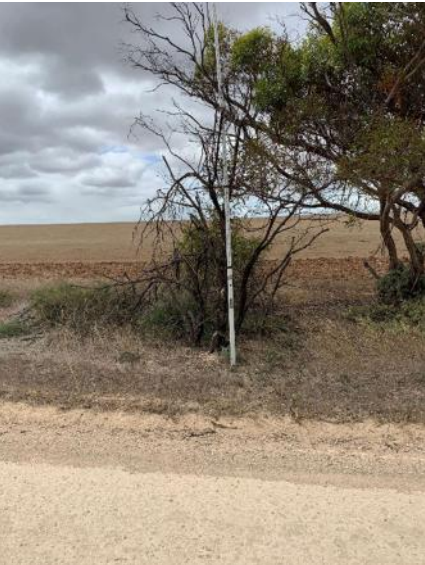
Tree ID – Tree 78	Representative photo(s)	
Tree spp. <i>Acacia pycnantha</i>

Photo direction East
Number of trees – 1		Waypoint 235
Height (m) –2		
Hollows –0		
Diameter (cm) – 12cm		
Canopy dieback (%) –90%		
Total Biodiversity Score –0.04		
This is a small tree with significant dieback

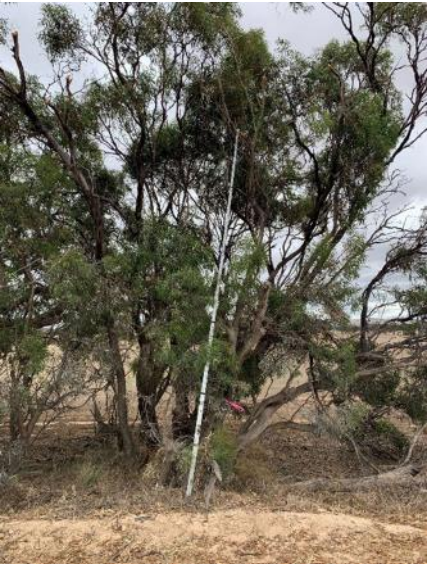
Tree ID – Tree 80	Representative photo	
Tree spp. <i>Eucalyptus largiflorens</i>

Photo direction West
Number of trees – 1		Waypoint 237
Height (m) –6		
Hollows –0		
Diameter (cm) –27cm		
Canopy dieback (%) –50%		
Total Biodiversity Score –0.17		
Multi stemmed tree as part of a group of trees close to the roadside verg and culvert

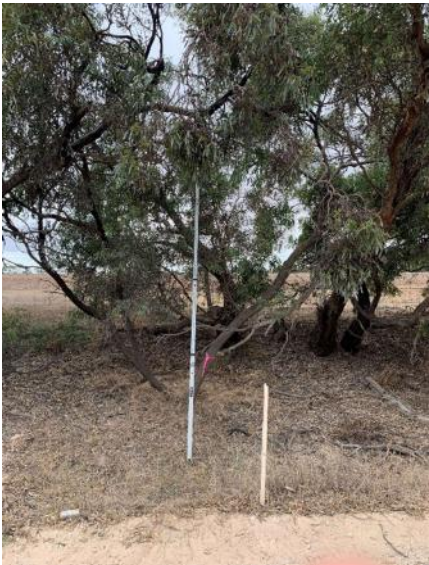
Tree ID – Tree 82	Representative photo	
Tree spp. <i>Eucalyptus largiflorens</i>

Photo direction East
Number of trees – 1		Waypoint 239
Height (m) –4		
Hollows –0		
Diameter (cm) –11cm		
Canopy dieback (%) –30%		
Total Biodiversity Score –0.09		
Multi stemmed tree as part of a group of trees close to the roadside verg and culvert

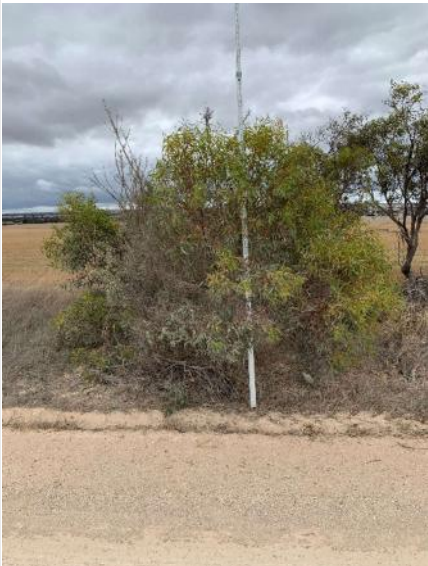
Tree ID – Tree 93	Representative photo	
Tree spp. <i>Eucalyptus socialis</i>

Photo direction West
Number of trees – 1		Waypoint 252 & 253
Height (m) – 2		
Hollows –0		
Diameter (cm) – 8 cm		
Canopy dieback (%) –10%		
Total Biodiversity Score –0.13		
Smaller mallee close to verg and cut frequently

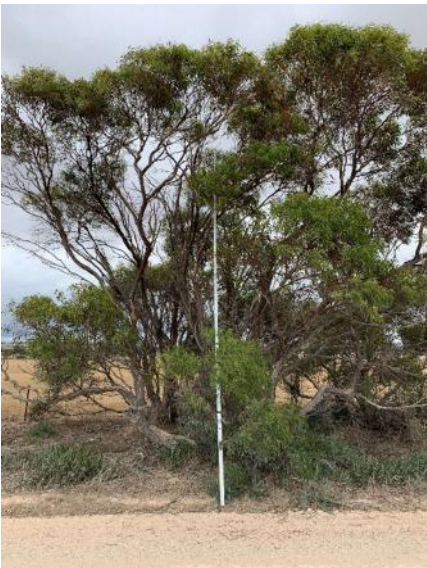
Tree ID – Tree 94	Representative photo	
Tree spp. <i>Eucalyptus socialis</i>

Photo direction West
Number of trees – 1		Waypoint 254
Height (m) – 6		
Hollows –0		
Diameter (cm) – 17cm		
Canopy dieback (%) –5%		
Total Biodiversity Score –0.48		
Multi stemmed tree close to the roadside verg no hollows
