Mallee Seep NDVI imagery Report October 2019

Rob Jericho's property

Andrew Baldock property Site 1

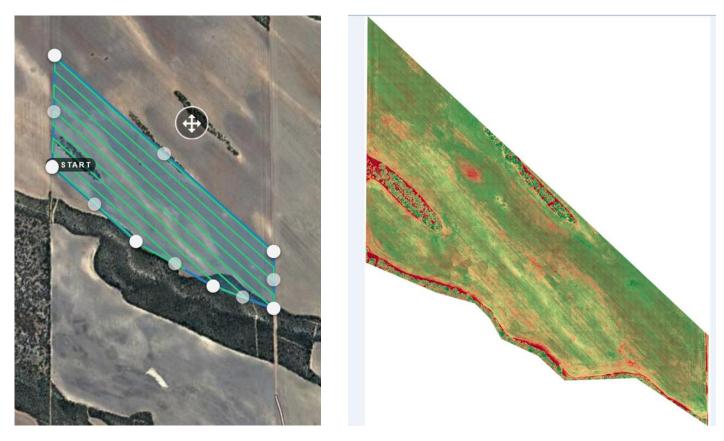
Rob Jericho Property Second paddock 'seep 2 north'

A second paddock was mapped with the flight Plan and drone map for Paddock 2 Site 1.

Second paddock 'seep 2 north' soil samples showed that the top 15cm was non wetting sands with a pH 5.5 in 0- 6cm. At 14 cm the pH lowered to pH 5 and then increased to pH 8.5 to 10 from 16cm –to 38cm.

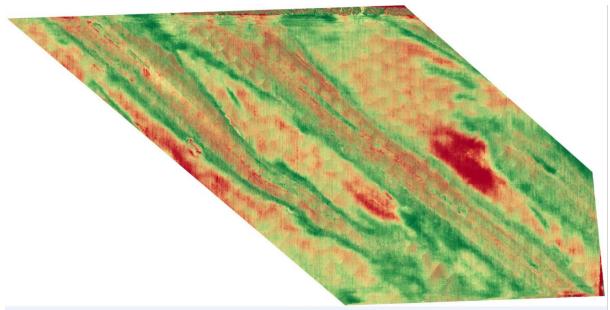
Site 2a

The NDVI map was flown over both flight paths.
