SA Seep Site 1: Kevin and Geoff Bonds, Mannum

“Repairing a recently formed seep scald area back into crop production.”

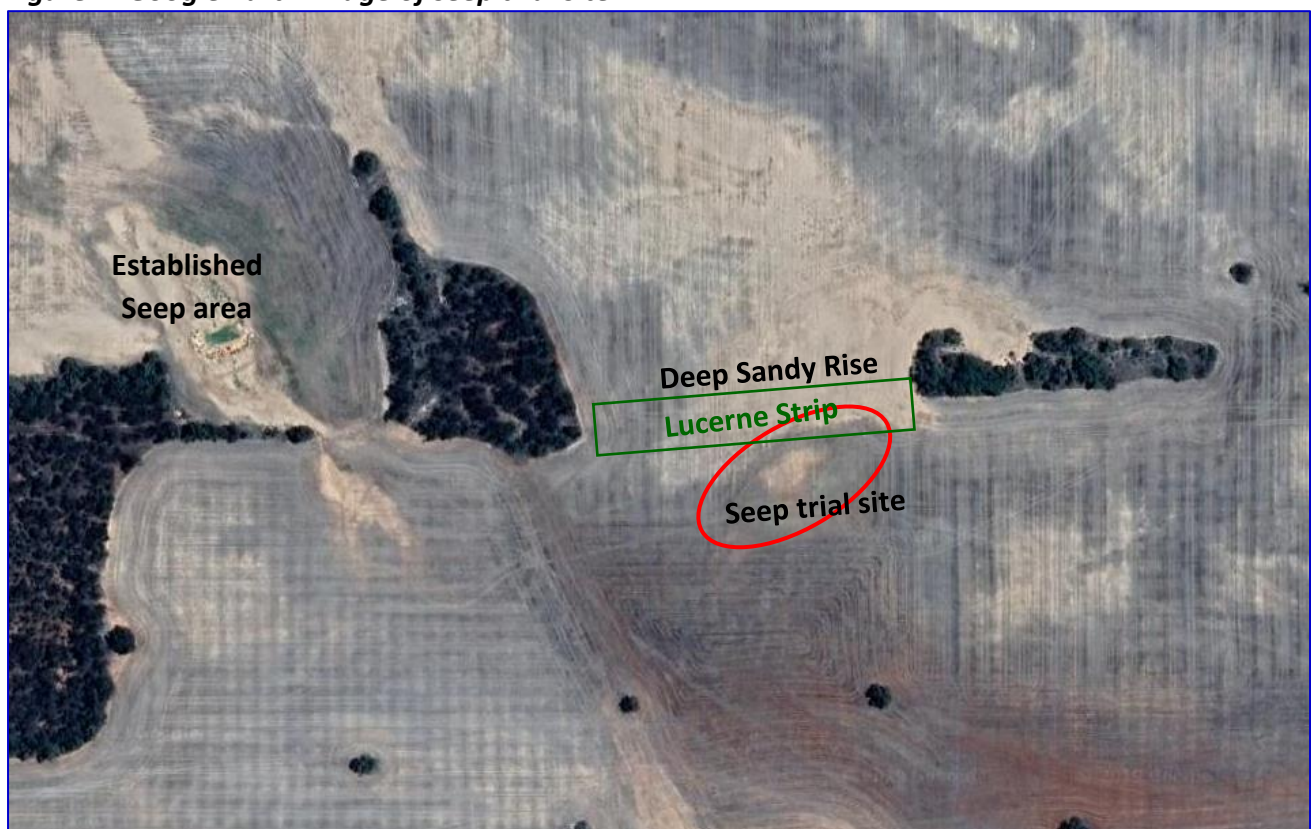
Figure 1. Google Earth Image of seep trial site

A seep area that has quickly developed over the few years, becoming initially waterlogged after the 2016 wet year, forming into a rapidly growing bare scalded area, not highly saline yet, but too saline in the surface to support wheat and summer crop growth. This is at the base of a deep sandhill and has the potential to spread into a much larger saline scald (Figures 1-2).

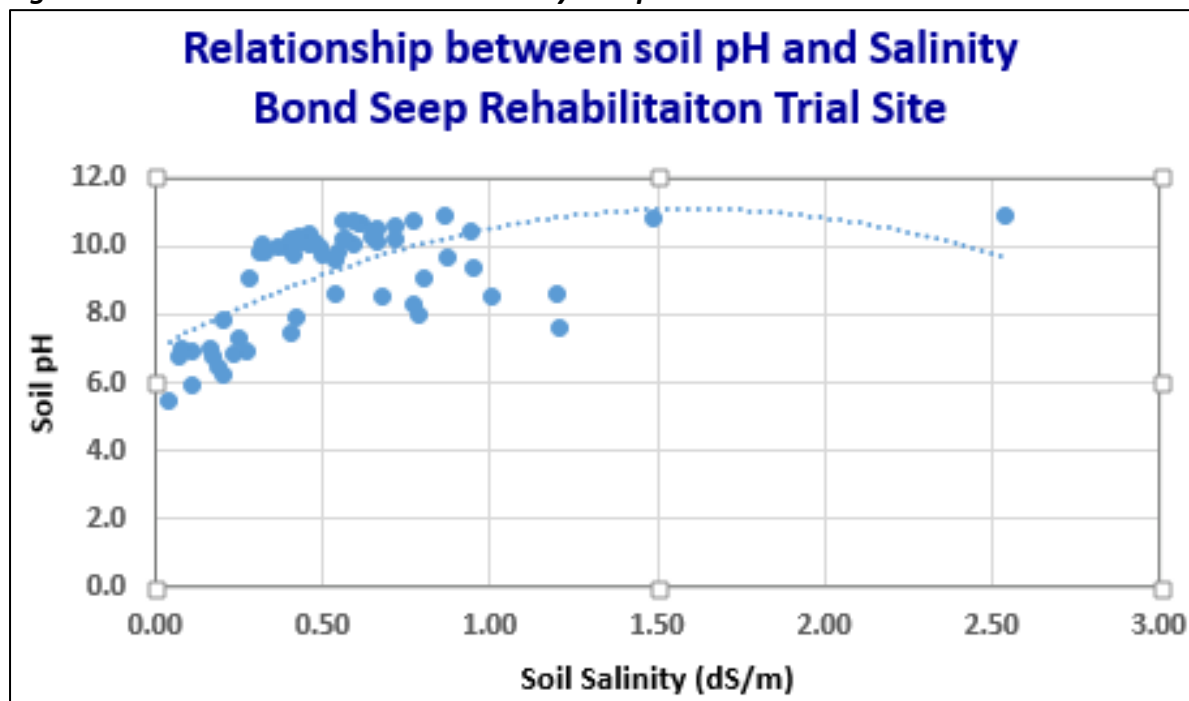
Figure 3. Correlations between soil Salinity and pH levels

4. There appears to be some correlation between increasing salinity and pH levels, but this may need further investigation (see Figure 3).
5. High subsoil salinity levels where no crop was growing may be partly due to being central to the worst of the original scald areas, but may have also deteriorated due to remaining bare (see Photo 5). This was not apparent even to 40cm depth where the 15cm of Sand was placed on top and the crop grew well.

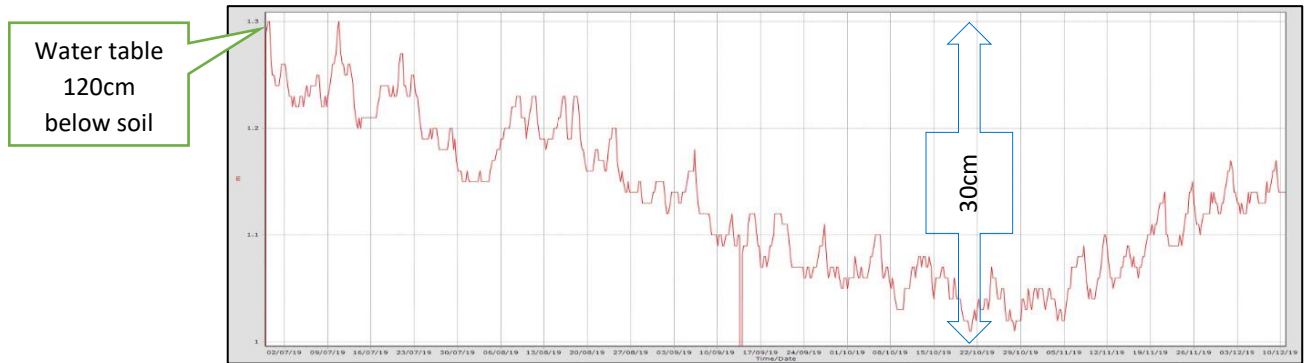
Figure 4. Piezometer levels at Rehab Scald site, July to Dec 2019 (not yet set to Aust Datum sea level)

Figure 4 shows that through the latter half of 2019 the water level dropped approximately 30cm from 120cm to 150cm depth, mainly due to the dry season. The level did rise by 15cm at the end of the year, possibly due to the 15mm rainfall in November after the crop had died, or also due to water still moving slowly through the system from earlier rainfalls. The success of this trial site will be seen in the long term reduction of the perched water table, presently sitting just below the limestone layer, over numerous seasons and higher rainfall periods.

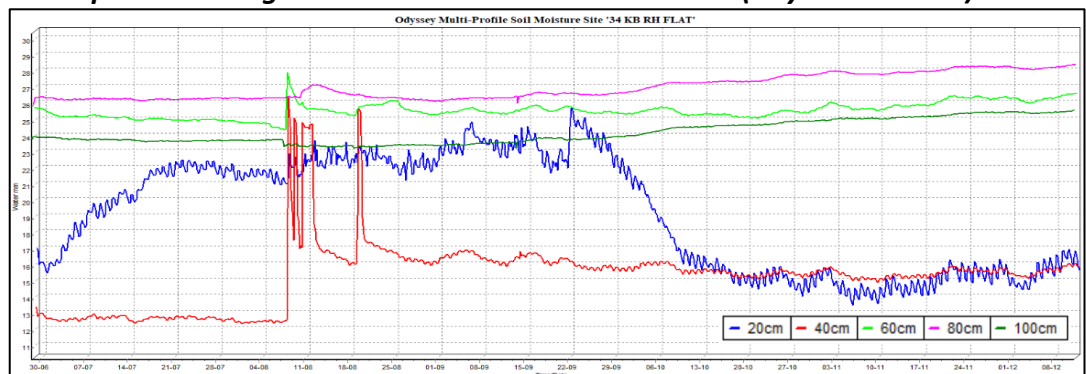
Figure 5. Soil Moisture probe readings at Rehab Flat next to Piezometer (July to Dec 2019)

Figure 5 shows the soil moisture probe set close to the piezometer. The idea behind this is to measure soil moisture dynamics within the crops rootzone due to rainfall and crop water use. It is also hoped to reveal any capillary rise of moisture from the water table to the surface, particularly over the summer months, and to assess this effect on surface salinity accumulation. Unfortunately, the limestone layer meant that a hole needed to be drilled through the stone to be able to establish this probe, causing far more soil disturbance than when normally inserting soil probes. The effectiveness of this probe is still being assessed because of this. At present the 20cm and 40cm depth sensors are responding to the limited rainfall events, while there has only been a slight rise in each of the deeper sensors down to 1m.

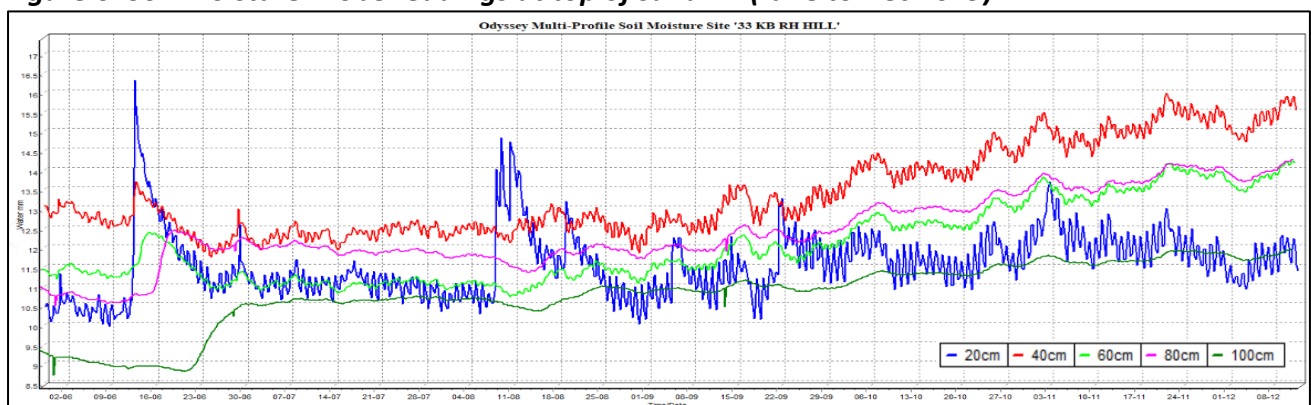
Figure 6. Soil Moisture Probe readings at top of sandhill (June to Dec 2019)

Figure 6 shows a slight rise in soil moisture at all levels due to the lack of crop growth at the probe site. There were major rainfall events recorded that would lead to a clear spike in the 100cm moisture sensor that would be indicative of water passing through the rootzone. Next season crop plants will be transplanted next to the probe.
