# Riparian Habitat Values Assessment of the Diamantina River Catchment; Lake Eyre Basin, South Australia

Henry Mancini  
June 2017

Report to the South Australian Arid Lands  
Natural Resources Management Board

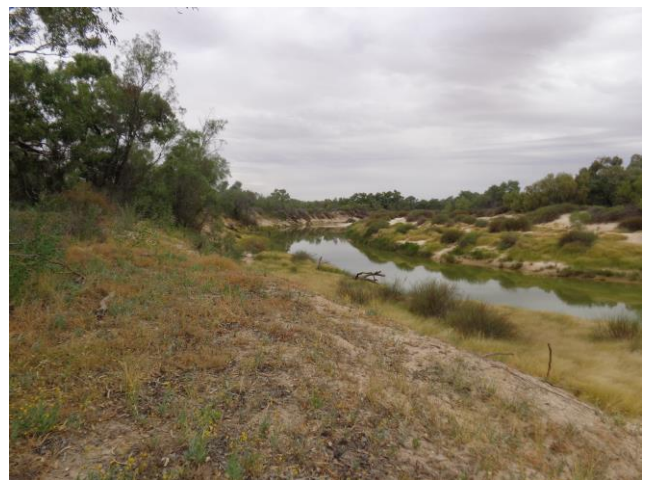
**Good riparian vegetation cover on streambank edge**

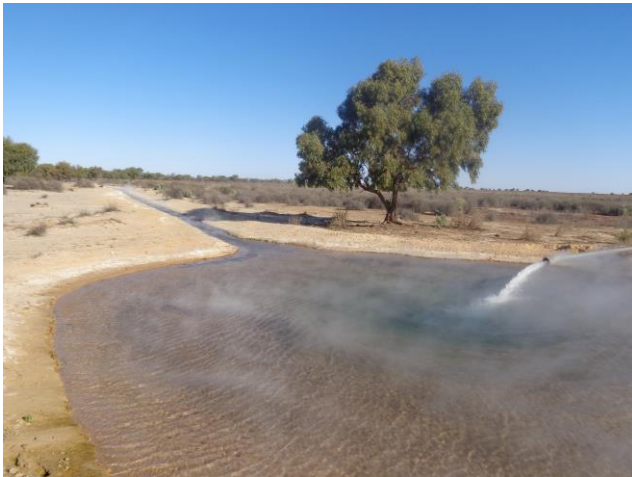
**Bore drain maintaining permanent waterhole**

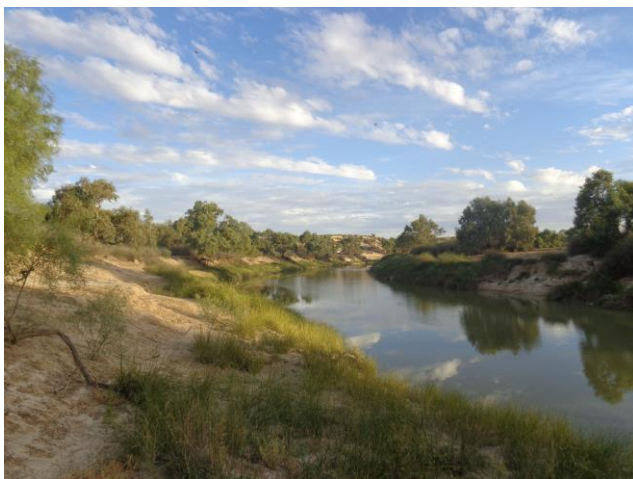
**Well vegetated banks**

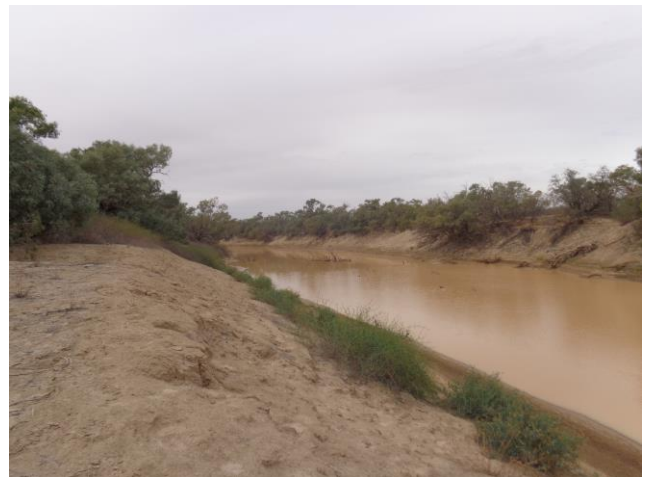
**Diamantina River channelised section – steep banks**
