# Native Vegetation Clearance

## Ten Trees Lagoon Road, Menzies

### Data Report

Clearance under the *Native Vegetation Regulations 2017*

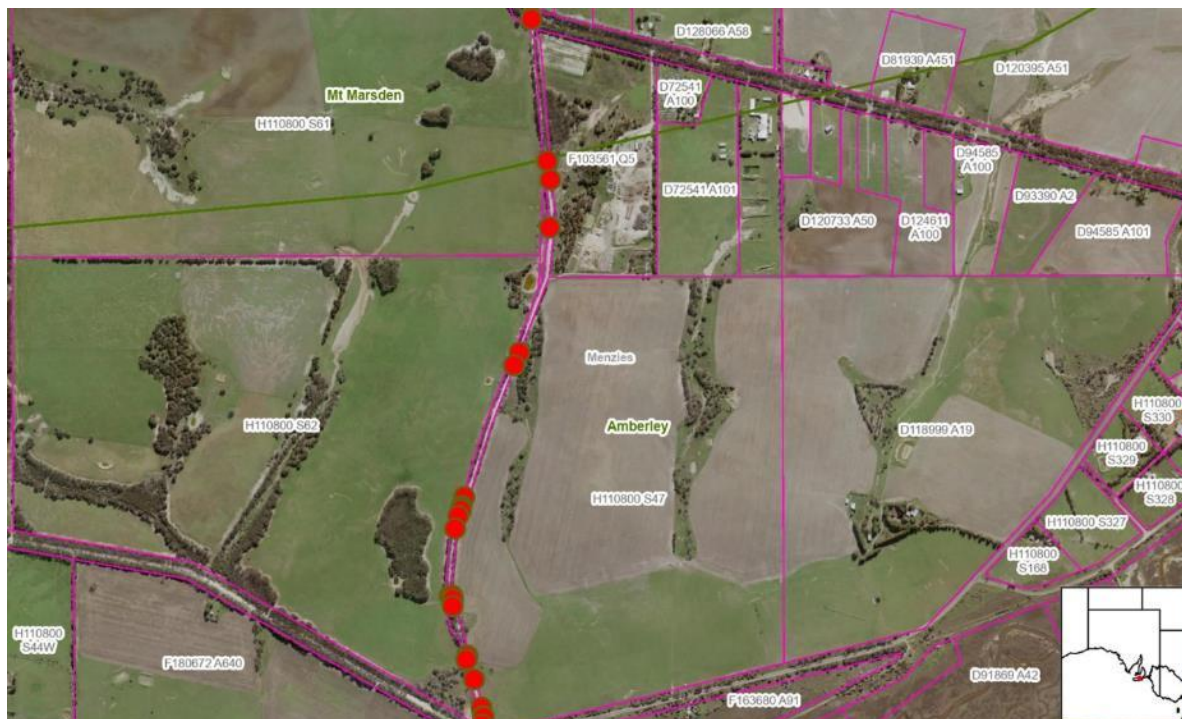
### Map of proposed clearance area

Purpose of clearance	Clearance required for the upgrade and sealing of Ten Trees Lagoon Road.
Native Vegetation Regulation	Regulation 12, Schedule 1; clause 34, Infrastructure
Description of the vegetation under application	4.70 ha of Narrow-leaf Mallee ( <i>Eucalyptus cneorifolia</i> ) Woodland in poor degraded condition.
Total proposed clearance - area (ha) and number of trees	32 scattered trees are proposed to be cleared.
Level of clearance	Level 4
Overlay (Planning and Design Code)	Native Vegetation Overlay

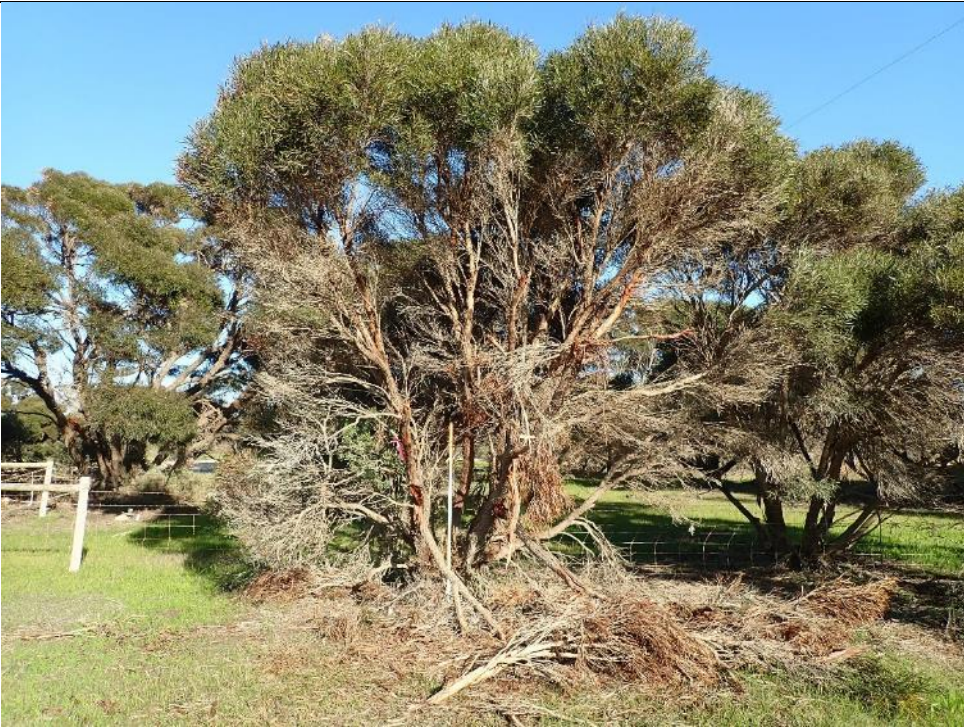
Tree ID - Tree 1

<i>Eucalyptus cneorifolia</i>	
1	
Height (m) – 6	
Hollows – 0	
Diameter (cm) – 22	
Canopy dieback (%) – 10	
Total Biodiversity Score – 1.11	
<b>Direction:</b> 246° <b>Latitude:</b> 35° 40' 40.81" S <b>Longitude:</b> 137° 34' 14.98" E	
Medium multi-stemmed mallee in good condition. The roadside of the tree has recently been pruned. It is not providing habitat for threatened species.

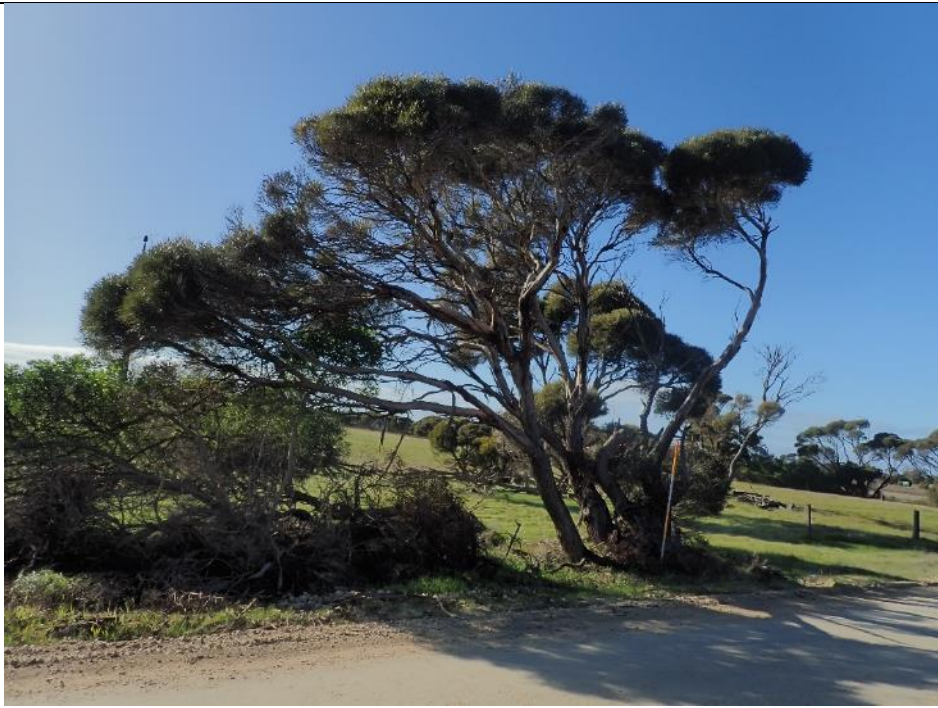
Tree ID - Tree 2

<i>Eucalyptus cneorifolia</i>	
1	
Height (m) – 6	
Hollows – 0	
Diameter (cm) – 41	
Canopy dieback (%) – 15	
Total Biodiversity Score – 2.10	
<b>Direction:</b> 155° <b>Latitude:</b> 35° 40' 39.89" S <b>Longitude:</b> 137° 34' 15.22" E	
Medium multi-stemmed mallee in good condition. It is not providing habitat for threatened species.

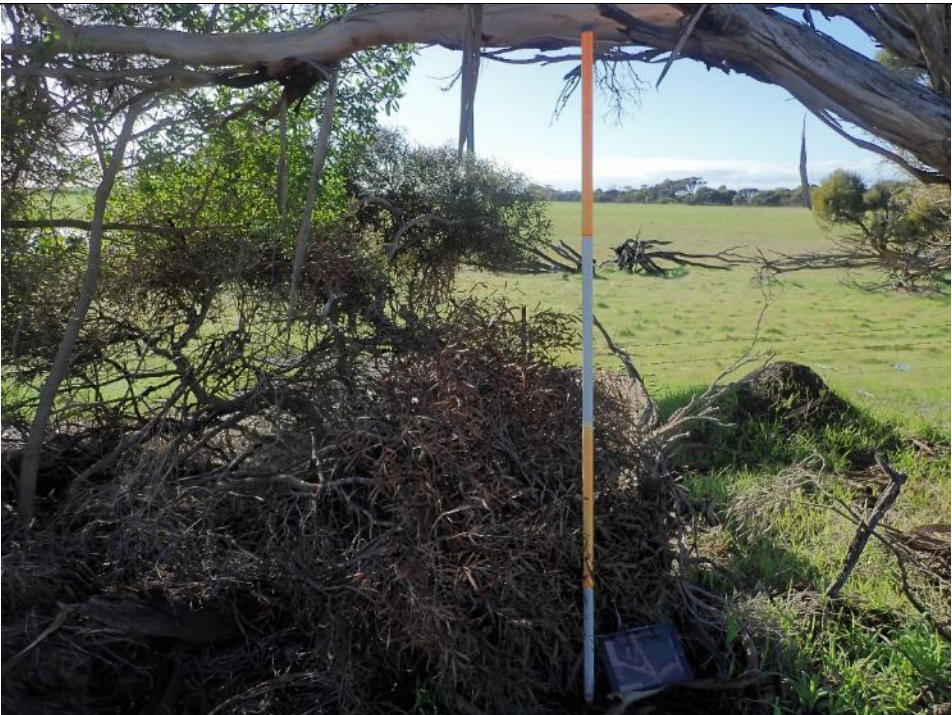
Tree ID - Tree 3

<i>Eucalyptus cneorifolia</i>	
1	
Height (m) – 2	
Hollows – 0	
Diameter (cm) – 8	
Canopy dieback (%) – 10	
Total Biodiversity Score – 0.25	
<b>Direction:</b> 61° <b>Latitude:</b> 35° 40' 39.81" S <b>Longitude:</b> 137° 34' 15.17" E	
Small multi-stemmed mallee that has fallen over, but in good condition. It is not providing habitat for threatened species.

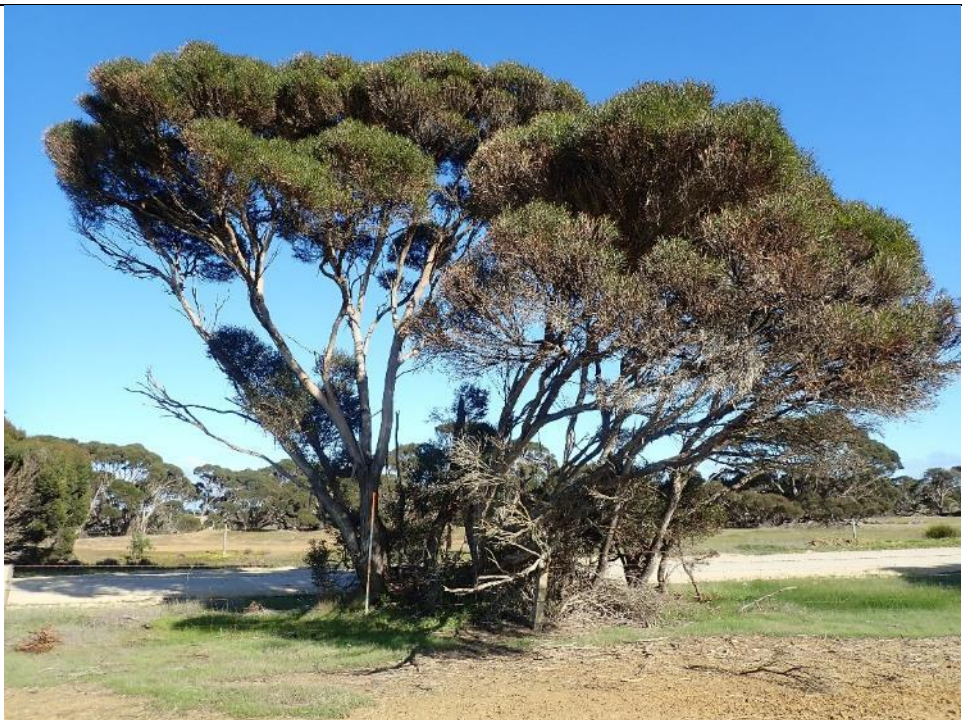
Tree ID - Tree 4

<i>Eucalyptus cneorifolia</i>	
3	
Height (m) – 7	
Hollows – 0	
Diameter (cm) – 33	
Canopy dieback (%) – 15	
Total Biodiversity Score – 6.24	
<b>Direction:</b> 282° <b>Latitude:</b> 35° 40' 38.85" S <b>Longitude:</b> 137° 34' 14.94" E	
Small clump of medium sized mallees in good condition. It is not providing habitat for threatened species.

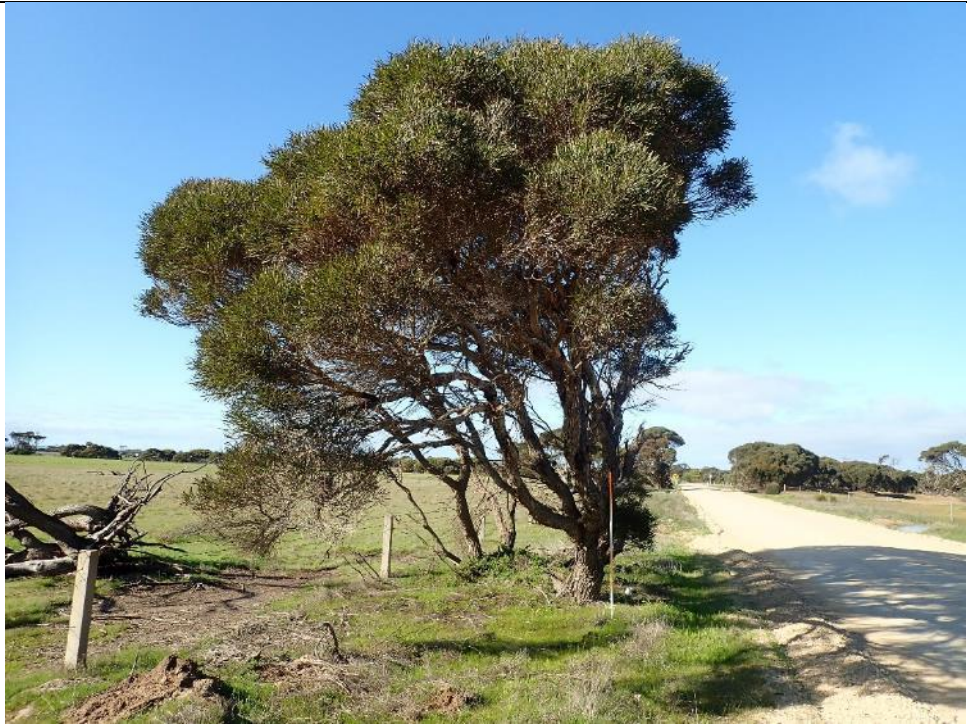
Tree ID - Tree 5

<i>Eucalyptus cneorifolia</i>	
1	
Height (m) – 6	
Hollows – 0	
Diameter (cm) – 35	
Canopy dieback (%) – 5	
Total Biodiversity Score – 2.03	
<b>Direction:</b> 165° <b>Latitude:</b> 35° 40' 35.72" S <b>Longitude:</b> 137° 34' 13.93" E	
Medium mallee in good condition. The roadside of the tree has previously been pruned. It is not providing habitat for threatened species.

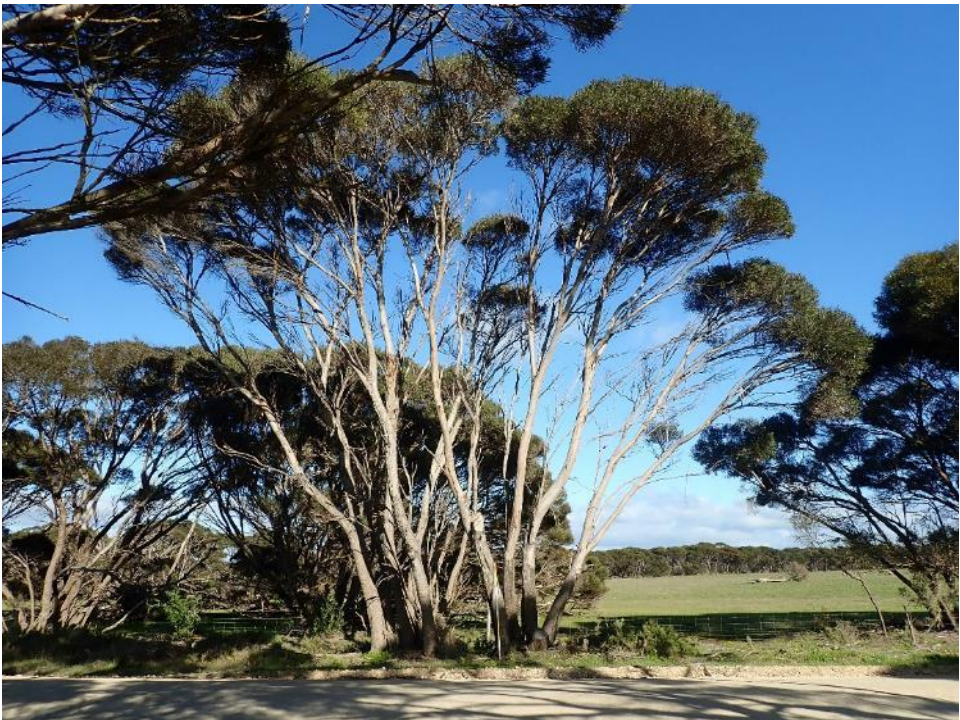
Tree ID - Tree 6

<i>Eucalyptus cneorifolia</i>	
1	
Height (m) – 9	
Hollows – 0	
Diameter (cm) – 32.5	
Canopy dieback (%) – 10	
Total Biodiversity Score – 3.44	
<b>Direction:</b> 268° <b>Latitude:</b> 35° 40' 33.50" S <b>Longitude:</b> 137° 34' 12.89" E	
Tall multi-stemmed mallee in good condition. It is not providing habitat for threatened species.

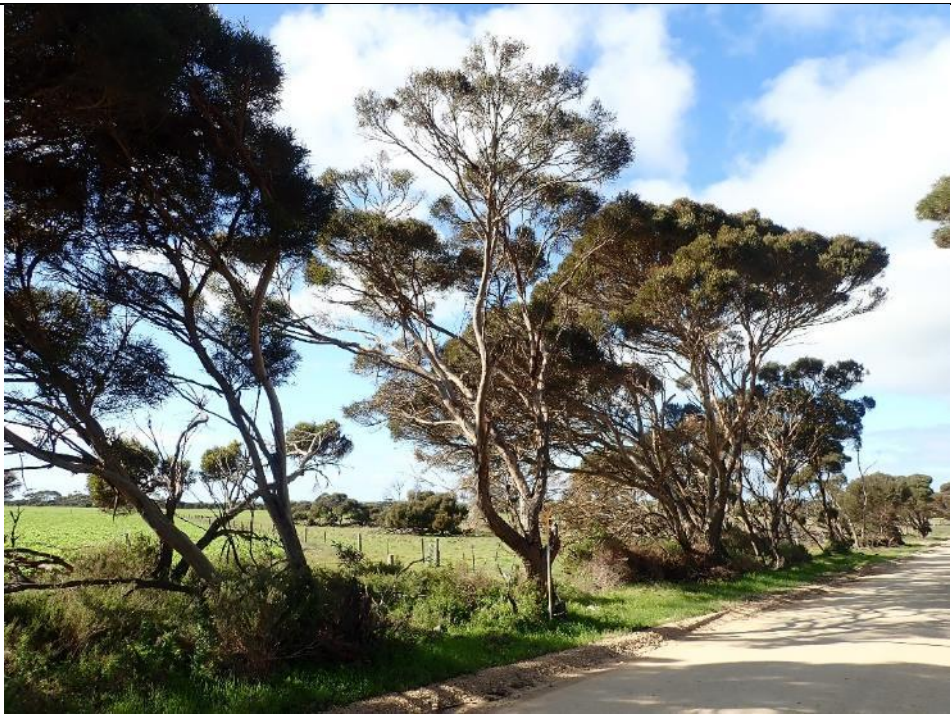
Tree ID - Tree 7

<i>Eucalyptus cneorifolia</i>	
1	
Height (m) – 7	
Hollows – 0	
Diameter (cm) – 44	
Canopy dieback (%) – 50	
Total Biodiversity Score – 1.44	
<b>Direction:</b> 150° <b>Latitude:</b> 35° 40' 33.11" S <b>Longitude:</b> 137° 34' 13.01" E	
Tall sized mallee in poor condition with considerable dieback. It is not providing habitat for threatened species.

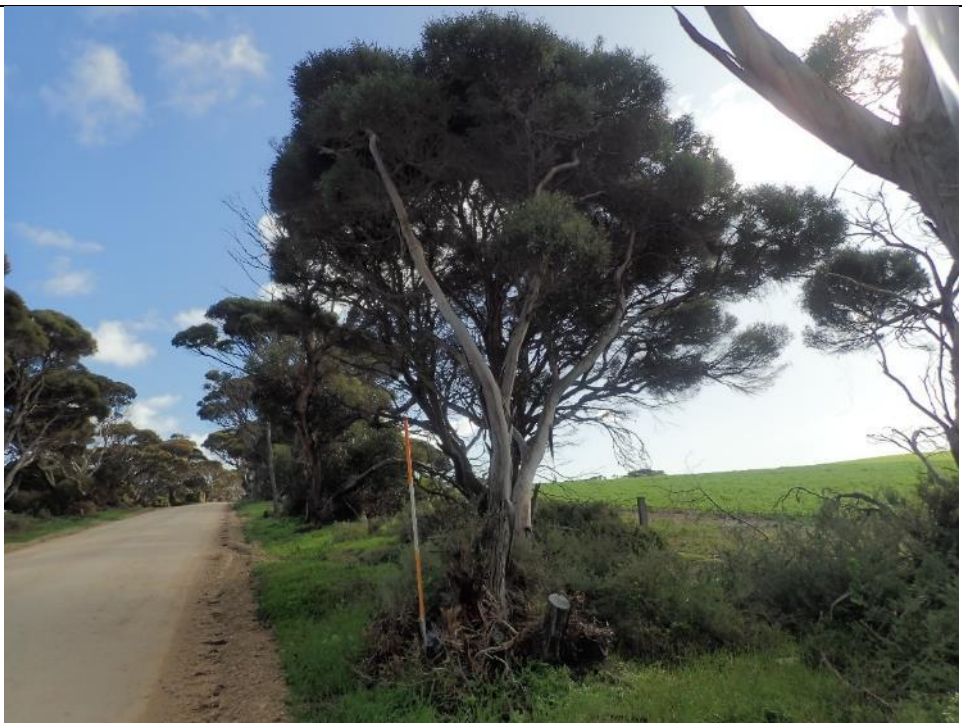
Tree ID - Tree 8

<i>Eucalyptus cneorifolia</i>	
1	
Height (m) – 5	
Hollows – 0	
Diameter (cm) – 21.5	
Canopy dieback (%) – 10	
Total Biodiversity Score – 0.63	
<b>Direction:</b> 340° <b>Latitude:</b> 35° 40' 33.02" S <b>Longitude:</b> 137° 34' 12.95" E	
Medium sized mallee in good condition. One of the trunks has previously been pruned off. It is not providing habitat for threatened species.

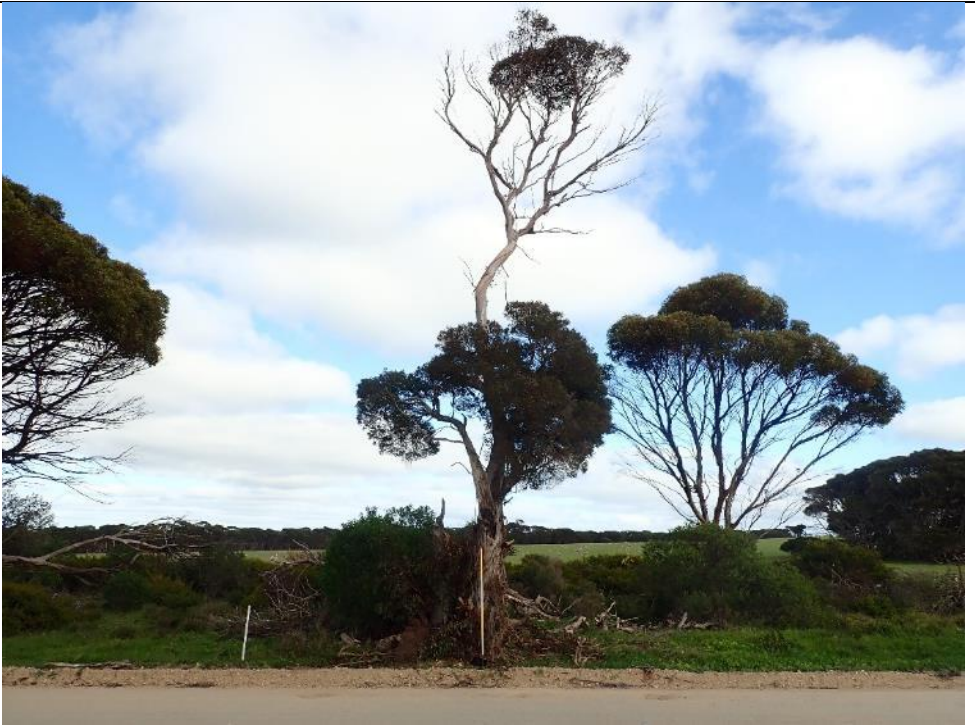
Tree ID - Tree 9

<i>Eucalyptus phenax ssp. compressa</i>	
1	
Height (m) – 11	
Hollows – 0	
Diameter (cm) – 63.5	
Canopy dieback (%) – 80	
Total Biodiversity Score – 2.59	
<b>Direction:</b> 259° <b>Latitude:</b> 35° 40' 27.51" S <b>Longitude:</b> 137° 34' 10.97" E	
Very tall mallee in very poor condition. The lower limbs have previously been pruned for road safety. It is not providing habitat for threatened species.

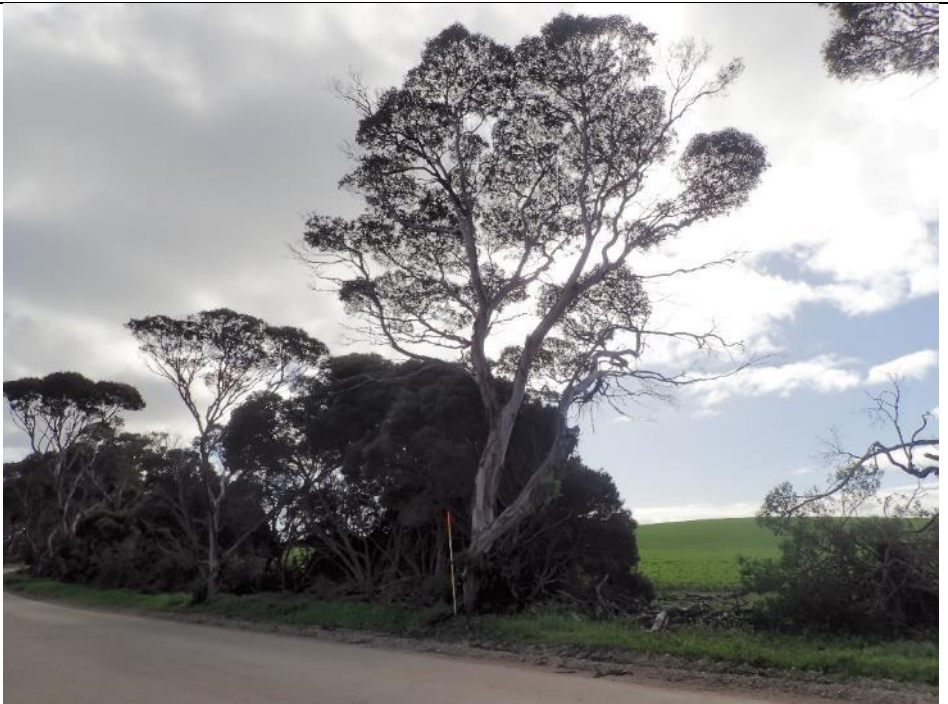
Tree ID - Tree 10

<i>Eucalyptus phenax ssp. compressa</i>	
1	
Height (m) – 9	
Hollows – 0	
Diameter (cm) – 86	
Canopy dieback (%) – 30	
Total Biodiversity Score – 6.30	
<b>Direction:</b> 37° <b>Latitude:</b> 35° 40' 26.73" S <b>Longitude:</b> 137° 34' 11.02" E	
Tall mallee in good, but senescent condition. It is not providing habitat for threatened species.

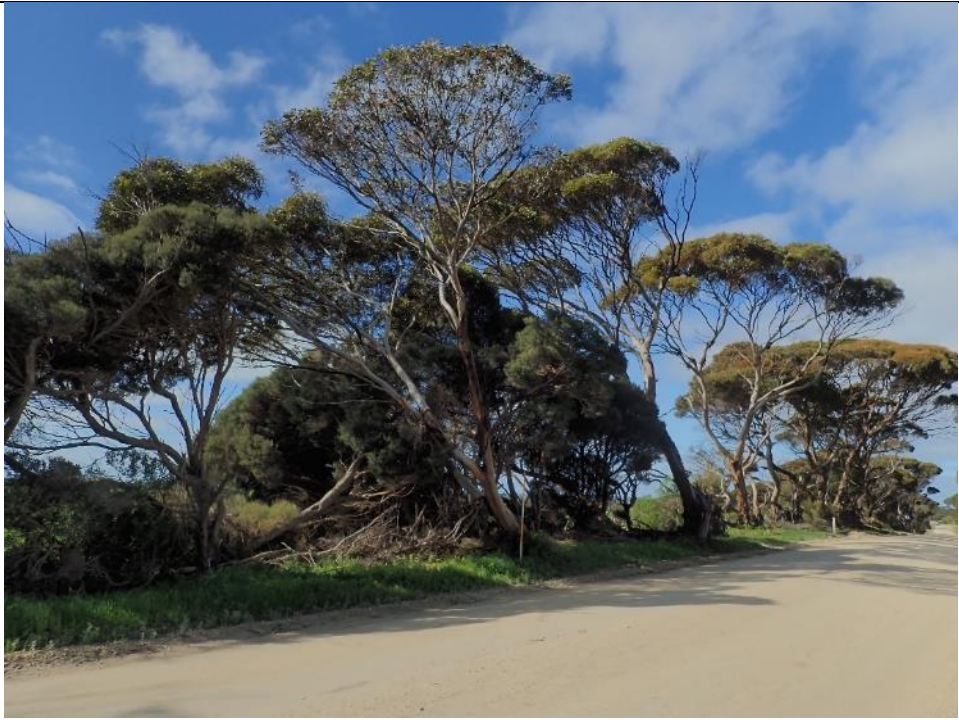
Tree ID - Tree 11

<i>Eucalyptus phenax ssp. compressa</i>	
1	
Height (m) – 9	
Hollows – 0	
Diameter (cm) – 34	
Canopy dieback (%) – 20	
Total Biodiversity Score – 3.53	
<b>Direction:</b> 165° <b>Latitude:</b> 35° 40' 26.34" S <b>Longitude:</b> 137° 34' 10.90" E	
Tall mallee in good, but senescent condition. It is not providing habitat for threatened species.

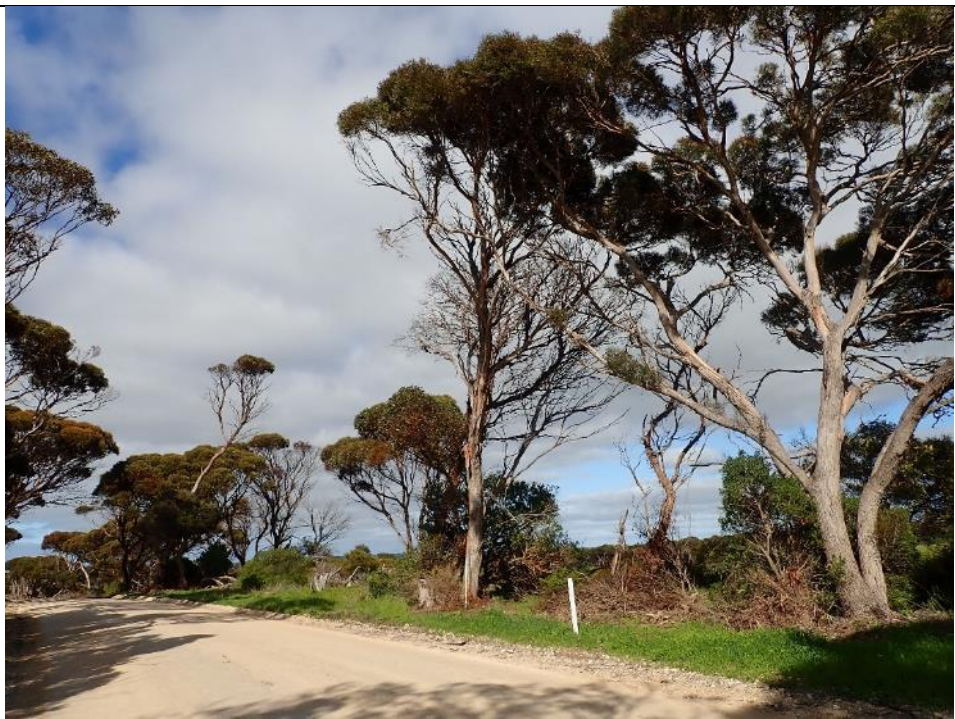
Tree ID - Tree 12

<i>Eucalyptus cneorifolia</i>	
1	
Height (m) – 9	
Hollows – 0	
Diameter (cm) – 39.5	
Canopy dieback (%) – 10	
Total Biodiversity Score – 3.89	
<b>Direction:</b> 200° <b>Latitude:</b> 35° 40' 26.35" S <b>Longitude:</b> 137° 34' 10.55" E	
Tall mallee in good, but senescent condition. Secondary trunks have previously been pollarded. It is not providing habitat for threatened species.

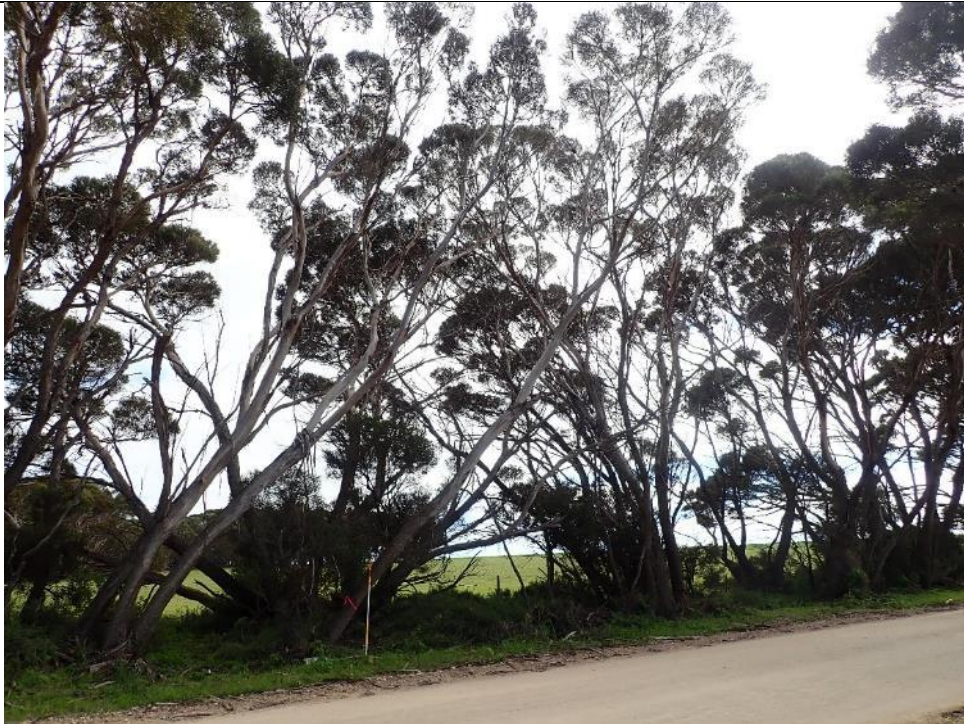
Tree ID - Tree 13

<i>Eucalyptus cneorifolia</i>	
1	
Height (m) – 10	
Hollows – 0	
Diameter (cm) – 28	
Canopy dieback (%) – 15	
Total Biodiversity Score – 2.45	
<b>Direction:</b> 281° <b>Latitude:</b> 35° 40' 18.84" S <b>Longitude:</b> 137° 34' 11.31" E	
Tall mallee in good, but senescent condition. It is not providing habitat for threatened species.

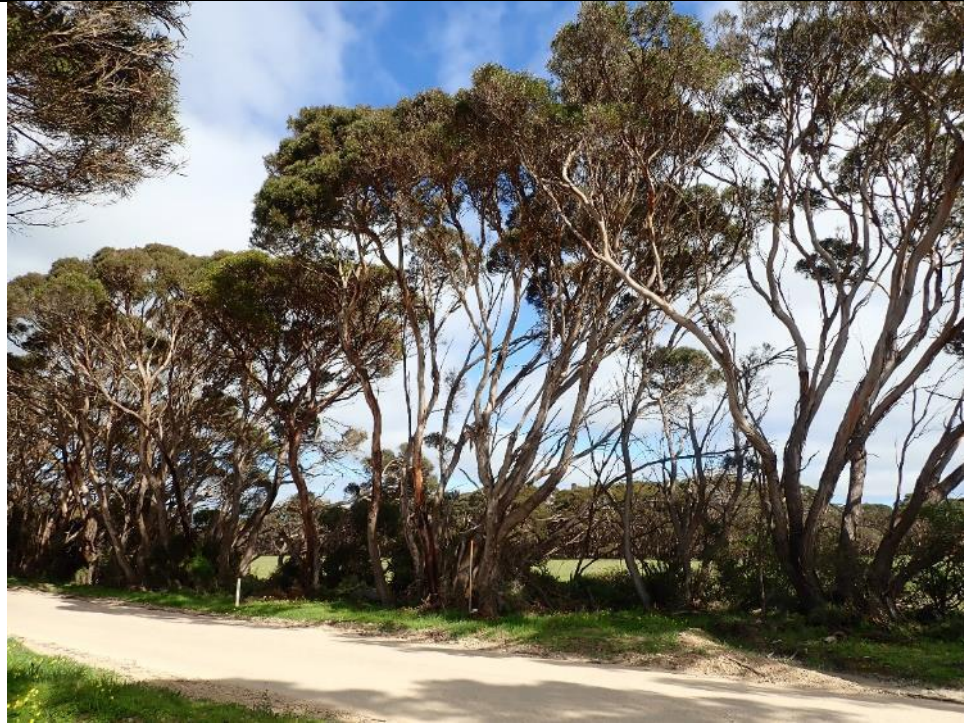
Tree ID - Tree 14

<i>Eucalyptus cneorifolia</i>	
1	
Height (m) – 11	
Hollows – 0	
Diameter (cm) – 61	
Canopy dieback (%) – 5	
Total Biodiversity Score – 4.82	
<b>Direction:</b> 224° <b>Latitude:</b> 35° 40' 17.42" S <b>Longitude:</b> 137° 34' 11.73" E	
Tall mallee in good, but senescent condition. It is not providing habitat for threatened species.

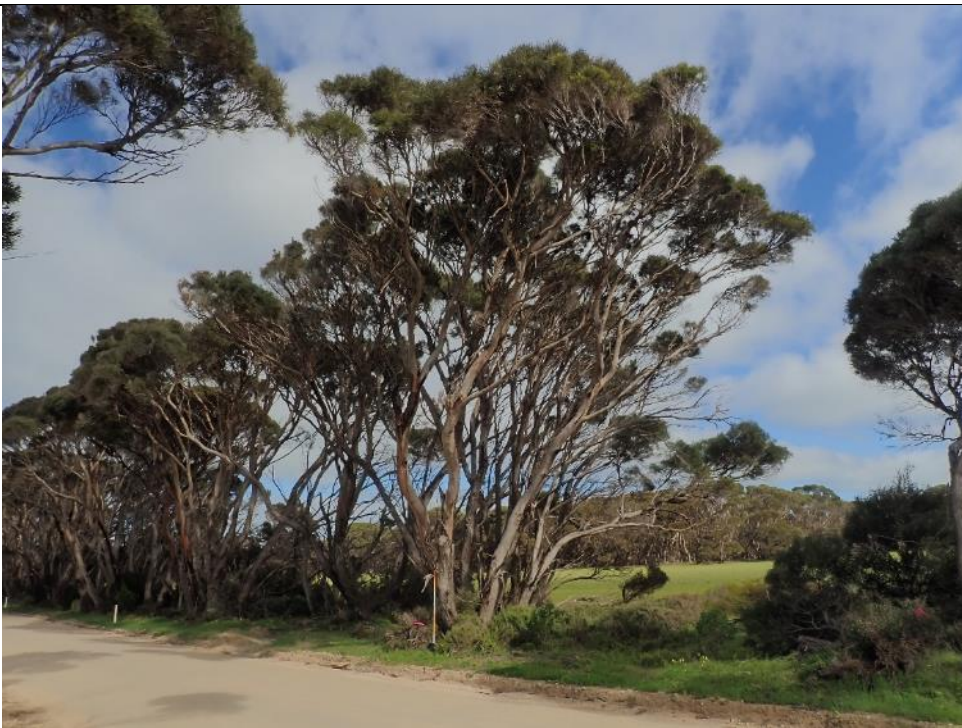
Tree ID - Tree 15

<i>Eucalyptus cneorifolia</i>	
1	
Height (m) – 12	
Hollows – 0	
Diameter (cm) – 35	
Canopy dieback (%) – 15	
Total Biodiversity Score – 3.48	
<b>Direction:</b> 135° <b>Latitude:</b> 35° 40' 16.77" S <b>Longitude:</b> 137° 34' 12.11" E	
Very tall mallee in good, but senescent condition. Lower limbs have previously been removed for road safety. It is not providing habitat for threatened species.

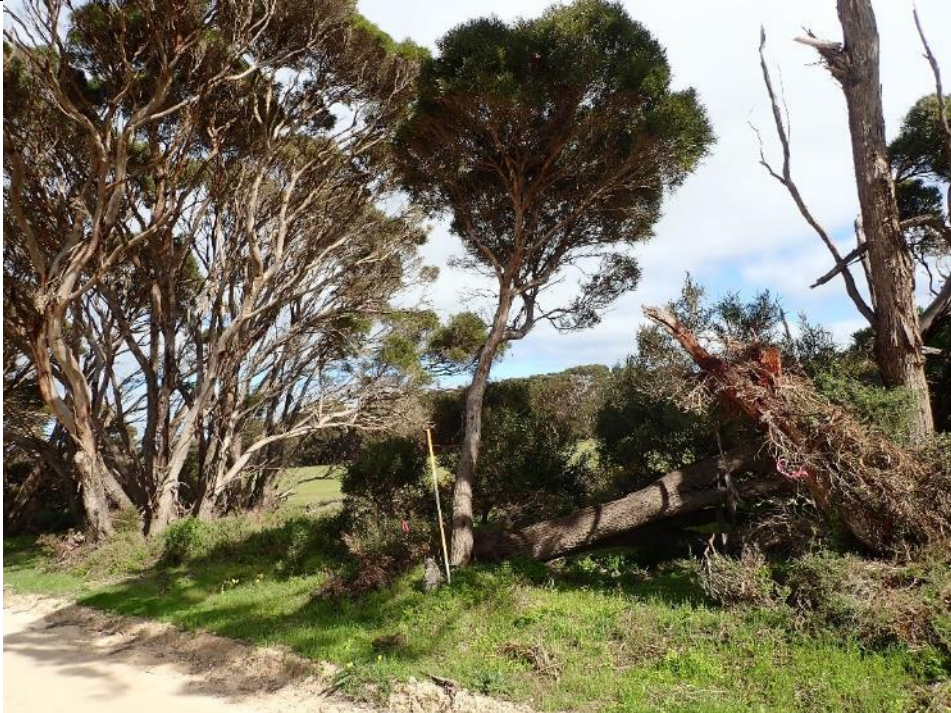
Tree ID - Tree 16

<i>Eucalyptus cneorifolia</i>	
1	
Height (m) – 5	
Hollows – 0	
Diameter (cm) – 23	
Canopy dieback (%) – 5	
Total Biodiversity Score – 1.02	
<b>Direction:</b> 251° <b>Latitude:</b> 35° 40' 16.49" S <b>Longitude:</b> 137° 34' 12.14" E	
Medium multi stemmed mallee in poor condition. One trunk has fallen over, another has been previously removed for road safety. It is not providing habitat for threatened species.

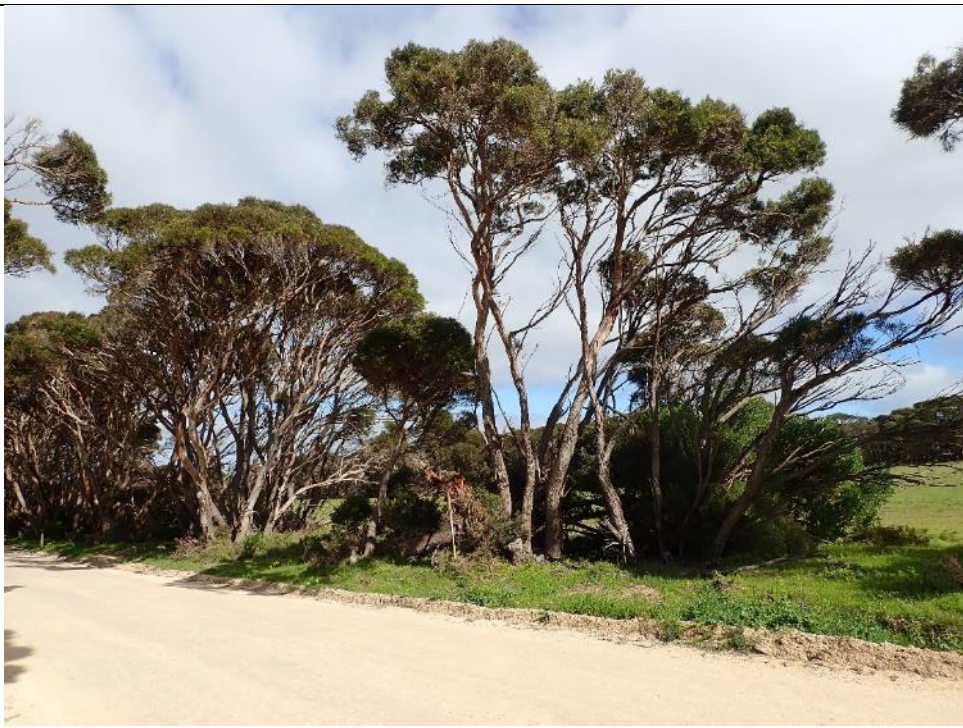
Tree ID - Tree 17

<i>Eucalyptus cneorifolia</i>	
1	
Height (m) – 10	
Hollows – 0	
Diameter (cm) – 32	
Canopy dieback (%) – 20	
Total Biodiversity Score – 2.55	
<b>Direction:</b> 203° <b>Latitude:</b> 35° 40' 16.32" S <b>Longitude:</b> 137° 34' 12.20" E	
Tall multi-stemmed mallee in good, but senescent condition. Two trunks have previously been pollarded; one of these is reshooting well. It is not providing habitat for threatened species.

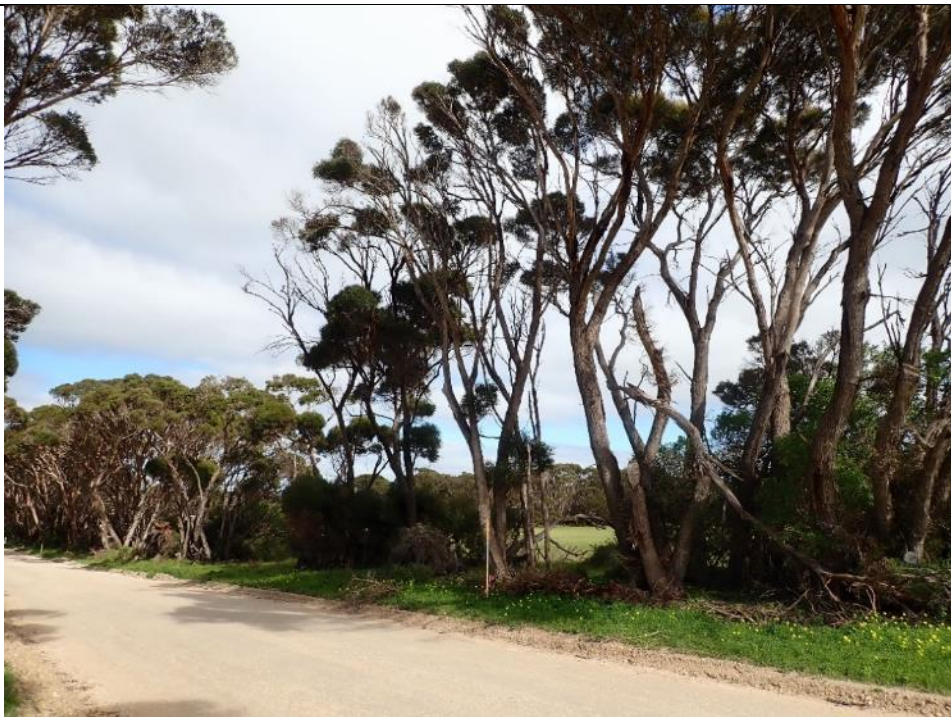
Tree ID - Tree 18

<i>Eucalyptus cneorifolia</i>	
1	
Height (m) – 10	
Hollows – 0	
Diameter (cm) – 30	
Canopy dieback (%) – 50	
Total Biodiversity Score – 1.97	
<b>Direction:</b> 206° <b>Latitude:</b> 35° 40' 15.31" S <b>Longitude:</b> 137° 34' 12.58" E	
Tall multi-stemmed mallee in poor condition. It is not providing habitat for threatened species.

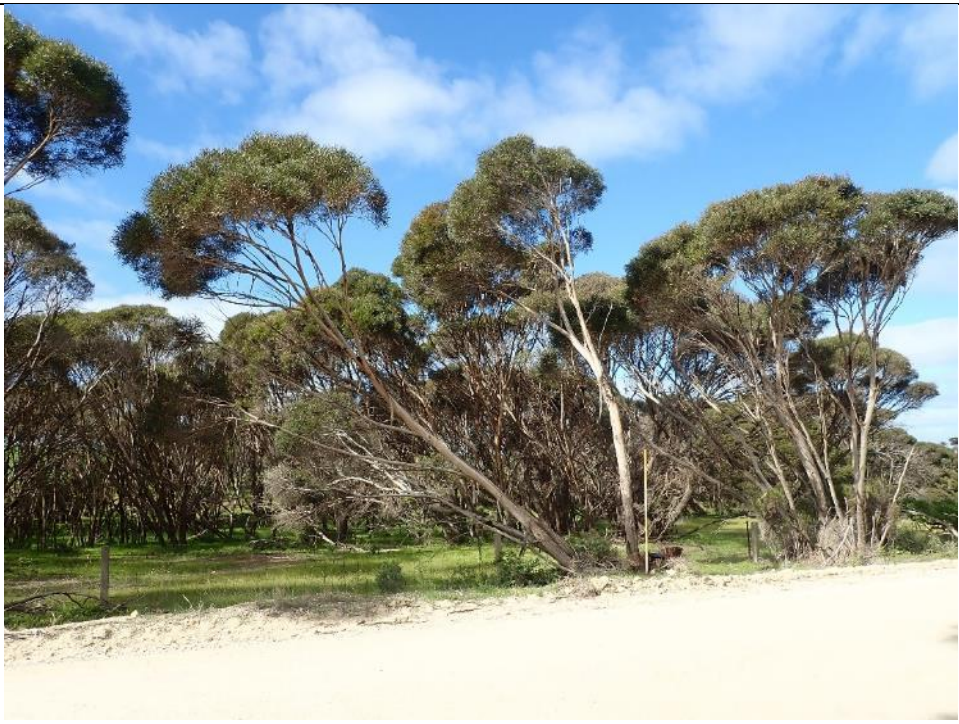
Tree ID - Tree 19

<i>Eucalyptus cneorifolia</i>	
1	
Height (m) – 6	
Hollows – 0	
Diameter (cm) – 19	
Canopy dieback (%) – 15	
Total Biodiversity Score – 1.00	
<b>Direction:</b> 92° <b>Latitude:</b> 35° 40' 0.57" S <b>Longitude:</b> 137° 34' 19.44" E	
Medium multi-stemmed mallee in good, but senescent condition. Multiple trunks have previously been pollarded for road safety. It is not providing habitat for threatened species.

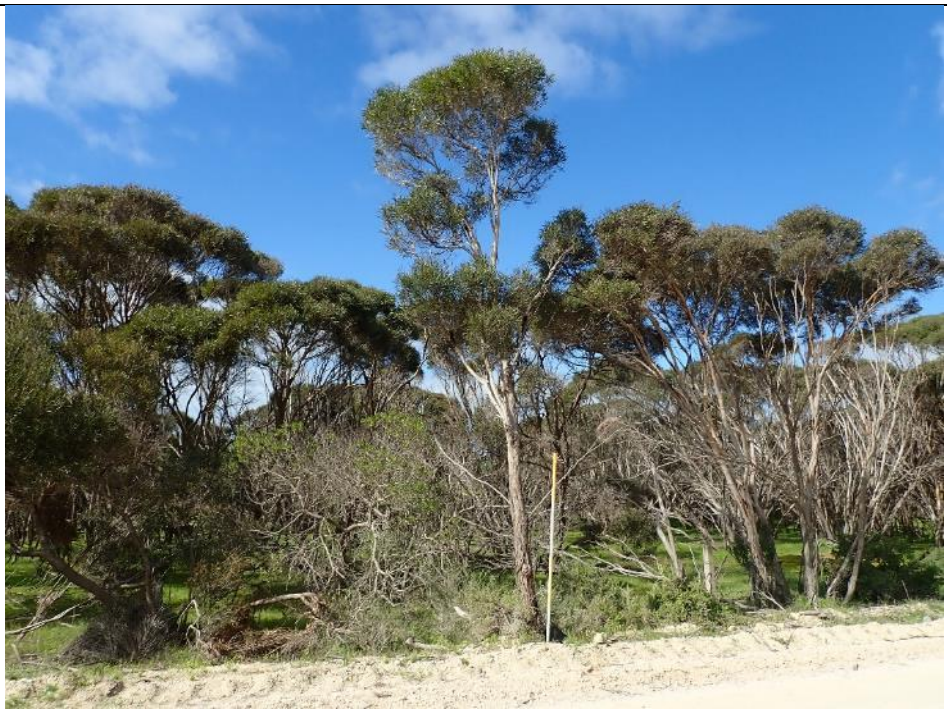
Tree ID - Tree 20

<i>Eucalyptus cneorifolia</i>	
1	
Height (m) – 5	
Hollows – 0	
Diameter (cm) – 16	
Canopy dieback (%) – 10	
Total Biodiversity Score – 0.55	
<b>Direction:</b> 95° <b>Latitude:</b> 35° 39' 59.16" S <b>Longitude:</b> 137° 34' 20.18" E	
Small mallee in good, but senescent condition. It is not providing habitat for threatened species.

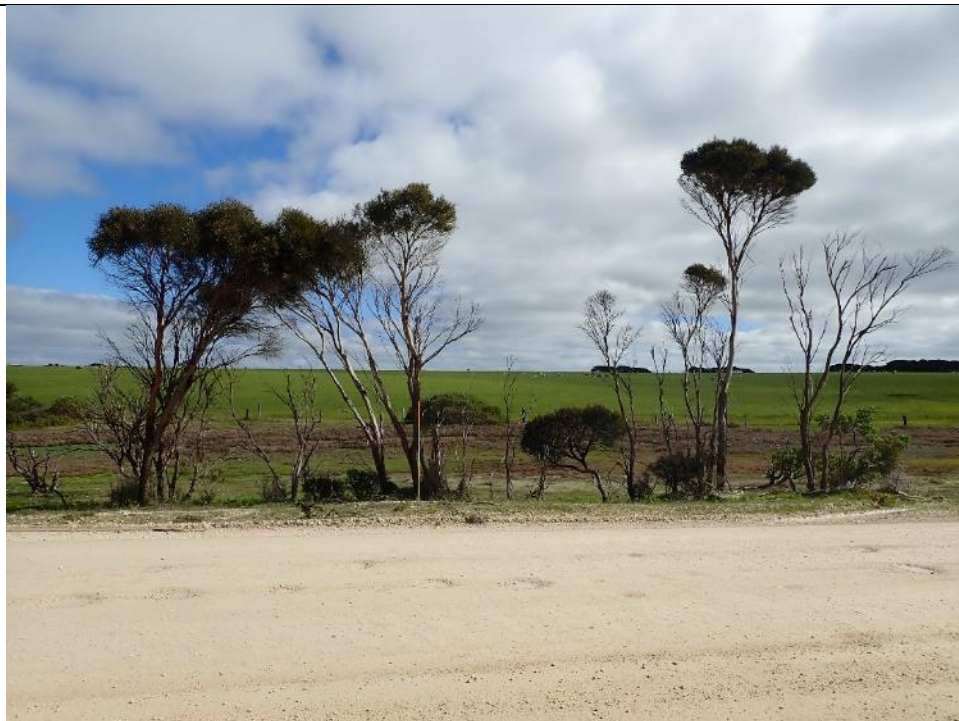
Tree ID - Tree 21

<i>Eucalyptus cneorifolia</i>	
1	
Height (m) – 4	
Hollows – 0	
Diameter (cm) – 18	
Canopy dieback (%) – 30	
Total Biodiversity Score – 1.59	
<b>Direction:</b> 273° <b>Latitude:</b> 35° 39' 45.14" S <b>Longitude:</b> 137° 34' 24.37" E	
Small clump of small multi-stemmed mallee in good to poor condition. They are not providing habitat for threatened species.

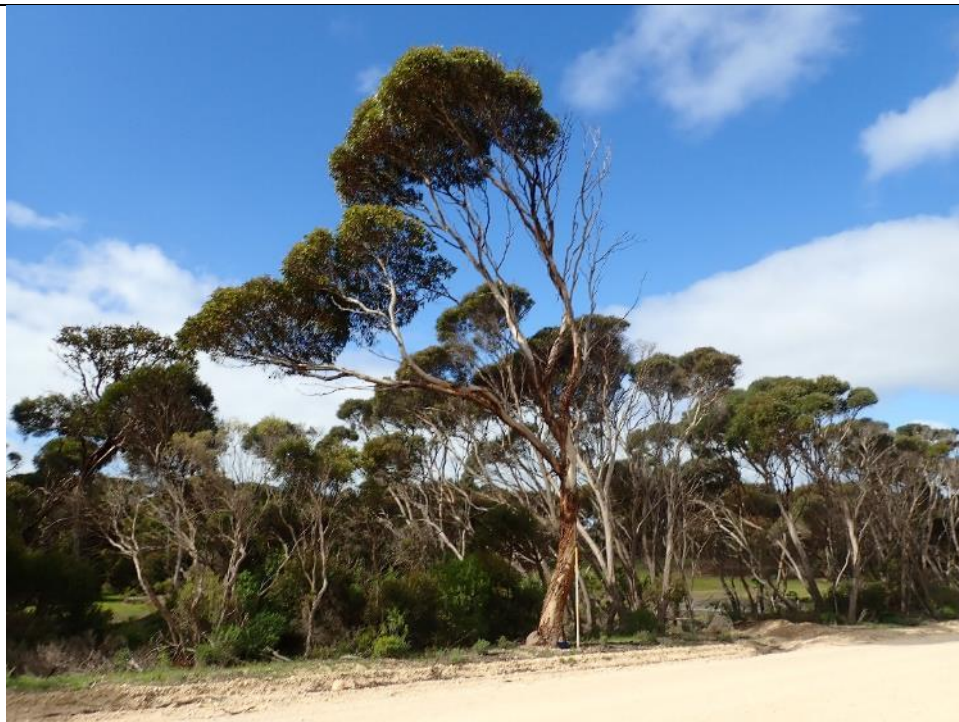
Tree ID - Tree 22

<i>Eucalyptus phenax ssp. compressa</i>	
1	
Height (m) – 10	
Hollows – 0	
Diameter (cm) – 44	
Canopy dieback (%) – 30	
Total Biodiversity Score – 3.81	
<b>Direction:</b> 121° <b>Latitude:</b> 35° 39' 39.81" S <b>Longitude:</b> 137° 34' 24.43" E	
Tall mallee in poor senescent condition. It is not providing habitat for threatened species.

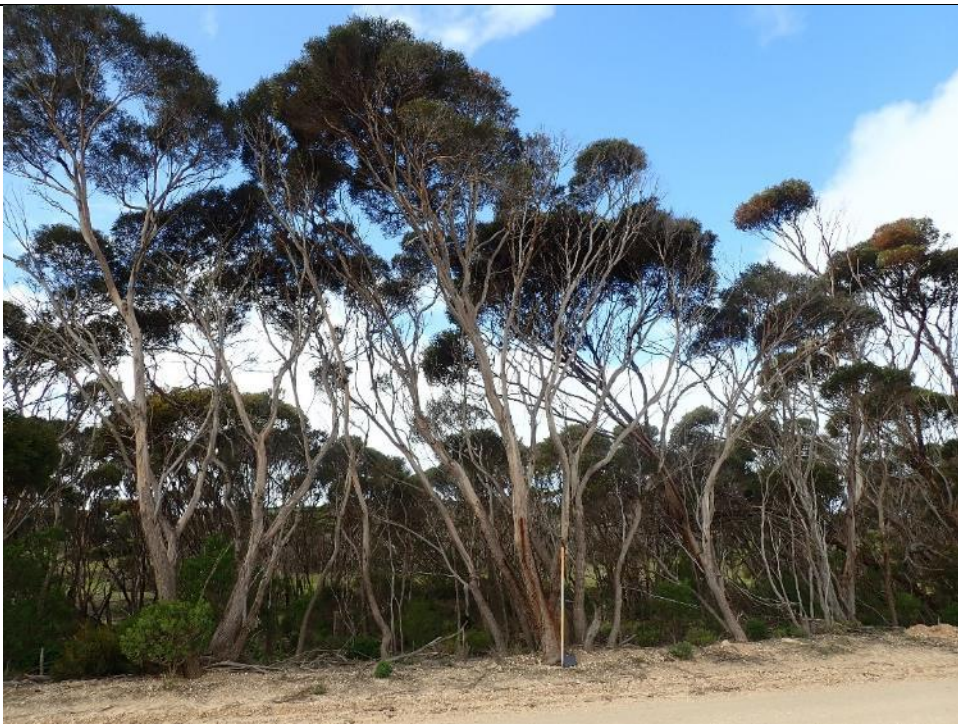
Tree ID - Tree 23

<i>Eucalyptus cneorifolia</i>	
1	
Height (m) – 9	
Hollows – 0	
Diameter (cm) – 31	
Canopy dieback (%) – 25	
Total Biodiversity Score – 2.41	
<b>Direction:</b> 97° <b>Latitude:</b> 35° 39' 37.71" S <b>Longitude:</b> 137° 34' 24.03" E	
Tall mallee in good, but senescent condition. It is not providing habitat for threatened species.

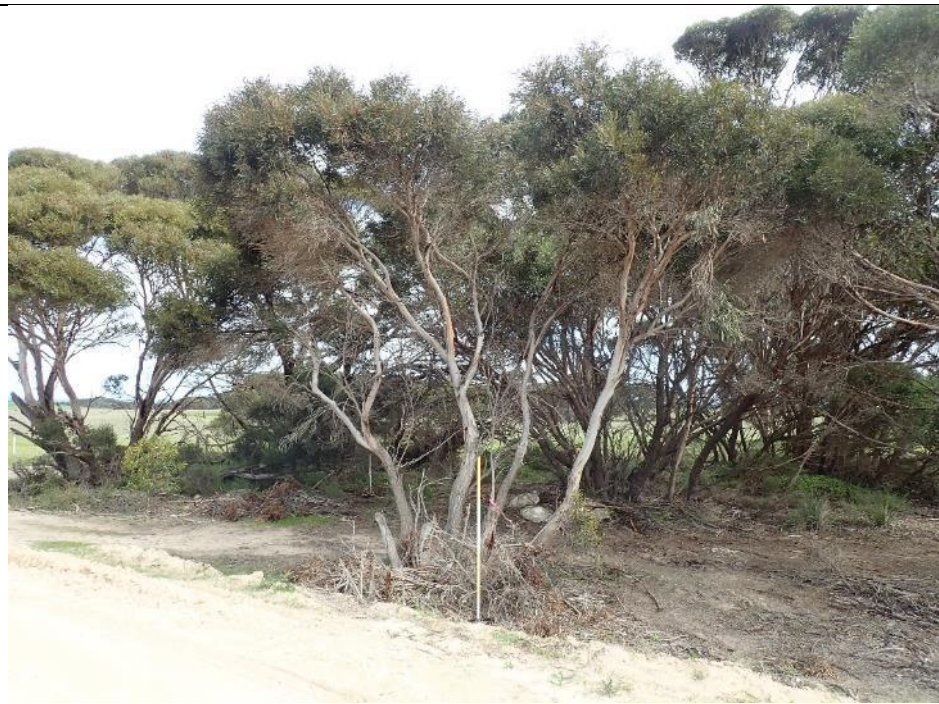
Tree ID - Tree 24

<i>Eucalyptus cneorifolia</i>	
1	
Height (m) – 5	
Hollows – 0	
Diameter (cm) – 21	
Canopy dieback (%) – 10	
Total Biodiversity Score – 0.47	
<b>Direction:</b> 231° <b>Latitude:</b> 35° 39' 21.83" S <b>Longitude:</b> 137° 34' 21.85" E	
Small multi-stemmed mallee in good condition. Several trunks have previously been pollarded for road safety. It is not providing habitat for threatened species.

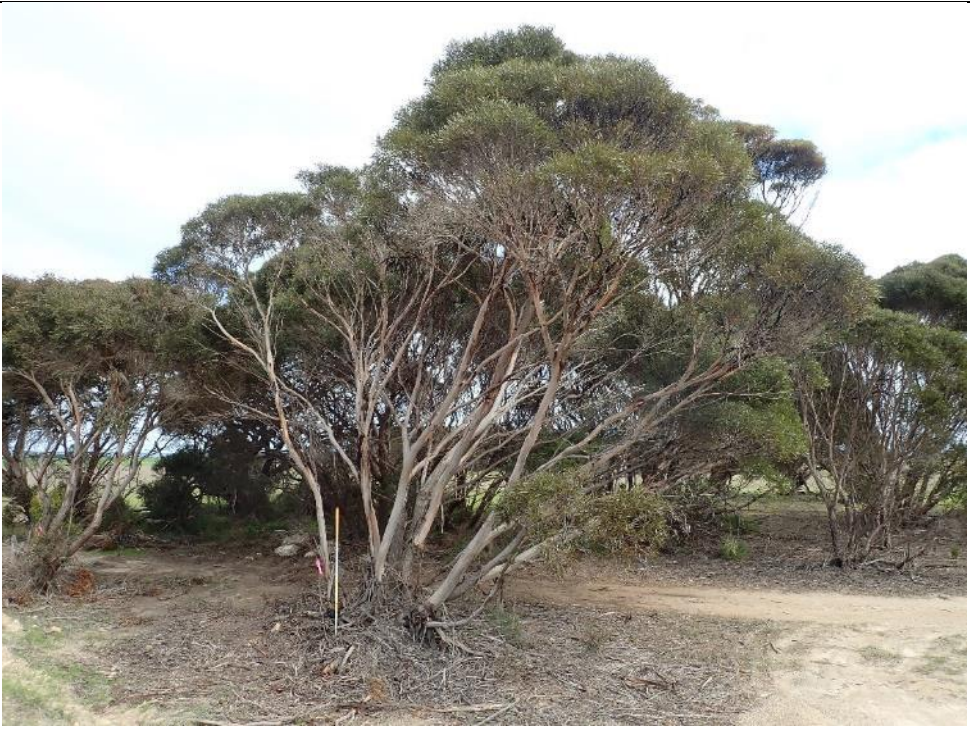
Tree ID - Tree 25

<i>Eucalyptus cneorifolia</i>	
1	
Height (m) – 6	
Hollows – 0	
Diameter (cm) – 17	
Canopy dieback (%) – 10	
Total Biodiversity Score – 1.02	
<b>Direction:</b> 260° <b>Latitude:</b> 35° 39' 21.63" S <b>Longitude:</b> 137° 34' 21.83" E	
Tall multi-stemmed mallee in good condition. Several trunks have recently been removed for road safety. It is not providing habitat for threatened species.

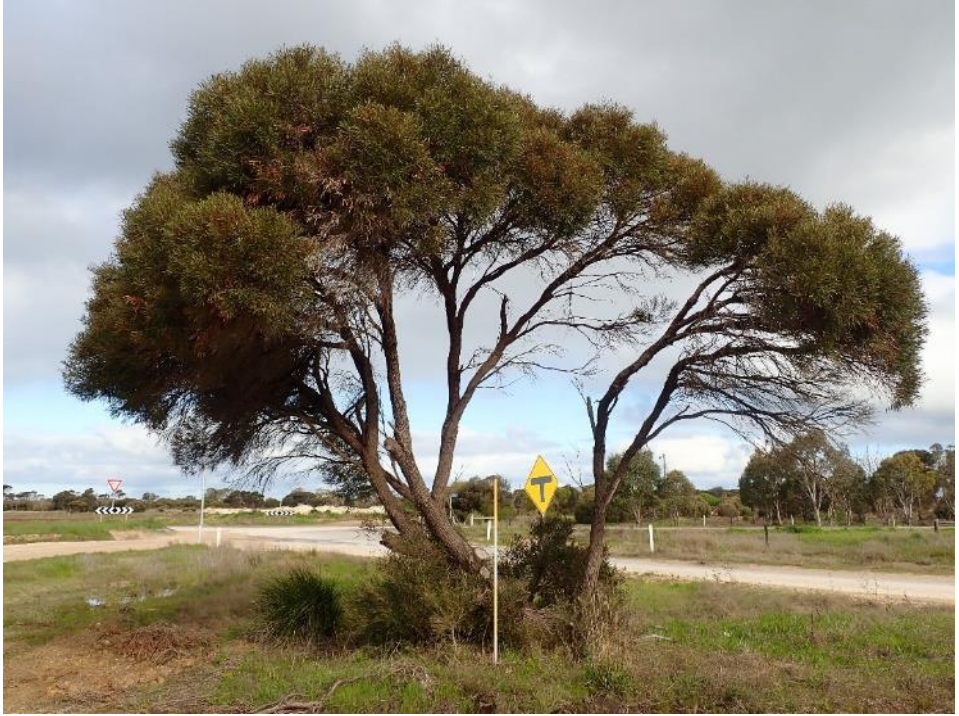
Tree ID - Tree 26

<i>Eucalyptus cneorifolia</i>	
1	
Height (m) – 5	
Hollows – 0	
Diameter (cm) – 38	
Canopy dieback (%) – 10	
Total Biodiversity Score – 1.35	
<b>Direction:</b> 154° <b>Latitude:</b> 35° 40' 41.85" S <b>Longitude:</b> 137° 34' 14.91" E	
Small multi-stemmed mallee in good condition. Several trunks have recently been removed for road safety. It is not providing habitat for threatened species.

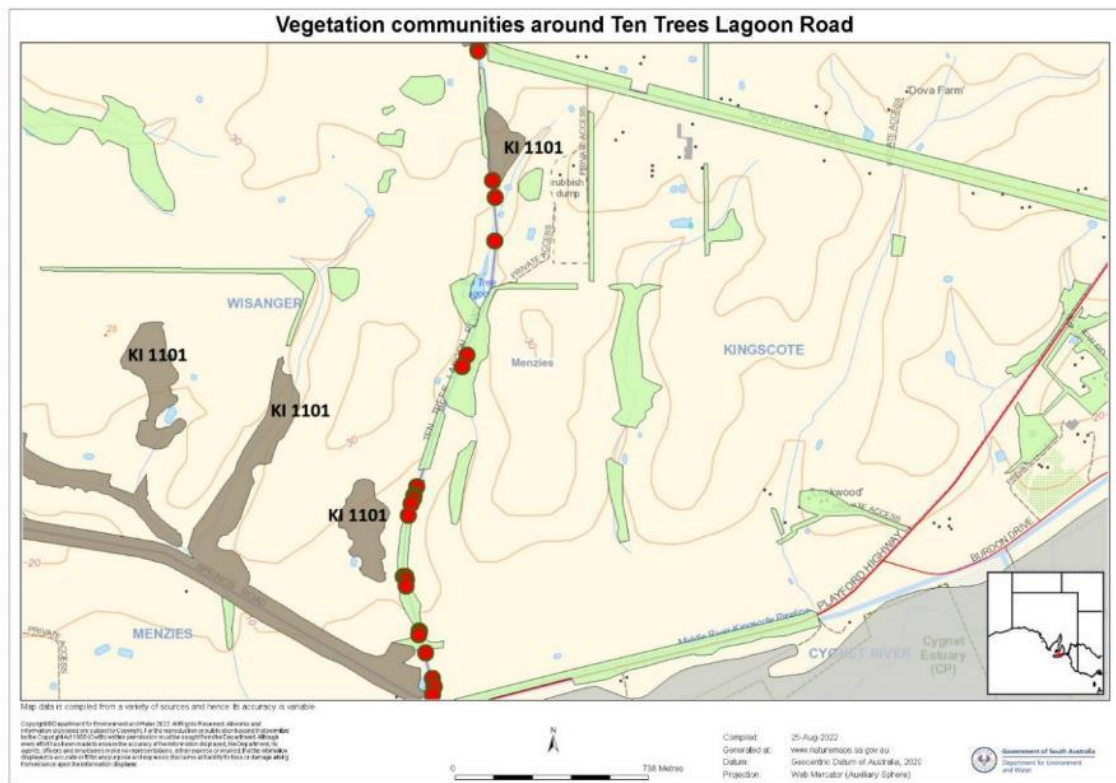
Figure 5. Vegetation communities around Ten Trees Lagoon Road. (Scale 1:18,056)
