# Native Vegetation Clearance

## Ten Trees Lagoon Road, Menzies

### Data Report

Clearance under the *Native Vegetation Regulations 2017*

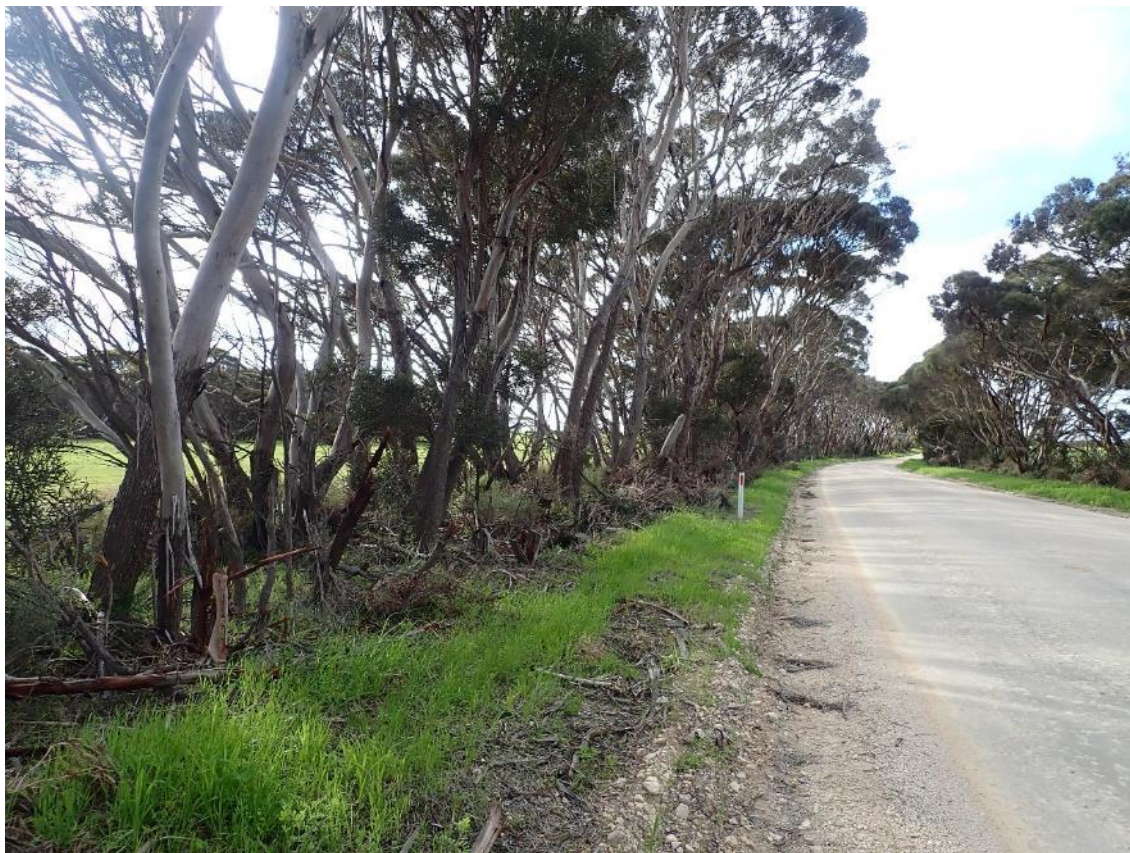
Photo 1. **Direction:** 358° **Latitude:** 40° 23.51" S **Longitude:** 137° 34' 10.40" E. Section of road in Figure 4

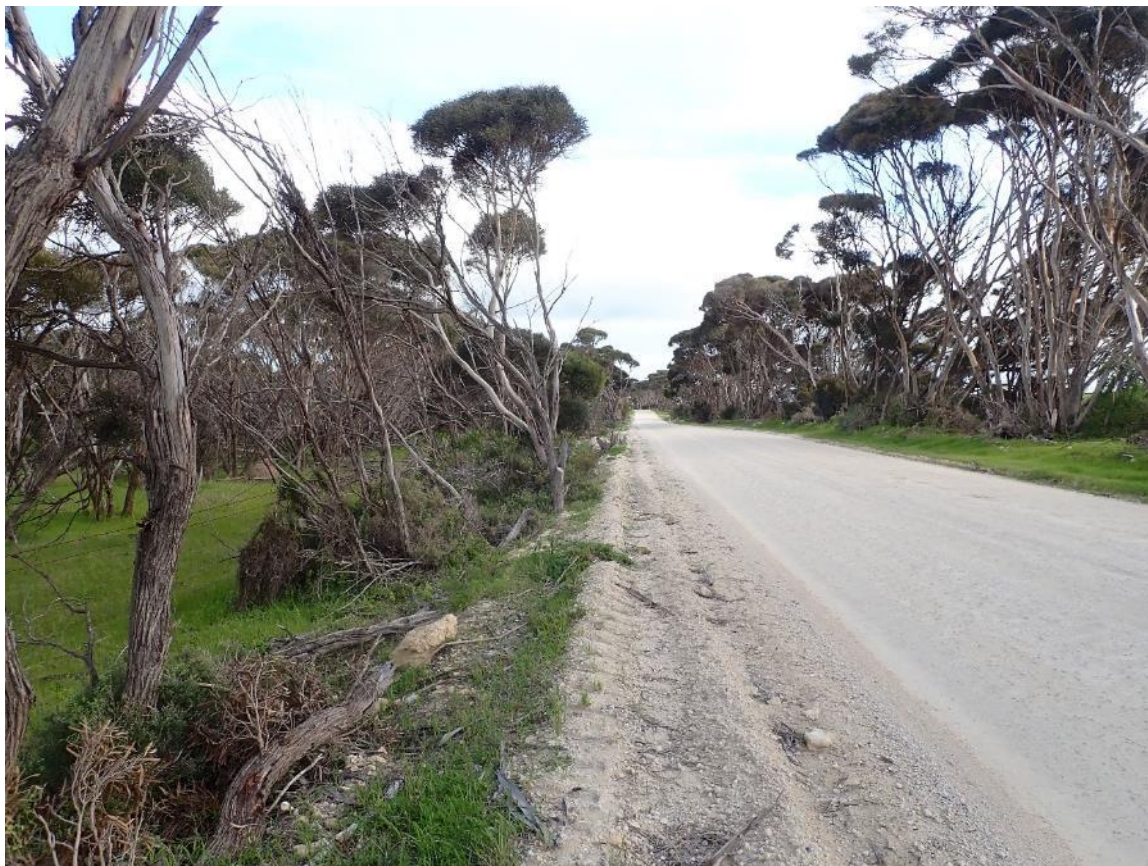
Photo 2. **Direction:** 211° **Latitude:** 35° 39' 57.33" S **Longitude:** 137° 34' 20.96" E. Location of Trees 19 and 20

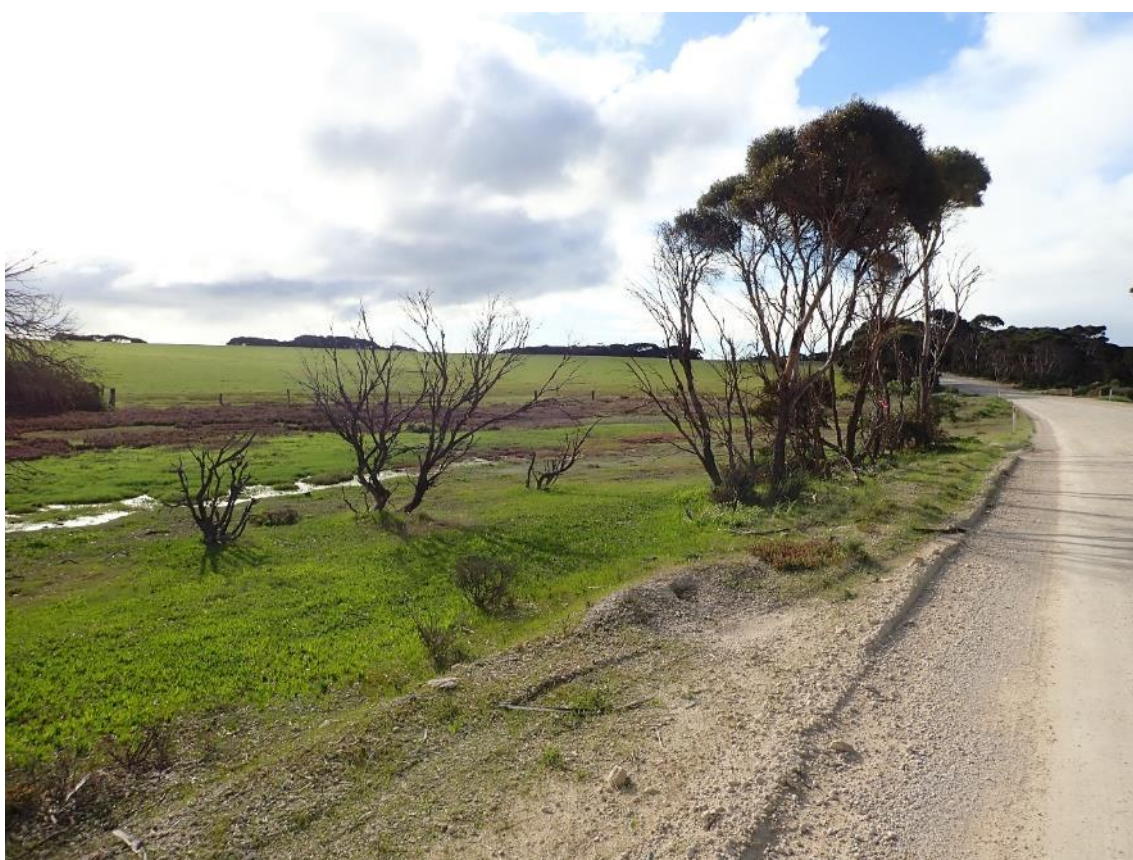
Photo 3. **Direction:** 343° **Latitude:** 35° 39' 45.57" S **Longitude:** 137° 34' 24.47" E. Trees near edge of Ten Trees Lagoon

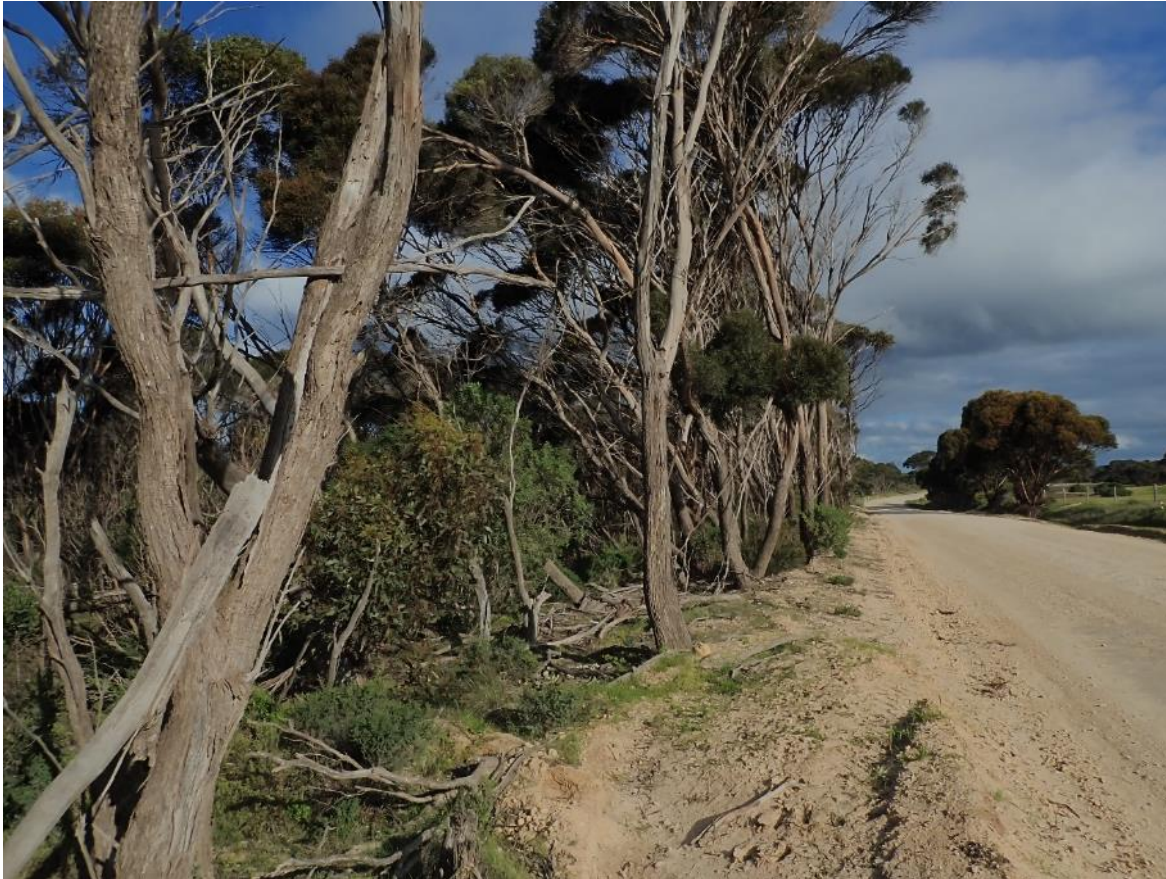
Photo 4. **Direction:** 131° **Latitude:** 35° 39' 36.93" S **Longitude:** 137° 34' 23.89" E. Location of Trees 22 and 23
