Earthen Levee Embankment Inspection and Repair Guide

This guide has been developed to assist councils and landholders with the inspection and repair of levee embankments. It is not intended to replace expert advice. It is recommended that landowners obtain advice from an experienced levee embankment or dam engineer, or other relevant expert.

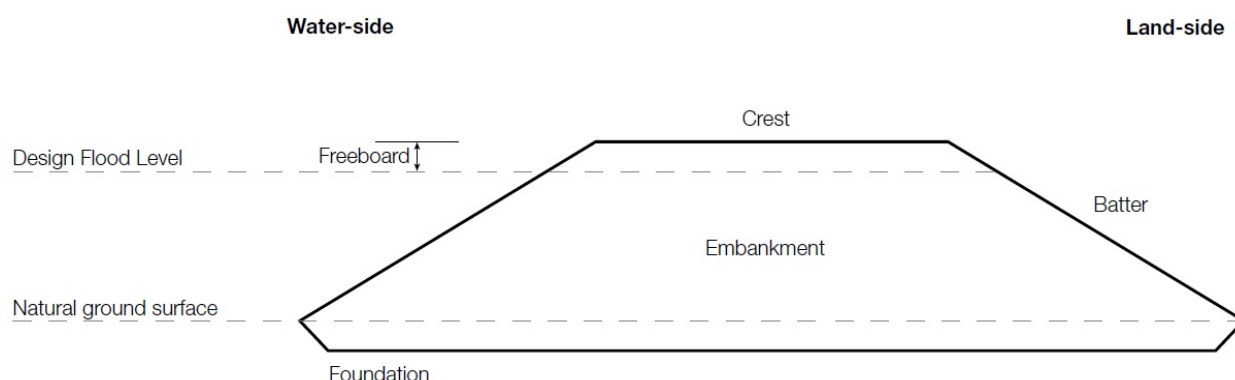
The general dimensions (or form) of an earthen levee embankment can vary to suit site conditions, and other considerations, but will typically have the following arrangement:

Figure 1 Simplified typical cross sectional arrangement of an earthen levee embankment

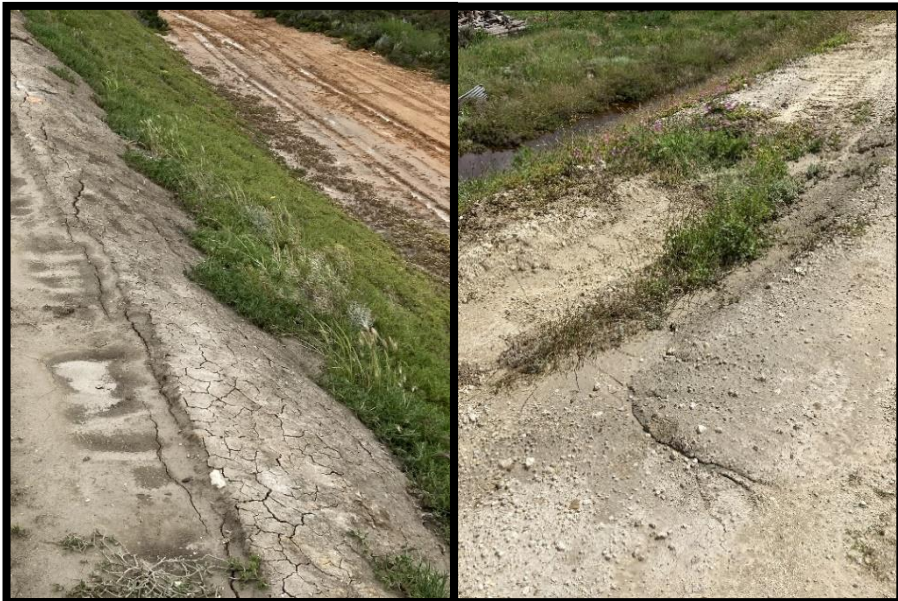
2)	Surface depressions, and material settlement, subsidence or slumping.	<p>The following images show an example of material settlement (first image) and surface depression (second image). Any surface depressions, material settlement, subsidence or slumping should be remedied. If these exist, refer to the 'Remediation and Repair of Earthen Levee Embankments' section below.</p>

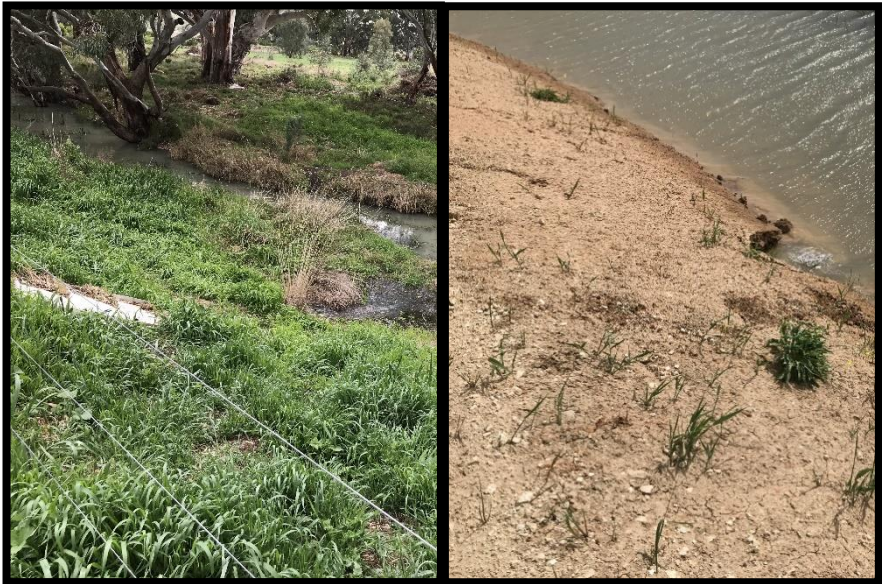
5)	Embankment accessibility and trafficability (if applicable).	Does the nature of the crest surface provide for suitable access i.e. even and uniform surface and appropriate width? If not, this may need to be remedied, so that the entire levee embankment can be accessed to be inspected, maintained or remediated.
6)	Water leakage or seepage through embankment.	<p>The following images show examples of water leakage and seepage. Any water leakage or seepage through an embankment indicate an integrity issue and should be remedied. If these exist, refer to the 'Remediation and Repair of Earthen Levee Embankments' section below.</p>
