# Department for Environment and Heritage Maintenance and Repair of Older Buildings in South Australia

## Technical Note 3.1

## Maintenance and Repair of Older Buildings in South Australia

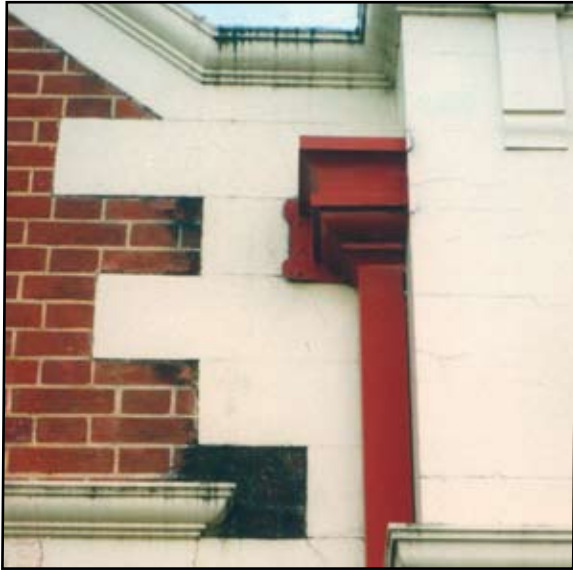
A blocked gutter and rainwater head have overflowed and saturated the surrounding brickwork, encouraging the growth of an unsightly fungal stain. Overflow such as this can also deposit harmful salts, resulting in salt attack of the masonry.

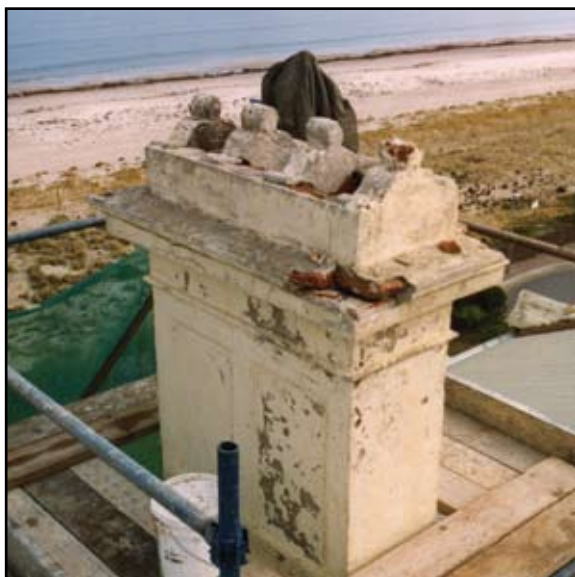
Check the condition of chimneys while on the roof. The erosion of these mortar joints will lead to eventual collapse of the brickwork. This chimney should be repointed using a traditional lime mortar mix.

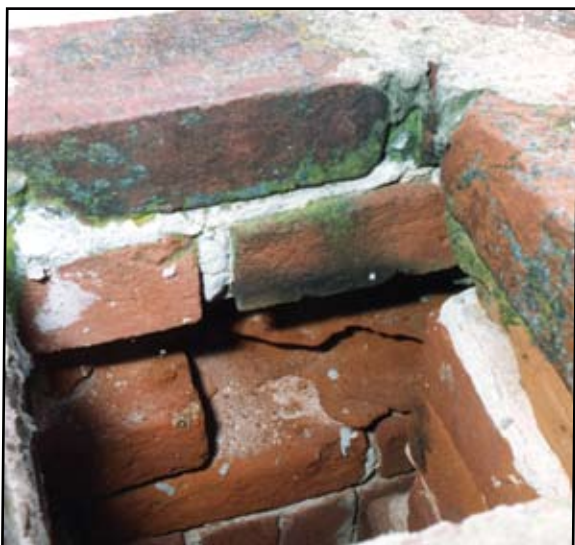
High rate of airflow up chimney has caused severe salt attack inside the flue, which is not visible from the outside.

The combination of airflow and moisture soaking down into the masonry from the top surface leads to a form of salt attack ('salt damp'). In the presence of this falling damp, the natural upward airflow results in a high evaporation rate of salt-laden moisture from the inside surface, which is exaggerated further if the external surface is rendered, impeding evaporation from the outside and concentrating it on the inside. The consequent growth of salt crystals causes erosion of the mortar lining (or parging) of the flue, and eventually of the mortar joints and even of the bricks or stones themselves.

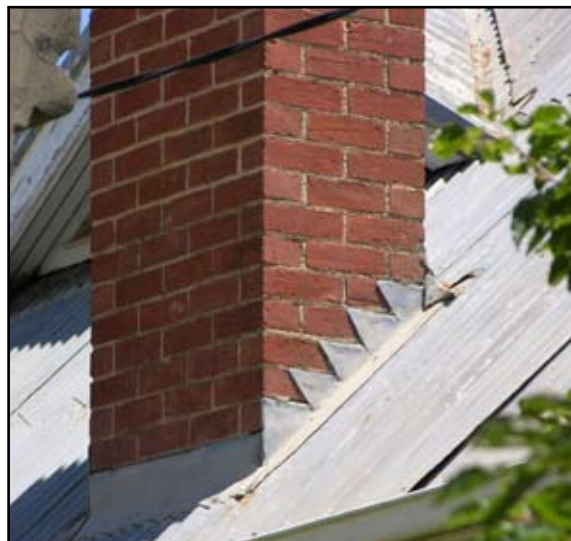
Typical chimney flashings.

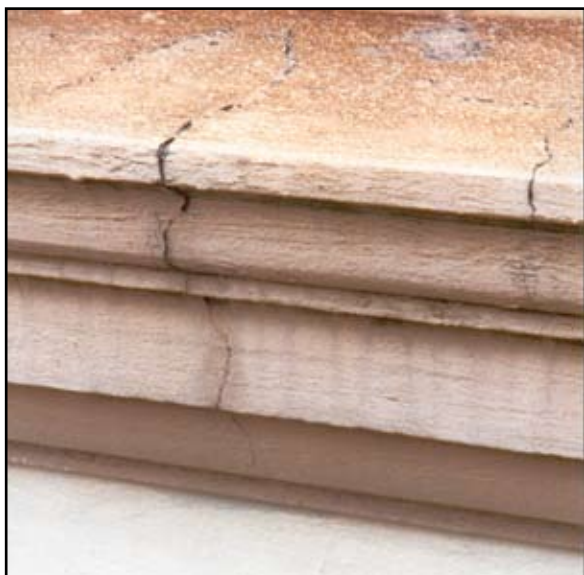
These fine cracks are sufficient to allow in water and eventually lead to the structural failure of this decorative cornice.

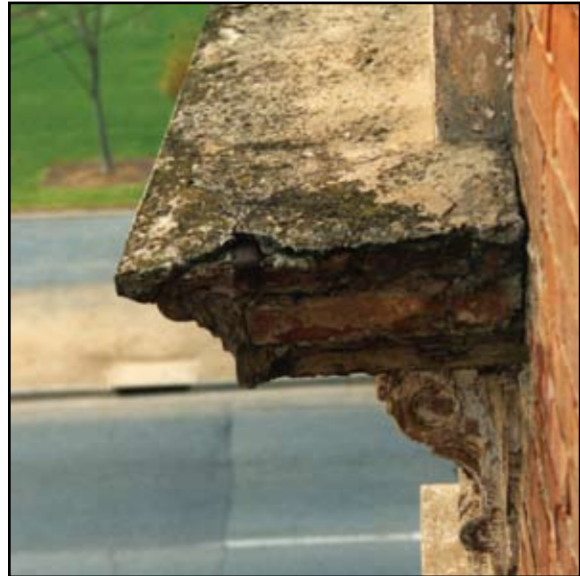
Lack of maintenance on top surface of cornice has allowed water to seep in and damage the moulding.

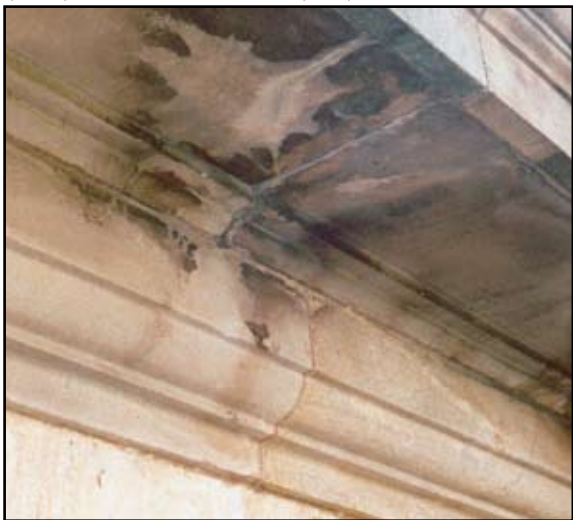
Mortar has been eroded from the joints in this stone cornice by the penetration of moisture through the top surface. Failure to repoint the joints has caused considerable damage to the stone either side of the joints. The damage is a form of salt attack due to air movement through the open joints in the presence of salts (from bird droppings for instance)

that the mortar between individual pieces of stone, particularly the vertical mortar joints, is intact. Even minor cracking or a small loss of mortar between the stones can result in rainwater penetrating into the masonry and causing delamination (deterioration of successive layers) of the stonework and structural weakening of the wall.

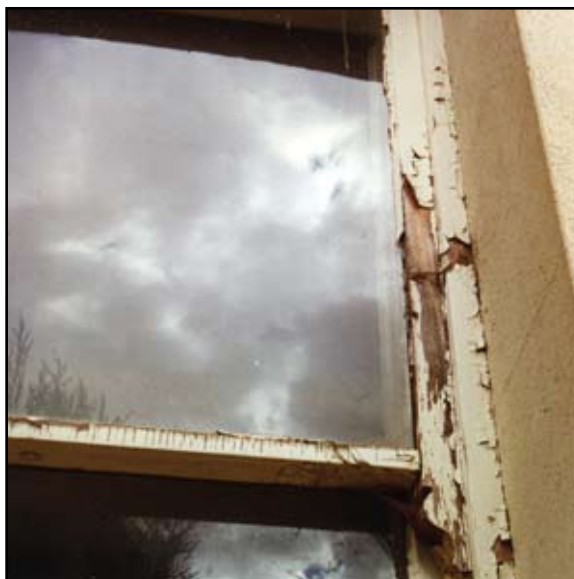
Peeling of paintwork is allowing rapid moisture damage to the window frame.

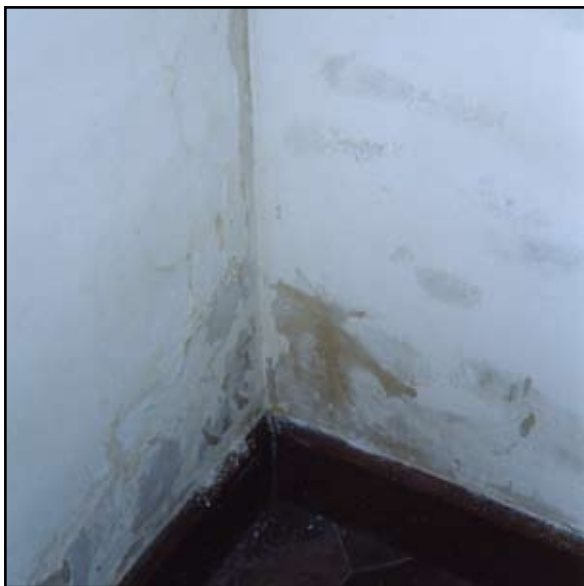
Efflorescent powdering on wall surface indicates active salt damp attack

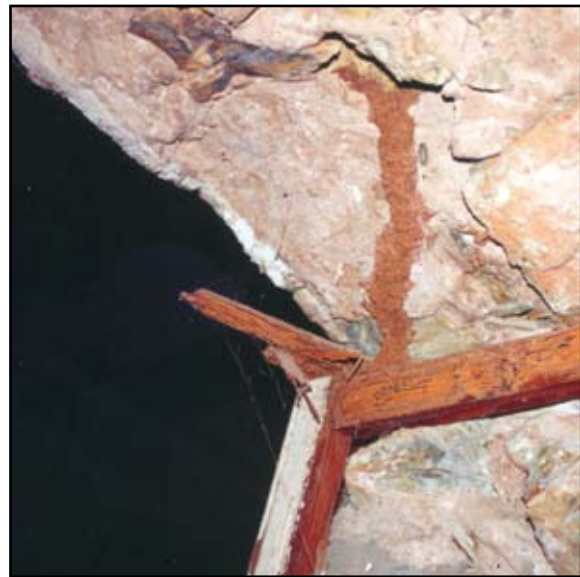
The door frame, lining and structural timber lintel of this doorway have been completely eaten by termites. A mud gallery is clearly visible at the centre of the picture.

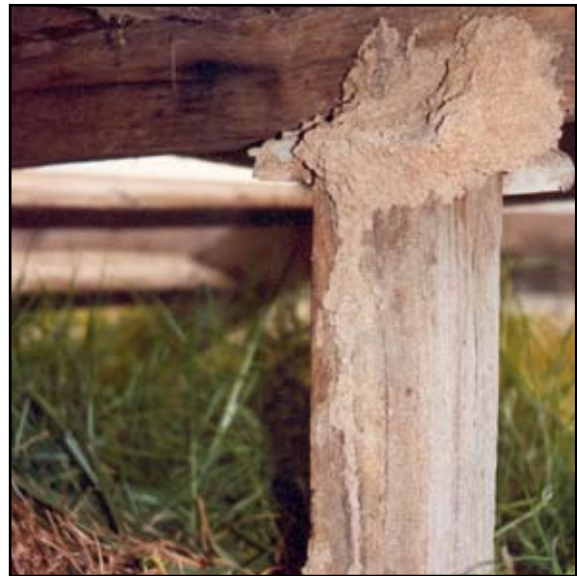
Termite attack on a stump

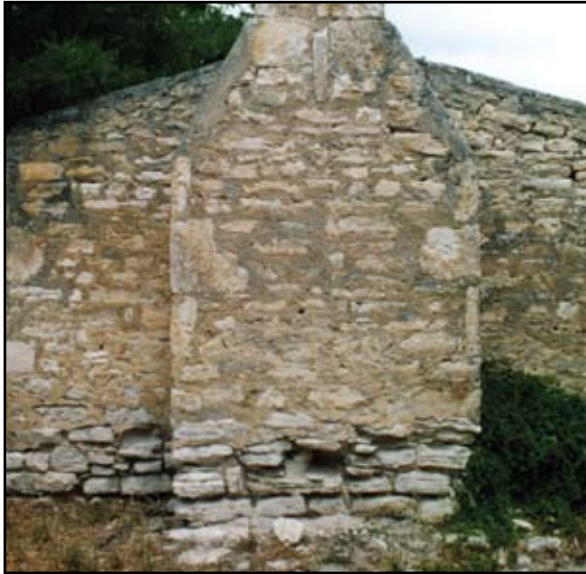
Typical case of rising damp due to lack of damp proof course.

The presence of **moisture** can be controlled by a number of means, including:

- introducing a damp course into the wall
- improving drainage of roof water and surface water away from the wall
- improving sub-floor ventilation
- keeping garden beds and sprinklers clear of the wall
