Groundwater access trenches

GAT remediation

Groundwater Access Trench Rehabilitation example: Option 1

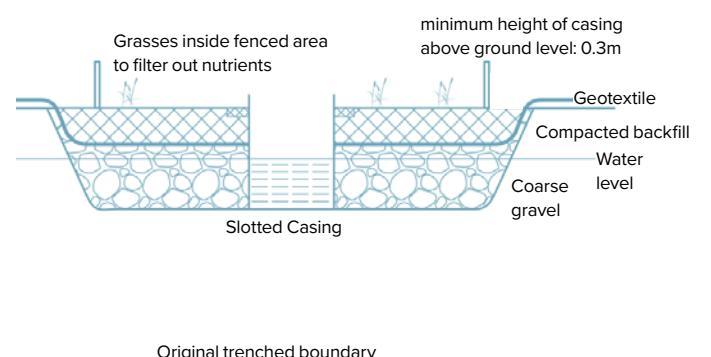
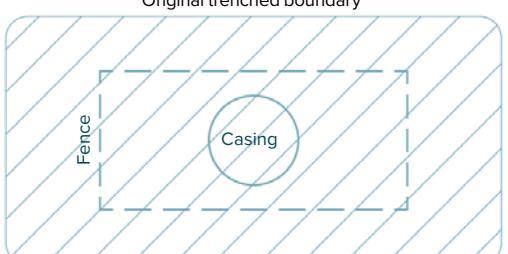
V1 Single casing

Back filled with coarse gravel/ rock to above water level. A layer of geotextile to underlay compacted spoil to original surface level.

This option is the recommended method for rehabilitating a GAT into a sustainable water source that is significantly protected from pollution and evaporation. Being more technical it involves installing a slotted well casing along with appropriate aggregate (clean gravel or rock) and a natural earth covering.

Note that in the diagrams below the casing material can be varied in diameter relative to the requirements of the user and the rate of the aquifer to 'make water'. Expert advice is recommended for this option, and for safety, large exposed well casings must have locking covers to prevent access.

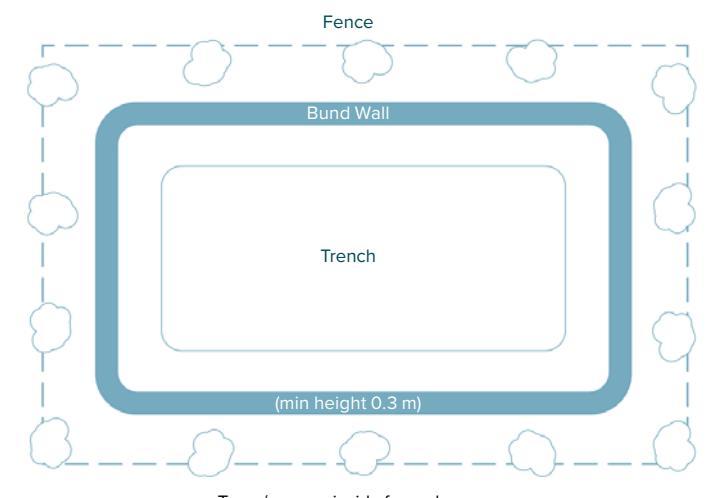
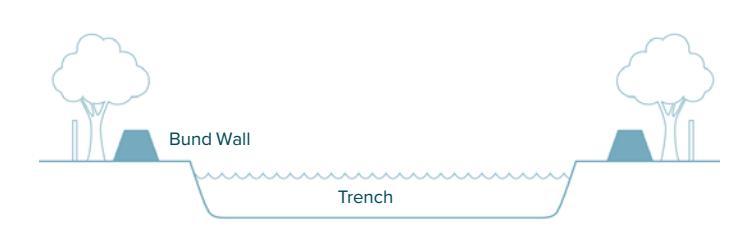
Option 2 diagrams

Trees/grasses inside fenced area to slow overland flow and filter nutrients

The simplest option that ensures a GAT is less degraded and subsequently complies with legislation is to build a bund wall around the GAT (approx. 300mm high earthen levee) to prevent surface water inflows and fence it off.

Groundwater in this style GAT is still an open pool and will increase in salinity due to evaporation. Sunlight can still contribute algal growth and birds and some animals can still enter the water. Additional roofing or a cover will minimise this.

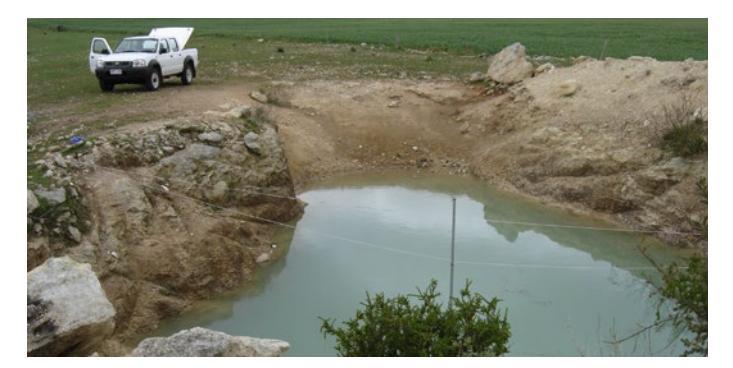
A GAT in limestone aquifer

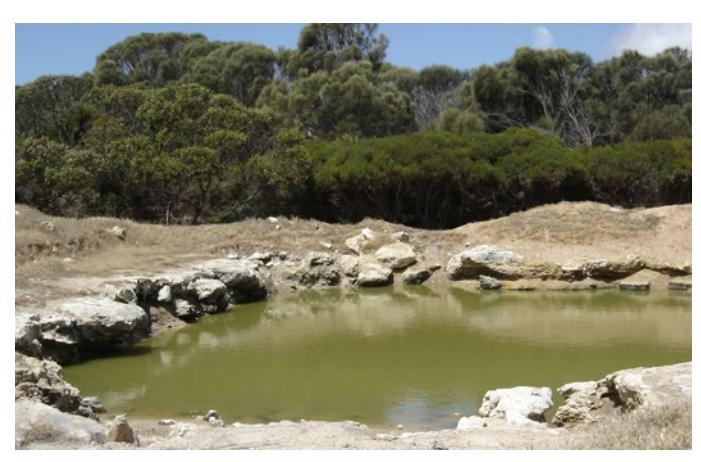
A GAT in weathered basement aquifer

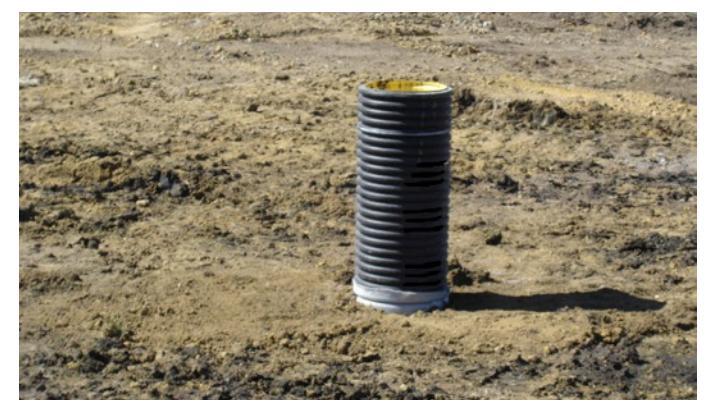
Proper well casing to access groundwater following a GAT rehabilitation.

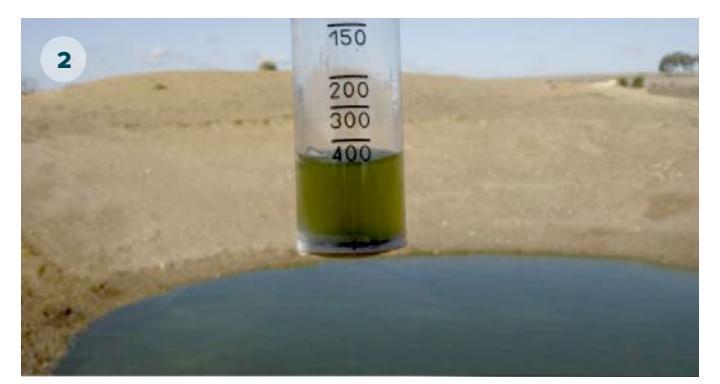
2. Highly polluted water

- Salinity 5526 ppm (16/04/2008)
- Extremely high algal growth
- Extremely High faecal Contamination (E.coli), well in extreme of documented safe levels for healthy stock water.

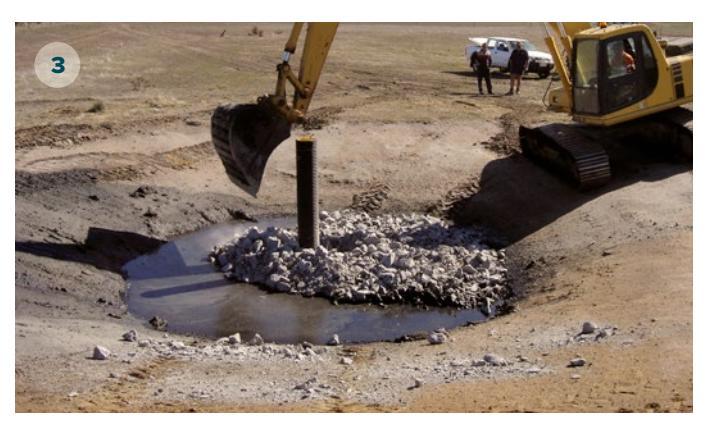
3. GAT rehabilitation

- Clean silt from existing GAT
- Install slotted casing
- Fill saturated zone with appropriate gravel

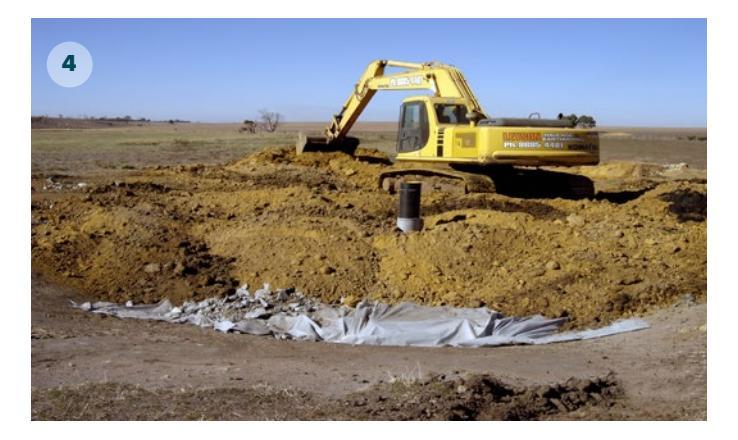
4. GAT rehabilitation

- Cover gravel with Geotextile cloth
- Backfill with original earth material

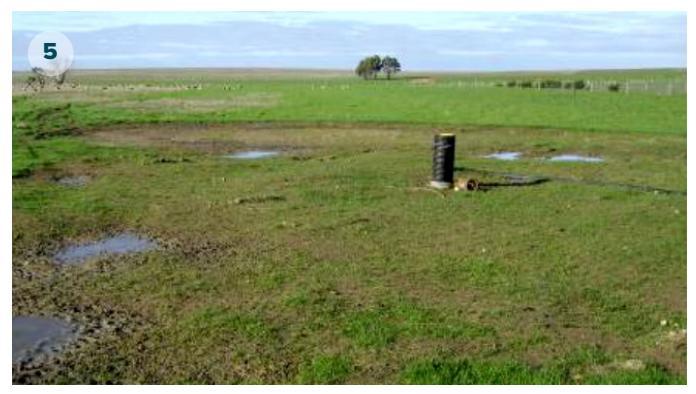
5. GAT rehabilitated into proper well

Protection of groundwater resource

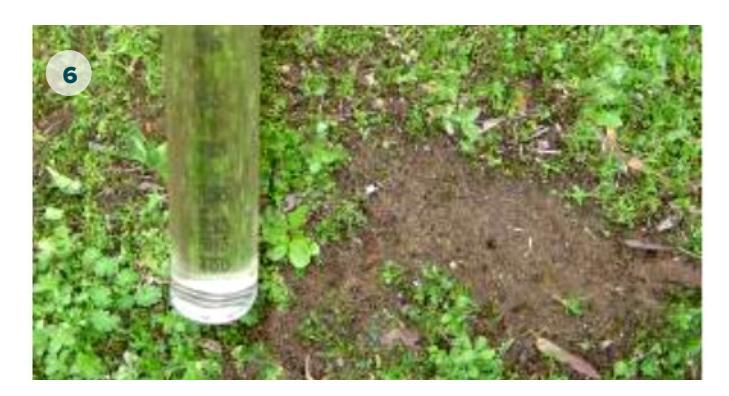
6. Water quality improved

- Salinity 4500 ppm (24/06/08)
- Salinity 2145 ppm (21/11/08)
- No algal growth
- No faecal contamination
