Kimba Mallee Seeps Sites Establishment Report

"Establishing Sandhill to Lucerne Pasture to Bring Recent Seep Scalds back to Cropping"

"Pumping Out Perched Water Table for Productive Farm Use & Seep Scald Rehabilitation"

"Using strategic narrow lucerne strips to intercept lateral water flows & rehabilitate scalds"

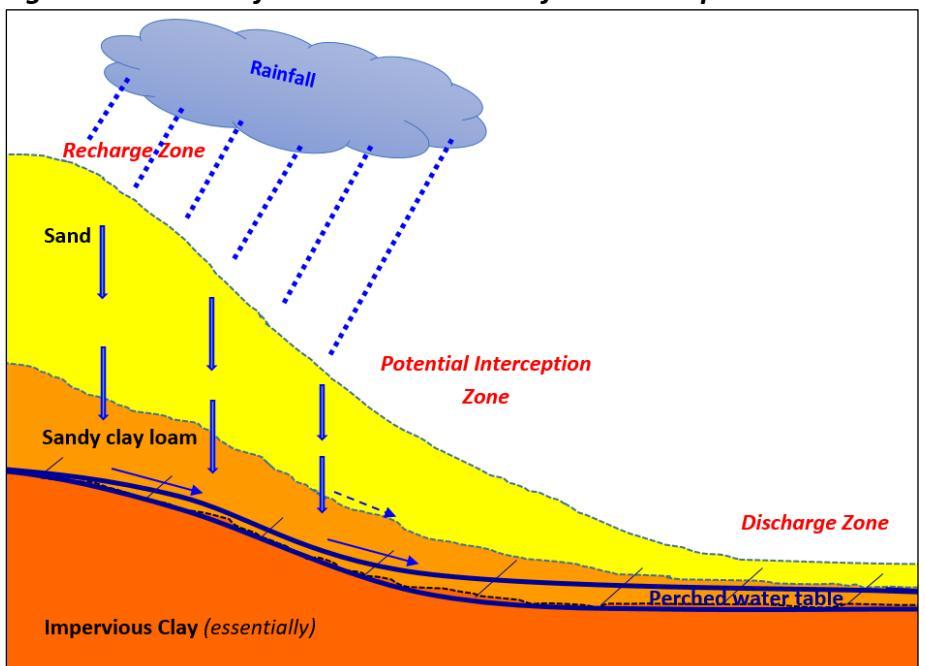
These seeps generally begin as areas inundated with too much fresh water but this will lead to permanent salinisation and land degradation if no remediation takes place. It would appear that many perched water tables have existed and become quite saline over a longer period, but have only more recently found surface expression due to changes in recent years. The key to managing seeps is to identify the problem early, assess and apply appropriate management into the three key zones of Recharge, Intercept and Discharge areas (Figure 1).

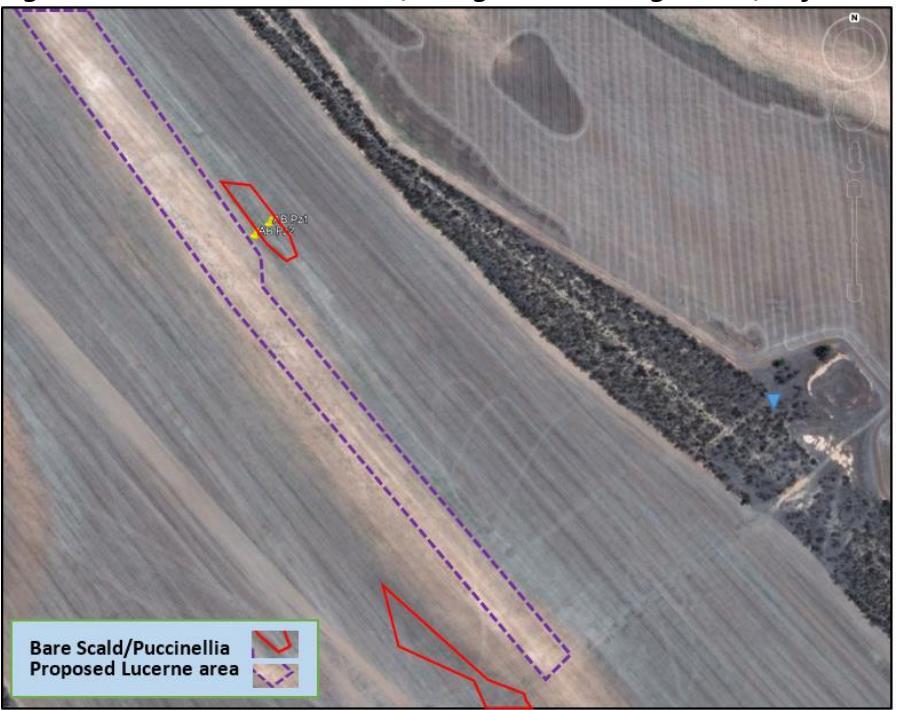
Figure 2. Demonstration Site 1, Google Earth Image 2015, before mallee seeps present.

The mallee seep sites in the Outlook paddock have essentially formed from the ongoing impacts of the wet season of 2016. This is evident from the NDVI images in Figures 4 & 5, showing strong green plant growth in the November after the 2017 season, with this effect still clearly visible mid-2018. This site was inspected on June 2nd 2020 to find a large, long sandhill running in a north-westerly direction that was thought to be the main source of water table recharge with bare scald areas evident on the eastern and western sides (Figure 3).

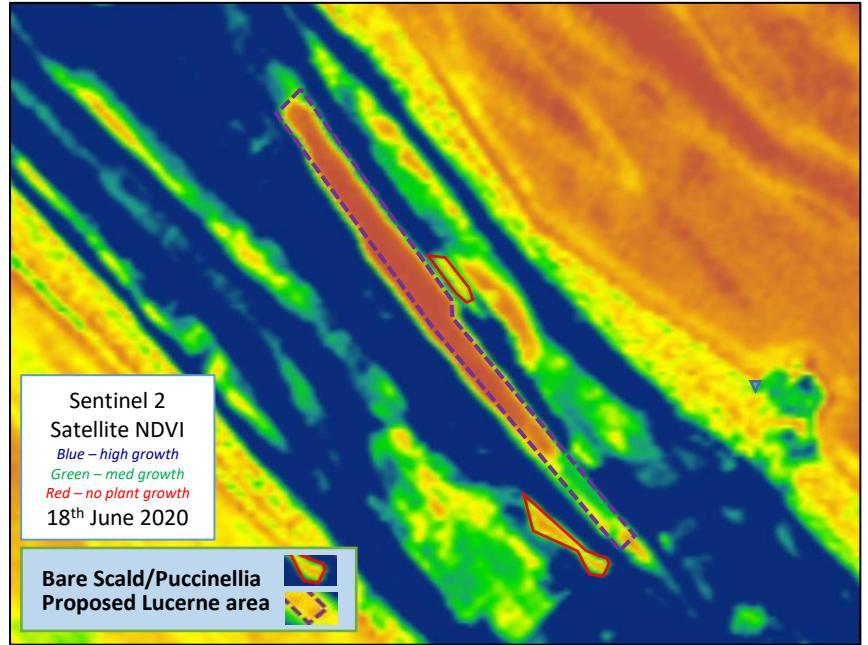
Figure 3. June 2020 NDVI image showing mallee seep bare scald areas and planned lucerne area

most threatening impediment to crop growth at the present time. A bare area of about 1ha lies immediately east of this scald (Figure 3), which was initially thought to have not grown due to the heavy clay and the dry season opening, but this may need further investigation.

On the south-western side of this sandhill there is a large developing scald area (0.7ha, Photo 3), which although many test wells were dug, there was no clear evident of a defined water table. After returning to these sites 6 hours after there was no water available to be sampled. Table 2 shows that the soil salinity levels within the top 30cm of soil at this site was very low at around 0.2 dS/m, and that pH levels were also good for crop growth. While it is expected that the Recharge Zone is the same sandhill as for the other seep, the sand depth is not as great on this western side. With no clear water table evident, both the Discharge and potential Intercept Zones are not as easily defined. Further investigation will need to be done at this site to see what has been the driver of this bare site. It may be possible that the scald may be seep related, but the waterlogging periods may have been transient, leading to crop failure and ongoing impacts. However, there is no clear reason why the crops have not established at this site this season, as evident in Figure 3.

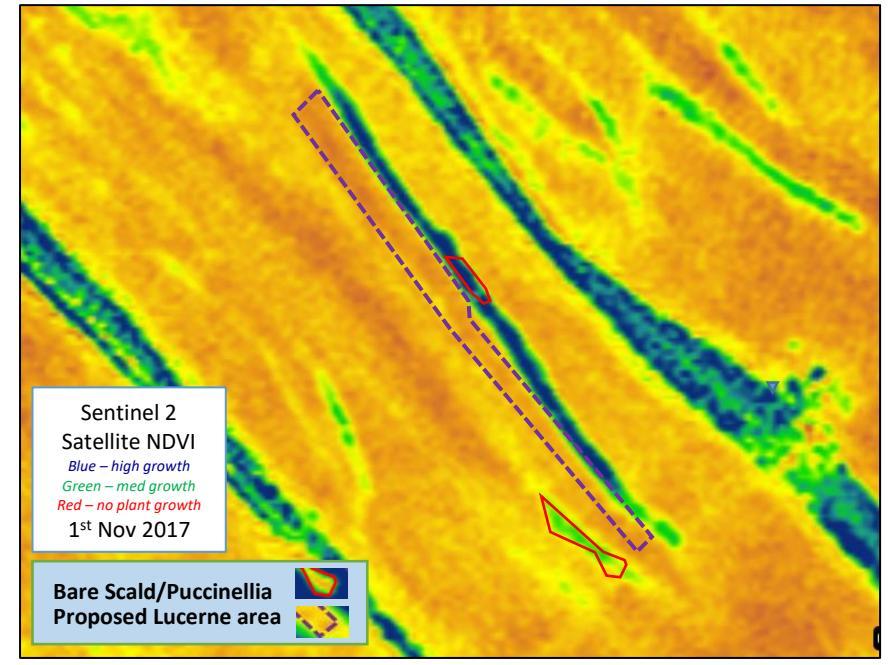
Figure 4 Nov 2017 NDVI image showing strong post season growth at eastern base of sandhill

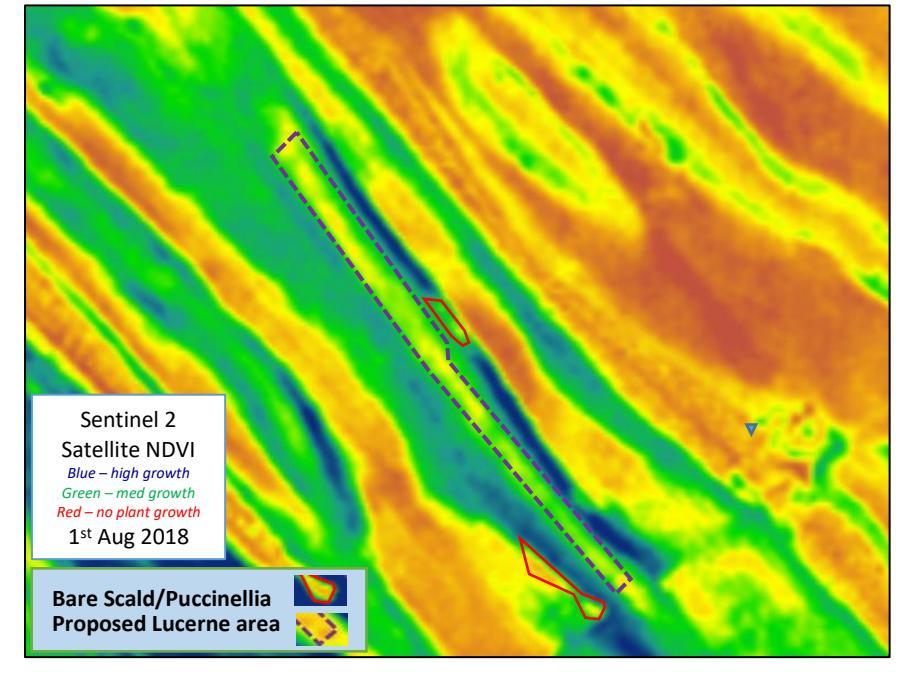
Figure 5. 2018 NDVI image still showing effects of 2016 rainfall at eastern base of sandhill

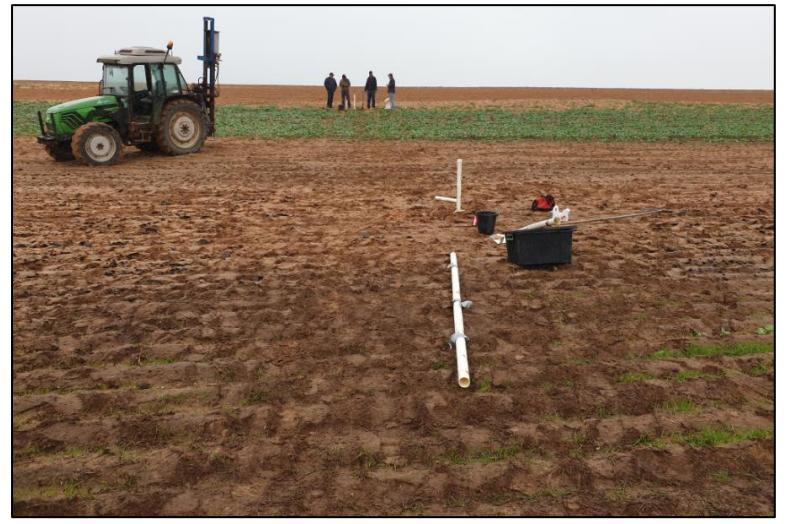
A test hole was dug in the middle of a seep scald on the eastern side to a depth of 1.8m, which has developed since 2016. A perched water table was found at a depth of 55cm with wet clay to a depth of about 160cm, and the dryer impervious clay layer beneath. The water flowed quickly into the hole. A piezometer (AB Pz1) was established here (Photo 1). The water quality was measured at a low salinity level of 1.8 dS/m. The area of bare scald and affected crop growth at this site is approximately 0.3ha. Soil test results (Table 1) show low levels of soil salinity in the top 20cm, but with medium levels at 20-30cm. The high pH levels and possible water logging appear to be the

Photo 1. Establishment of Scald (AB Pz1) and Midslope (AB Pz2) piezometers

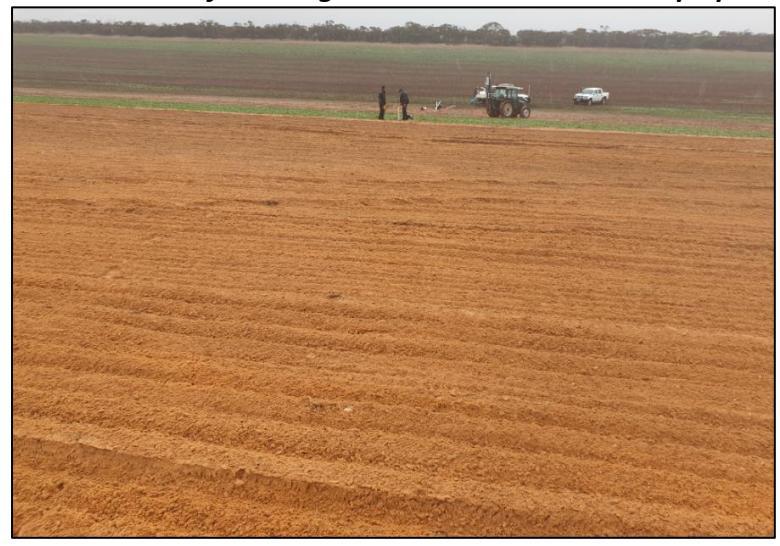
A second test well was dug 20m up the sandhill, to a depth of 2.8m, and a water table at approximately 1.2m to 2.6m depth and a similar water quality. The water seeped more slowly into the hole at this site. A second piezometer (AB Pz2) was established here (background of Photo 1). The top of the sandhill was another 40m up the sandy rise (Photo 2).

Photo 2. 40m of Recharge Zone sand above midslope piezometer

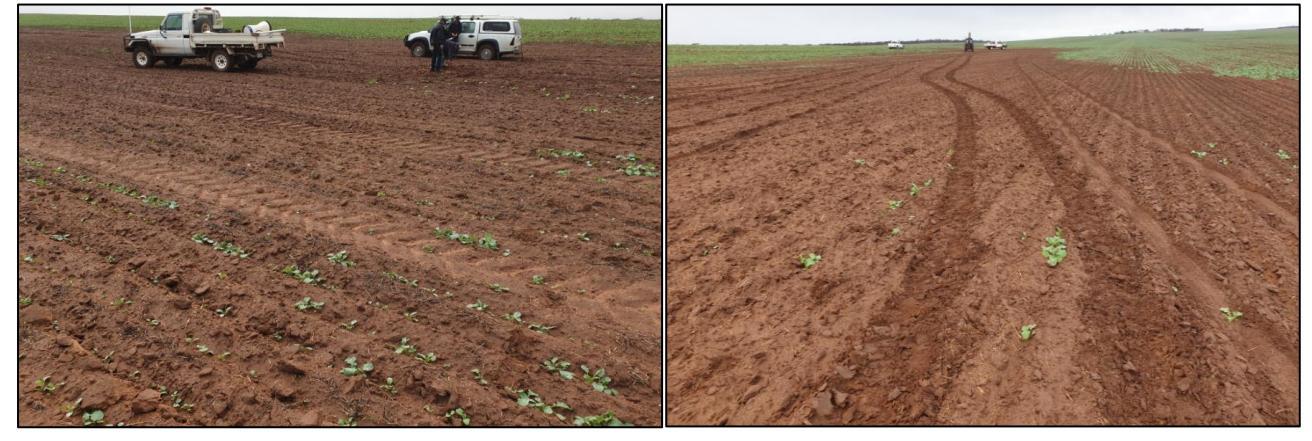
Photo 3 Bare scald area west of sandhill showing poor crop germination

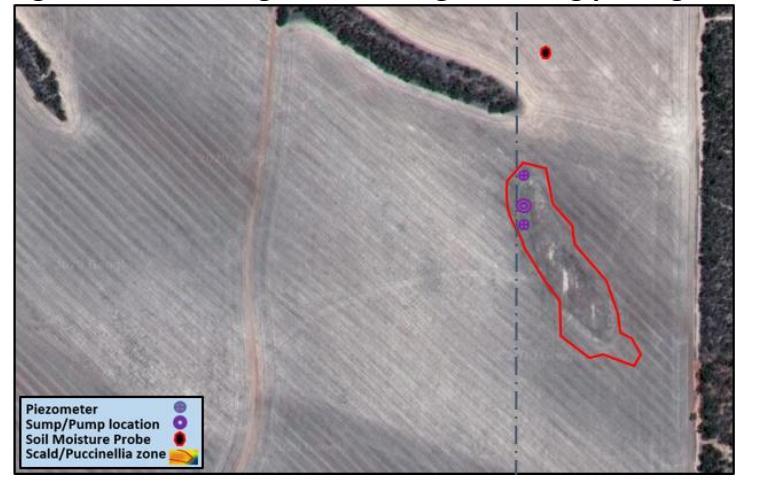
Since 2015 (Figure 6) this site has formed from a waterlogged area (Figure 7 & 8) to a large bare scalded area (Figures 9-11) after the very wet 2016 season. It appears from landscape observation and confirmed from NDVI images (Figure 7) that a large mass of water flows from the sandy catchment above to be concentrated through the sandy surface area where the scalded seep has appeared. The drilling of numerous test wells and placement of piezometers (Photos 4-6) showed a saturated sandy soil layer from 10cm to at least 2.5m depth with water quality tested at 2.8 dS/m. The sandy nature of this soil profile meant that water inflow into each hole was rapid. This suggests that there is a very large volume of water present which appears suitable for stock water and could possibly be used for tank spraying with the blending of some rainwater. This could prove to be a very valuable farm resource given the cost of purchasing water for farm use on the Eyre Peninsula.

Figure 6. 2015 Google Earth image showing plant growth through most the current scald area

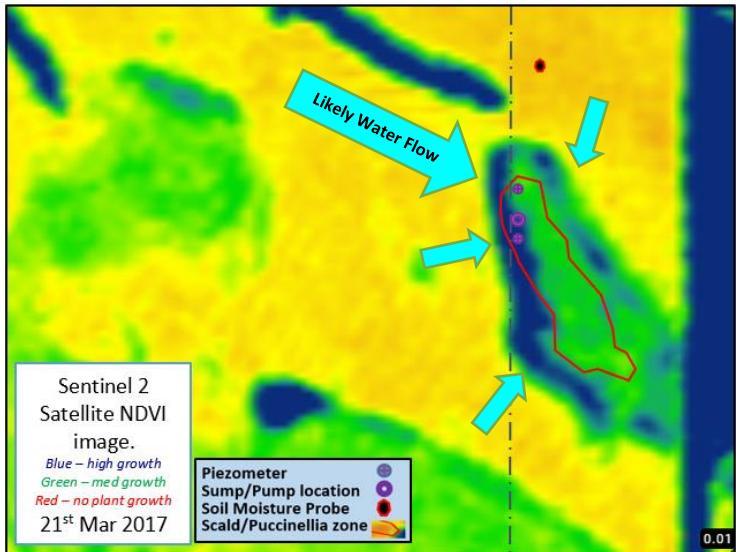
Figure 7. March 2017 large area of plant growth where seep formed following wet 2016 spring

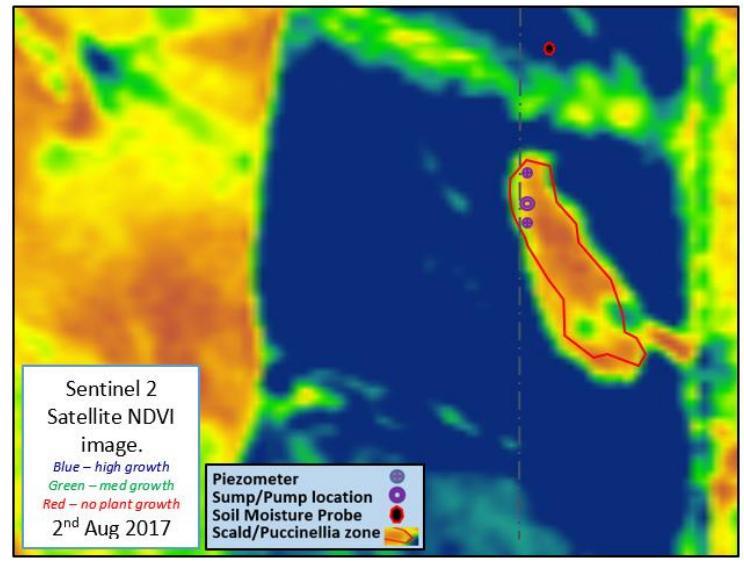
Figure 8. Seep area orange due to surface ponding and flow most of the 2017 growing season

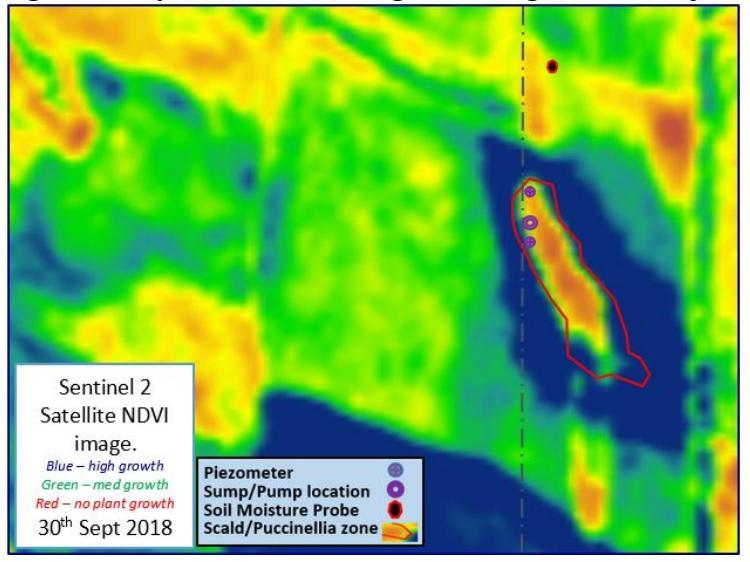
Figure 9. Sept 2018 NDVI image showing bare scald forming within high growth area

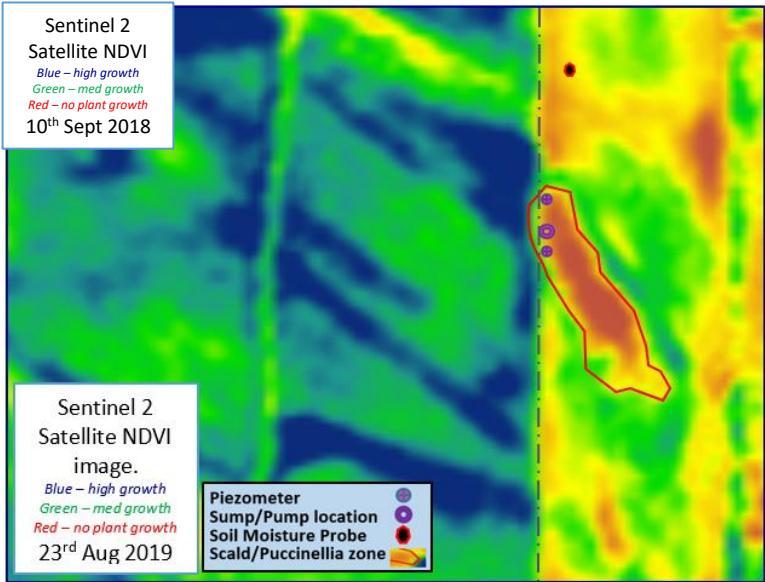
Figure 10. Aug 2019 NDVI image of scald with strong plant growth west.

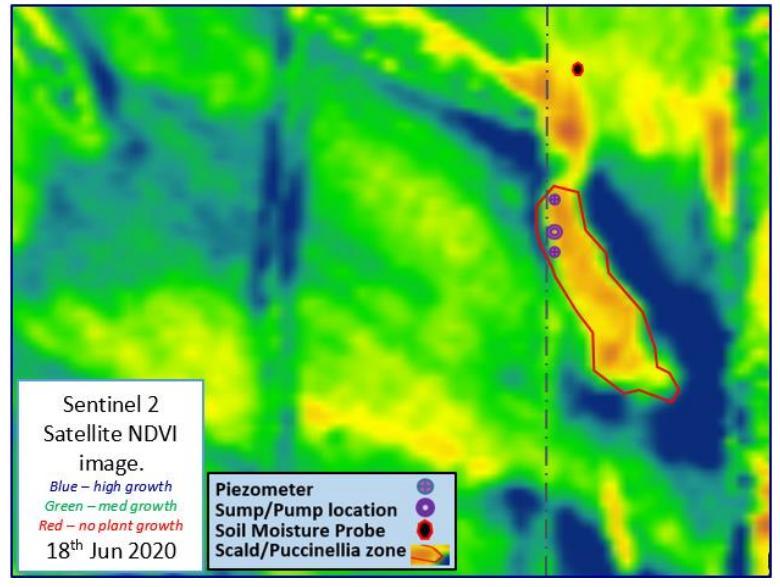
Figure 11. Jun 2020 with strong surrounding growth despite dry season start.

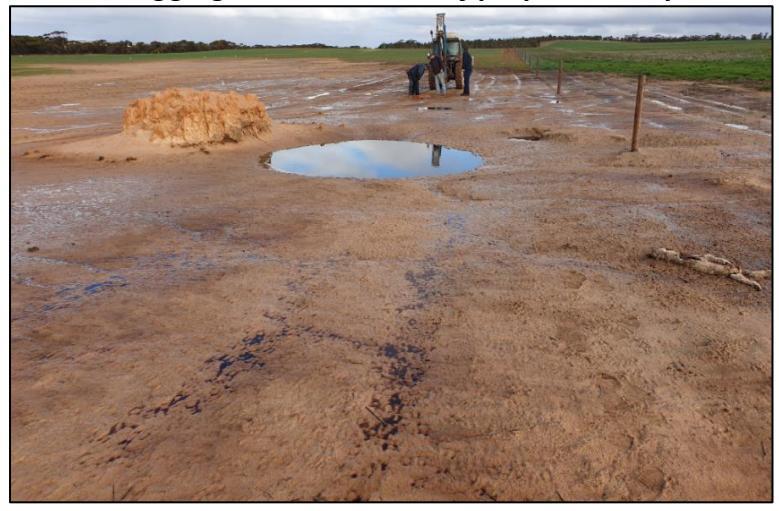
Photo 4. Digging test well at site of proposed sump and solar pump location AB Site 2.

This site is being set up with a sump at a key location at the top edge of the scalded area near the fence, close to a small open dam that was dug in 2018. It is very important to set up a properly constructed, deep covered sump to collect the water, as the water quality in open dams will deteriorate very quickly. The site needed to be in a place that would have maximum impact, being not too high in the catchment to miss significant inflows from either side below the site, and not too low to prevent degradation above. The water will be pumped up to a large tank which already sits at the top of the hill to the south.

For a sump the farmer has acquired a large tuna pipe (5m diameter) to be dug in to the ground to 2.5m depth. This is to be set up with a solar pump and floatation switch and flow meter to allow for the measurements of water extraction. A water level monitor with continuous data-logging will be placed within the sump which should give a good indication of the very localised water table changes. Two piezometers have already been strategically placed, one 20m to the south and one 40m to the north, and will have data-loggers attached to measure the corresponding changes to water table levels as water is pumped out. It may also be good to place a further piezometer and water table data-logger 60cm below (southeast of the sump) to test the treatments effectiveness.

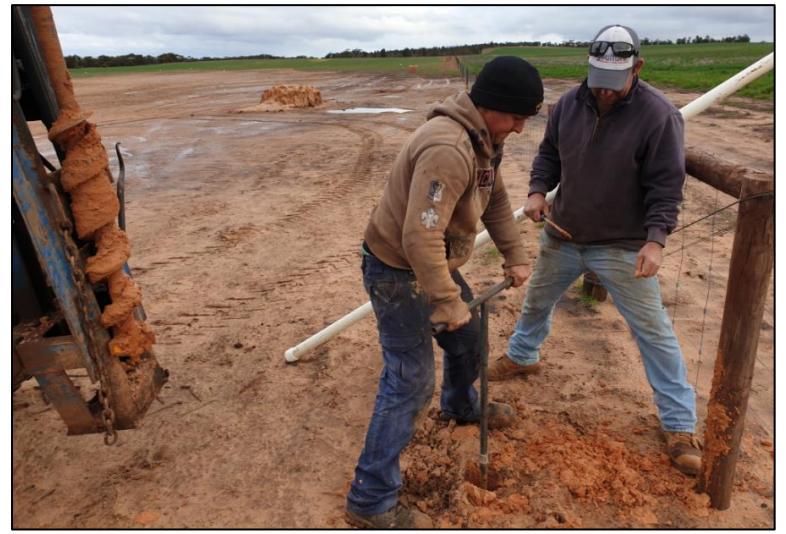
Photo 5 Digging for AB Piezo 3, 40m north of pump site.

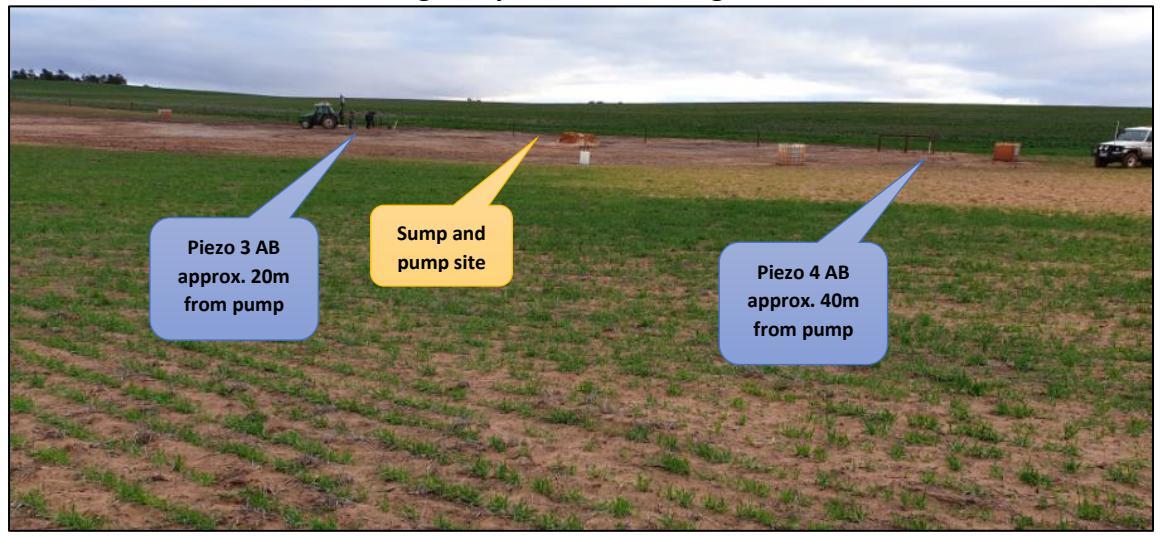
Photo 6. AB Site 2 scald showing sump and monitoring sites

The Site 2 bare scald is also in the process of being sown to the salt tolerant puccinellia to provide perennial soil cover and grazing and reduce topsoil salinisation because of capillary rise and evaporation of this waterlogged landscape. Topsoil (0-10cm) salinity was measured at 0.49 dS/m, 0.2 dS/m (10-20) and 0.34 dS/m at 20-30cm depth, which is not considered too saline to grow crops at this stage (Table 3). However, the high pH levels of 10 at this site may well be the most toxic factor inhibiting rehabilitation to cereal growth. It may also be that waterlogging in the rootzone may also be the main driver of this bare patch, which hopefully will be changed through this sites water use strategy. All these factors will need to be progressively monitored over time.

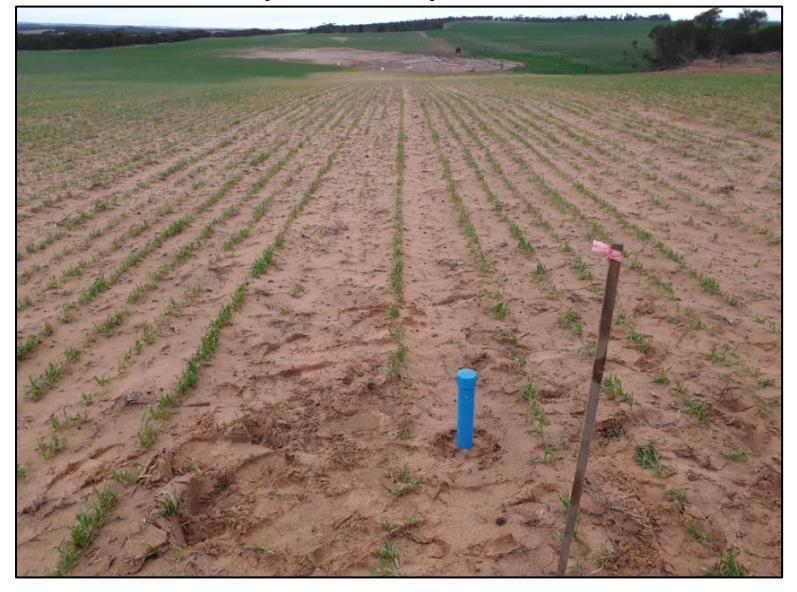
Photo 7. Moisture probe in deep sand above AB Site 2 to assess plant/soil/rainfall dynamics

A soil moisture probe has also been placed in the deep sand toward the top of the side to the north of the seep scald to help assess how compacted this sand may be (measuring profile moisture extraction by crop roots) as well as which rainfall events may be contributing to recharge (Photo 7).

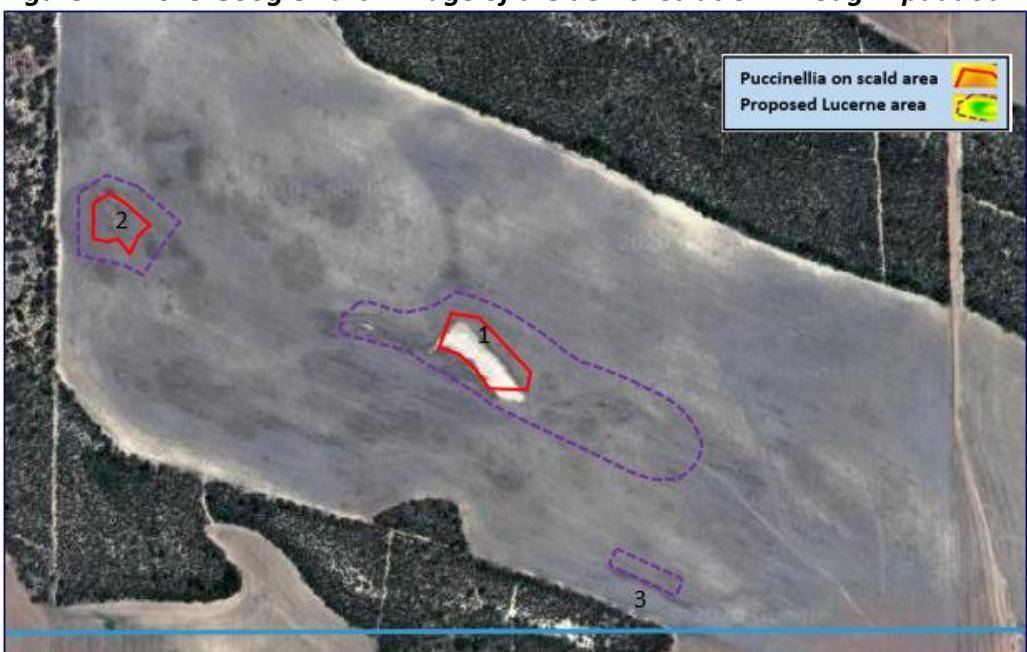
The Jericho Trough Paddock was visited on June 3rd 2020. The paddock has many jumbled sandy rises, loamy flats and 3 seep areas of varying stages of development as shown in Figures 12 and 13.

Figure 12. 2015 Google Earth image of the demonstration "Trough" paddock

The areas targeted for both Puccinellia and Lucerne is indicated in Figures 12, 13 and 14.

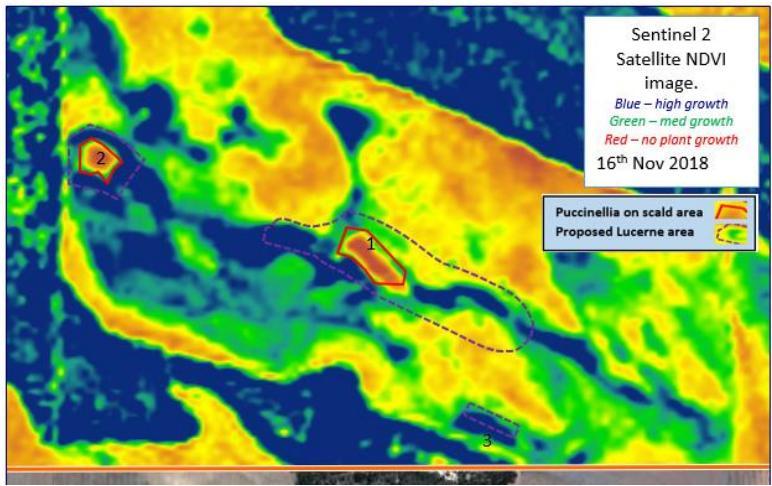
Figure 13. Nov 2018 Satellite NDVI image highlighting deep sand (orange) and loamy (blue) areas

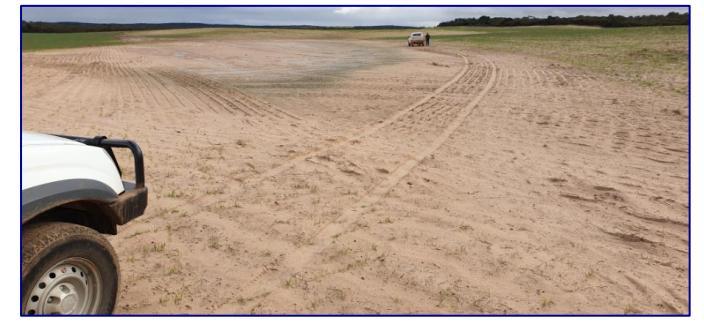
The first site is a large white scalded area that has been present since before 2000 but in recent years has begun to extend in an easterly direction (Photos 8 & 9). It has a large sandy rise to the northwest, the northeast and southeast that could all be contributing recharge water (Figure 13). The scalded area has had most of the sand eroded from the topsoil over the years, exposing the slippery wet clay to the surface. Interestingly, a bore hole drilled to over 2m depth in the middle of the scald revealed no clear water table (Photo 10), with just enough water seeping in to test after 6hrs, reading at a very high 15 dS/m. It was thought that the essentially impervious clay layer was now very close to the eroded surface. However, in the northern edge water was found at a shallow depth at only 2.9 dS/m and at the western edge at 6.3 dS/m. The lower reading edge levels gave confidence that lucerne planted close to the seeps could successfully intercept water moving into this scald area.

Photo 8. Jericho Seep 1 scald in middle of paddock

The bare scalded areas of Seep 1 and Seep 2 should be sown to the salt tolerant grass Puccinellia to provide soil cover, grazing and water use. This will stop further surface soil degradation by utilising water within the rootzone, rather than allowing it to rise to the surface, evaporate and leave salts to concentrate. In time it may be possible to return Seep 2 to cropping, possibly with the addition of sand to the surface, however, such rehabilitation may take far longer in Seep 1, given the much higher salinity levels of soil and water measured.

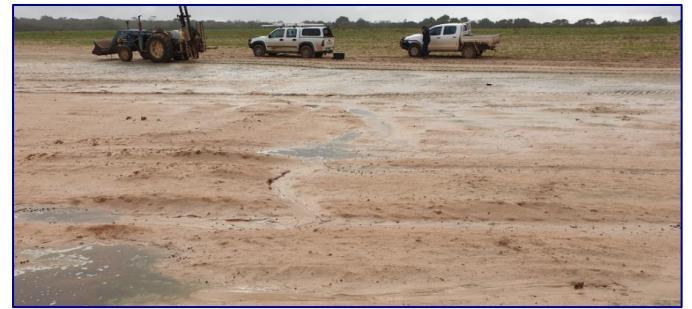
Photo 9. Clear indications of water seeping out of the sandy rise to the north of scald.

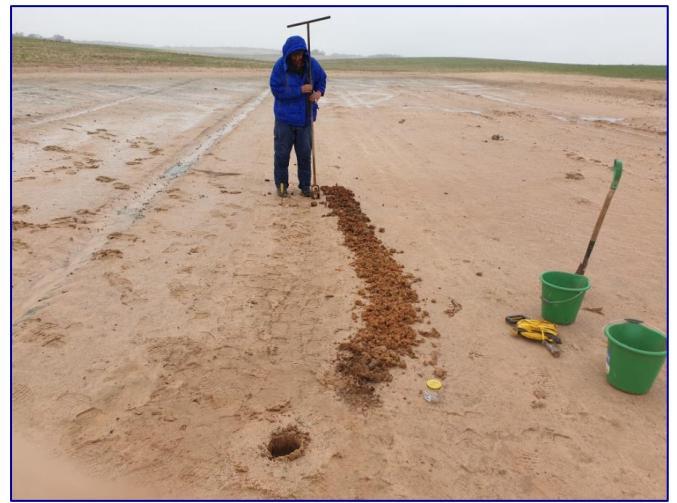
Photo 10. Deep test hole revealing no sloppy clay layer.

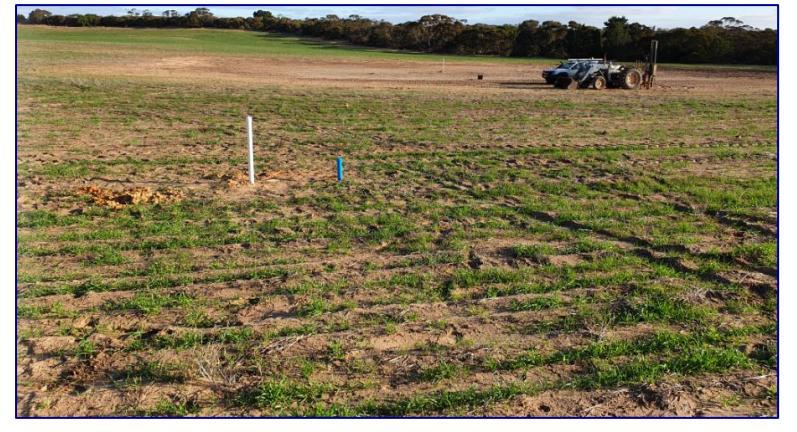
The second (Seep 2) site has a sandy rises to the north (Figure 13, Photos 11 & 12) which appeared to be contributing water to the seep. This was confirmed by the piezometer established approximately 30m up the slope that had a water table at 2.2m, and a salinity level of 3.3 dS/m. A piezometer was also placed in the middle of the scald, showing a water table at 30cm with a salinity level of 4.5 dS/m. This has given confidence that a ring of lucerne established around this scald could utilise the water and reduce the water table. Data loggers were set in each piezometer so that continuous monitoring of the perched water table levels can be analysed in response to both rainfall events and management practices undertaken. A probe containing 5 soil moisture sensors at 20cm, 40cm, 60cm, 80cm and 1m was also set up in the midslope to assess how this soil retains loses water throughout the seasons, as well as there is a compacted layer preventing root access.

Photo 11. Jericho Seep 2 showing mid-slope piezometer and moisture probe in foreground.

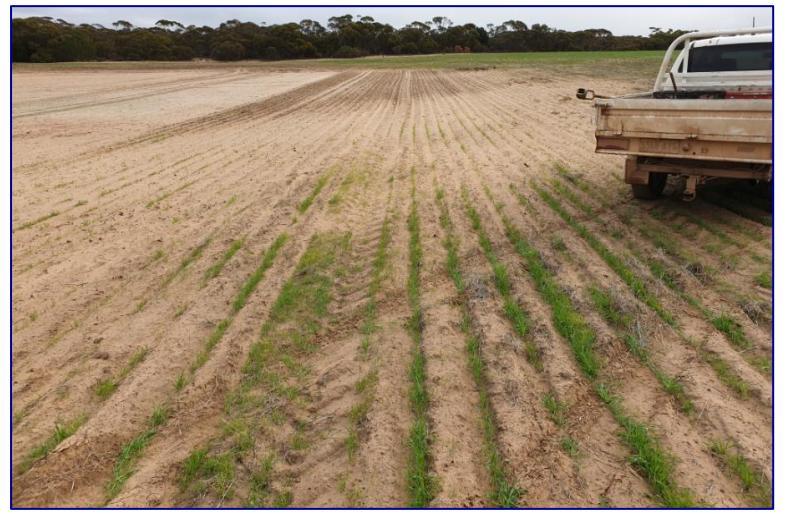
Soil tests from the middle of the scald show a high salinity level concentrated in the surface of 0.79 dS/m, with low salinity levels of 0.21 dS/m at 10-20cm and 0.21 dS/m at 20-30cm depth within this sandy profile (Table 2). This is indicative of a recently formed scald (since the wet season of 2016) with capillary rise bringing slightly saline water to the surface where it evaporates, but leaves the salt behind to gradually concentrate. This scald should initially establish well with Puccinellia, and may well be restored back to cropping if management strategies prove successful. Some Puccinellia seed was thrown over the site to see if it would germinate, and some germinated seed samples were also planted around the scald piezometer.

Photo 12. Jericho Seep 2 scald area rapidly spreading though cropping land.

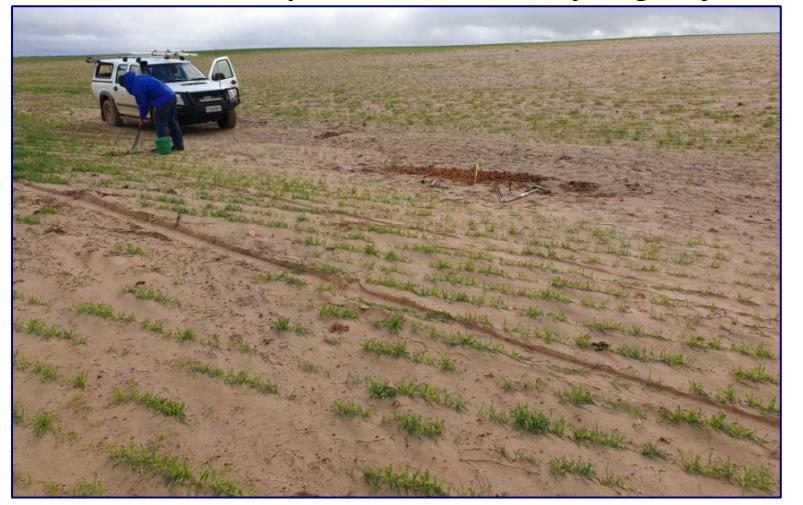
The third (Seep 3) site is located in the south edge of the paddock at the base of a large sandy rise (Photo 13). It was found to have very wet clay close to the surface containing high transient salinity (Table 2). It would appear that this salinity is beginning to rise into the surface layer. However, if the stem of moisture from above this scald is dried up using a narrow strip of lucerne, it is expected that this relatively small area will be restored back to crop production.

Photo 13. Jericho Seep 3 site that is its early stages of development.

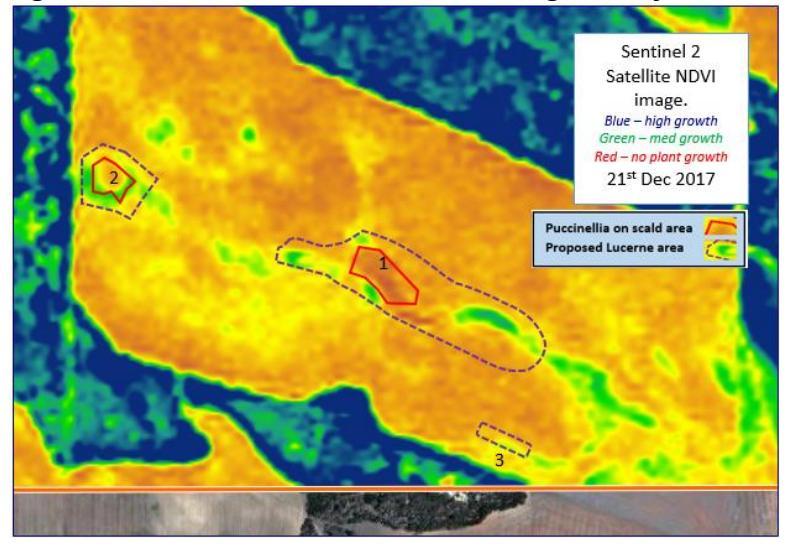
However, after a closer examination of the NDVI satellite imaging since 2016, it appeared to indicate that Seeps 1 and 2 are linked by the water moving through the landscape of the paddock. This is particularly evident in Figure 14, which is taken from Dec 2017, a year after the very wet spring of 2016, showing plant growth continuing in an east-west line when the rest of the paddock was dry. This pattern is repeated in other years, and was certainly a consideration when the paddock was first inspected. So while it is clear that water is flowing into these sites from the surrounding sands to the north in particular, there may also be a significant contribution coming through this water flow from east to west. It has therefore been decided to extend the lucerne strip to the east of Seep 1 to capture this flow, as this may well be the key to drying our both seep areas. This also will show the value and practicality of utilising the NDVI technology, which all farmers can access, to better manage mallee seeps.

Figure 14. Green east/west line indicating water flow connecting sites in summer after wet 2016

The initial main innovative practice to be tested at this site was to use of strategic 20-30m wide lucerne strips planted immediately around the discharge zones (or just above in the case of Seep 3), to utilise enough excess water to lower the water tables, to stop the spread of the land degradation and, in time, possibly restore areas back to crop production. The farmer has acquired the lucerne seed and will sow these areas as soon as the conditions are deemed to be good to proceed. The advantage of lucerne is that it is very deep rooted, and perennial, meaning that it will utilise all the summer rainfall, which has been identified as a key contributor to seep formation since the success of chemical summer weed control by farmers.
