Wanilla

Eyre Peninsula Groundwater Dependent Ecosystems monitoring site

2019 Report Card

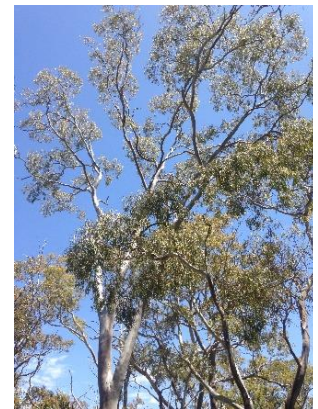
Adult Red Gums at Wanilla assessed as in 'moderate' condition.

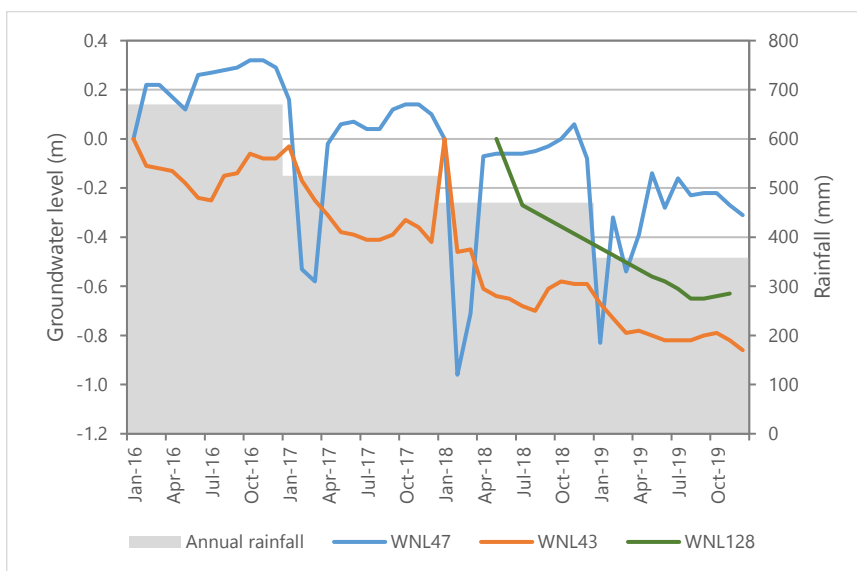
- In the short term (2016 to 2019) total annual rainfall has decreased from 670.5 mm in 2016 to 358.0 mm in 2019, with an associated decline in groundwater levels. Large drops in water levels at WNL47 at the start of each year are due to this well being next to a production bore.
- Graph 2 shows in the long term, there is also a decline in total winter (May to September) rainfall (blue line). Daily rainfall events of more than 10 mm in winter (between May and Sept) are also in decline (orange line). These events are likely to be the main cause of recharge to underground water and are thought to be significant for long-term Red Gum health (Graph 2).

Graph 1 Total annual rainfall^{^^} and change in groundwater levels^{**} at three wells, from 2016 to 2019.

^{^^}Rainfall data for 2016 to 2018 is regional data obtained from the Bureau of Meteorology station, Port Lincoln, Big Swamp (number 18017). Rainfall data for 2019 onward is site specific data obtained from the rainfall gauge installed at the Wanilla GDE site.

^{**}For each well, the groundwater levels shown are relative to the groundwater level at the start of the monitoring period, which is shown as zero.
