FARMERS IN THE TATIARA ARE GETTING INNOVATIVE WITH LEAK DETECTION SYSTEMS

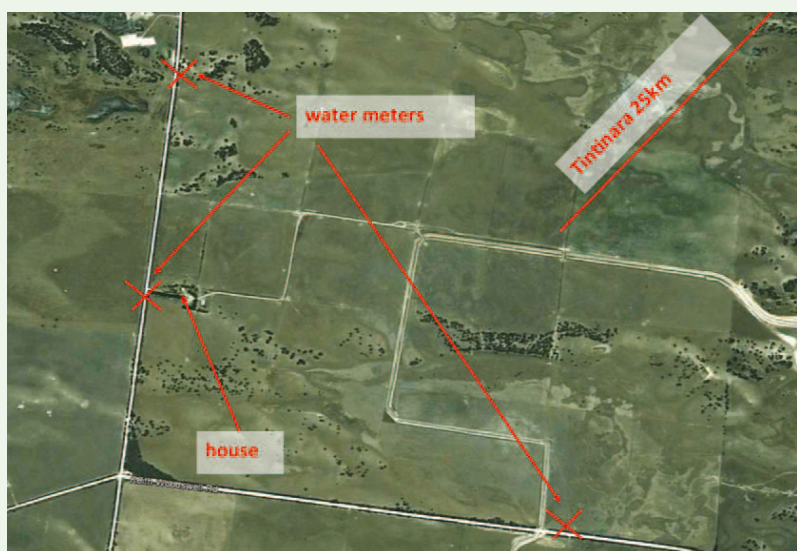
The leak detection system and base station enables Frank and Carole to track and record the hourly, daily and monthly water flows and most importantly detect any water leaks or excessive usage.

Frank has programmed the base station's warning system to alert them of excessive flows via a flashing light at the homestead. Warning categories include:

- Major Leak: >2KL total during two consecutive hours
- Minor Leak: >Flow fails to drop to below 25L/hr or less between 6am-6pm

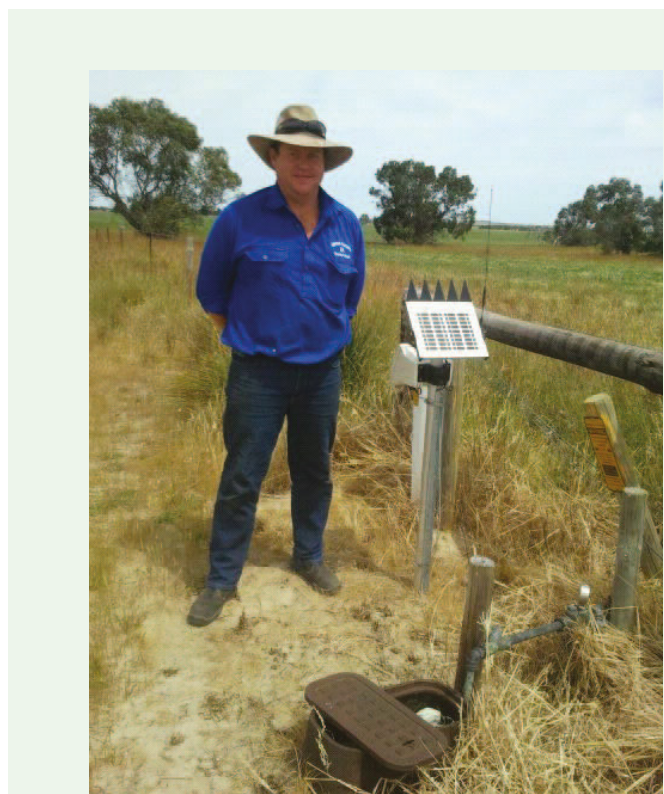
The Sentek MULTI has a logging and data transmission system that captures a range of on farm information. The system monitors and records flows from the SA water meters every 15 minutes and provides daily water alerts / meter readings via SMS and email. Adam and Julian receive a daily SMS at 7:30am with the meter readings they can also track via Alpha Groups website. This enables them to monitor their daily water usage and identify any excessive flows that may have occurred. Graphs of the daily, monthly and yearly water usage can be viewed via Alpha Group website 24 hours a day.
