# Riparian Habitat Values Assessment of the Diamantina River Catchment; Lake Eyre Basin, South Australia

Henry Mancini  
June 2017

Report to the South Australian Arid Lands  
Natural Resources Management Board

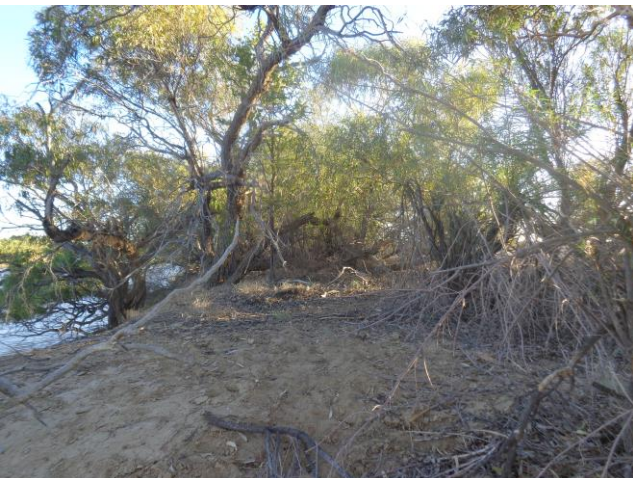
**Heavily grazed riparian zone**

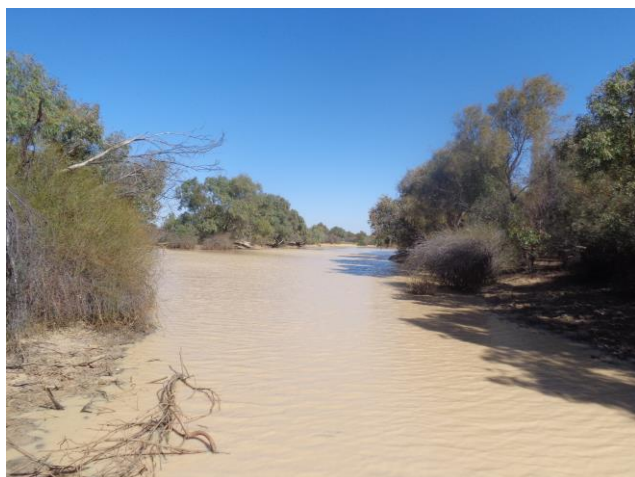
**Burt Waterhole riparian vegetation – highly turbid water**

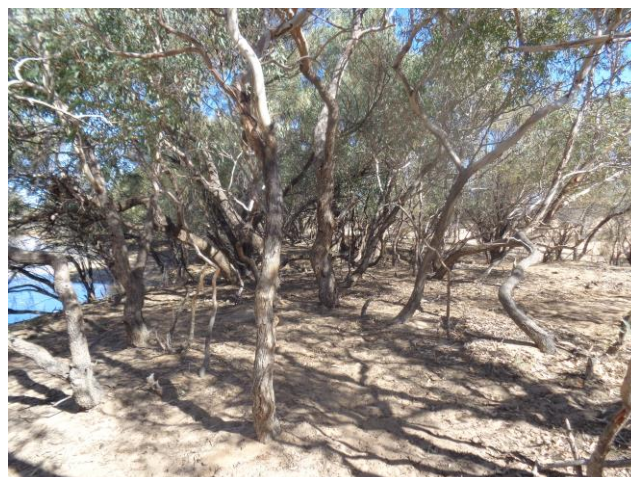
**Reduced understorey & mid-stratum layer**

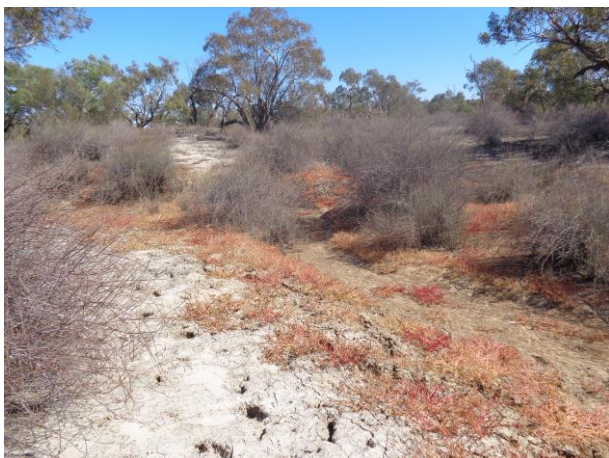
**Dry conditions with groundcover of *Portulaca***

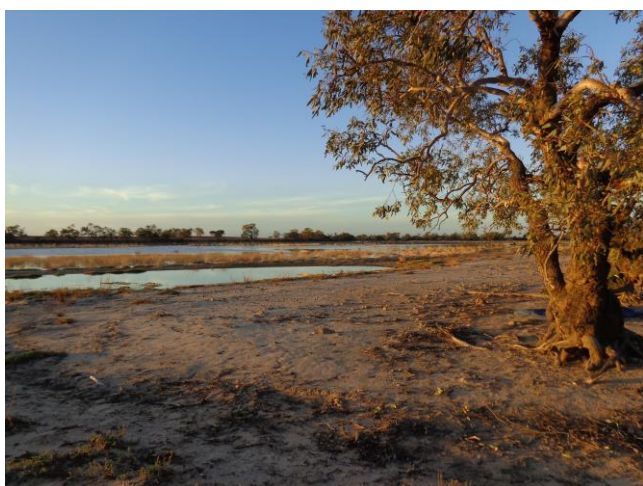
**Low gradient waterhole receives runoff from nearby gibber** **Reduced groundcover and shrublayer along riparian edge**

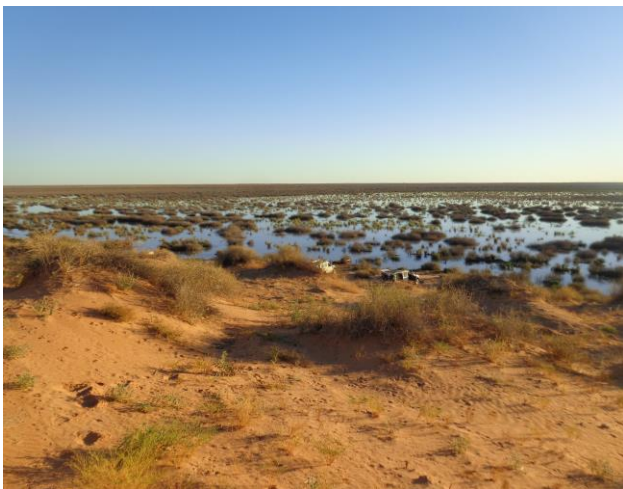
**Thin riparian vegetation corridor**

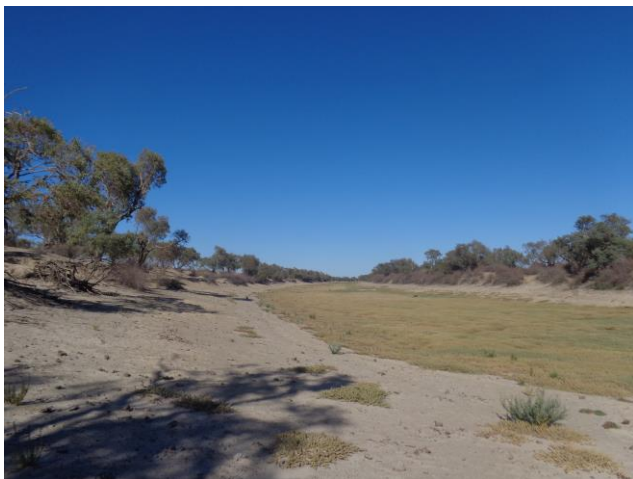
**Dry creek bed and thin riparian corridor vegetation**

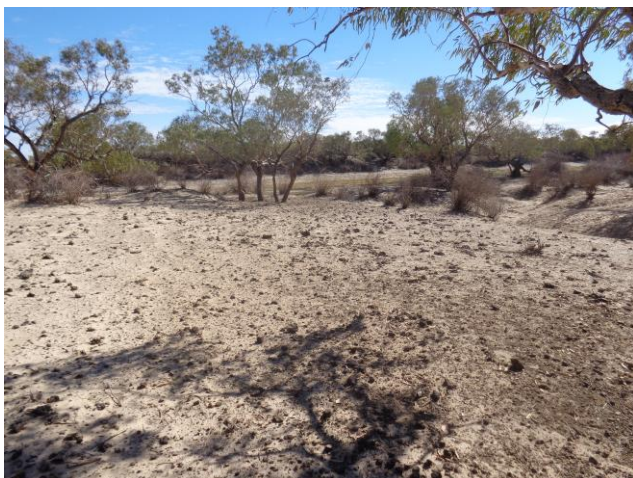
**Heavily grazed area near waterhole**

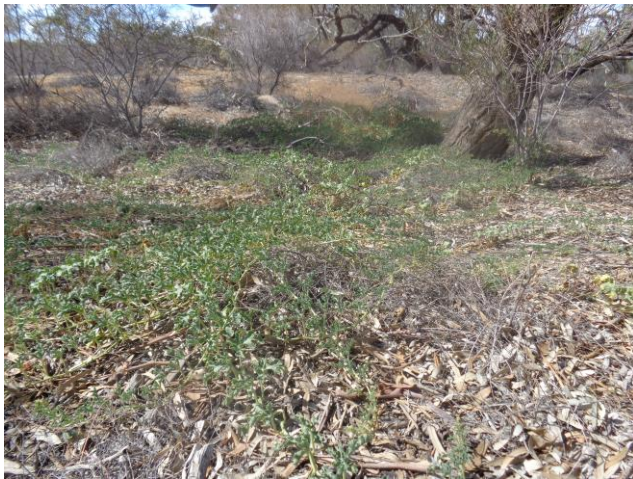
**Good leaf litter and ground cover along riparian corridor**

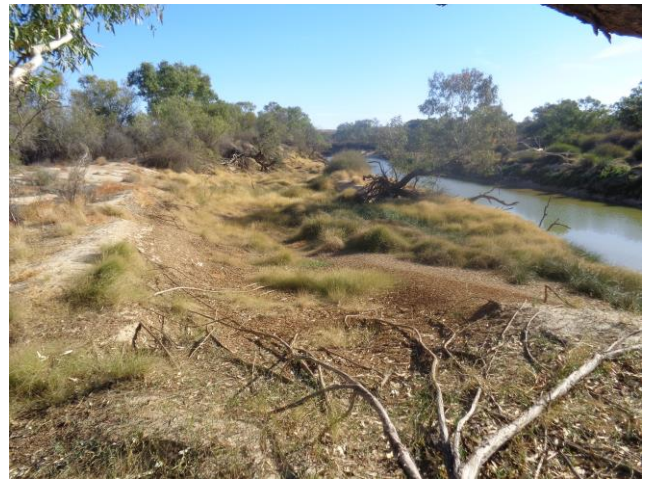
**Recovery of riparian vegetation**

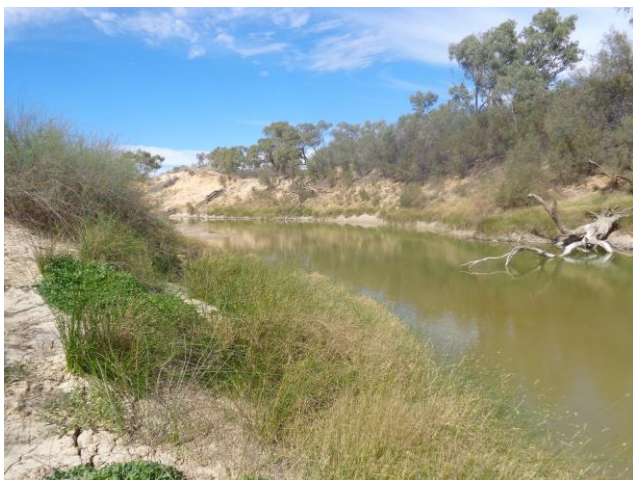
**Streambank habitat features – fallen and submerged logs**

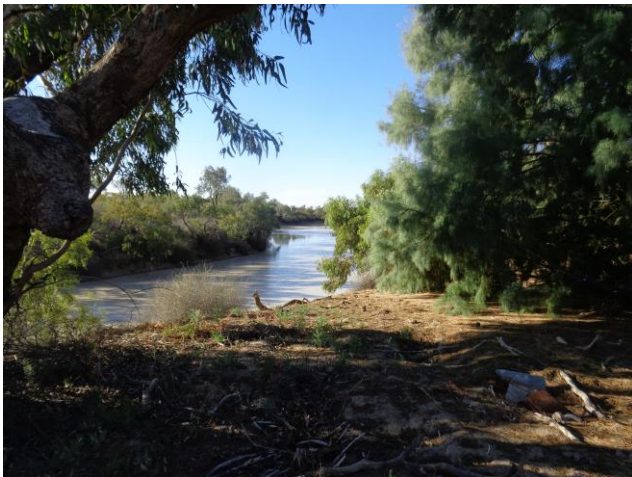
**Athel pine regrowth at Mona Downs Station ruins**

| <b>Riparian Habitat Summary</b> | <b>Ranking</b> | <b>Comments</b> |
|---|---|---|
| <b>Management priorities</b> | HIGH | Apply grazing strategies to enable recovery of the site. Destocking when required according to condition. Control and remove Athel Pine and monitor for any regrowth. |

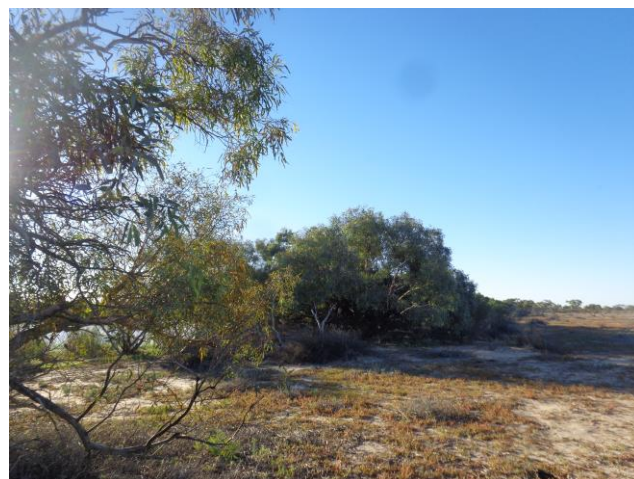
**Riparian vegetation high understorey species richness**

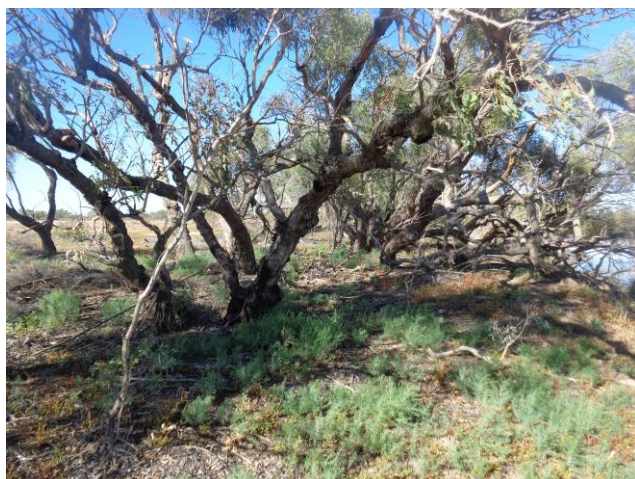
**Riparian vegetation good groundcover vegetation and leaf litter cover – low shrub-layer species richness**

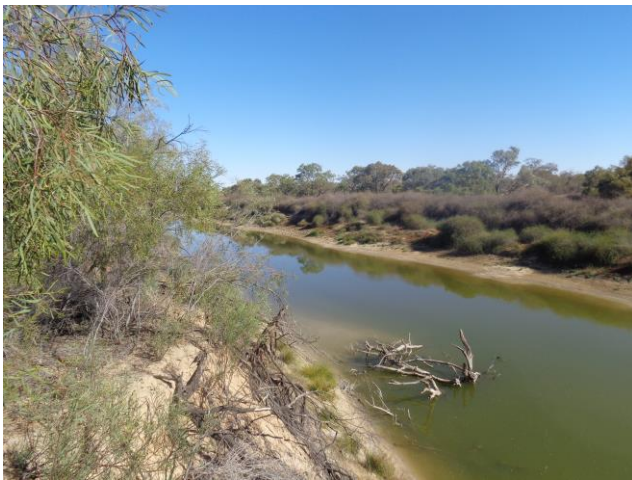
**Good vegetation cover along waterhole edge**

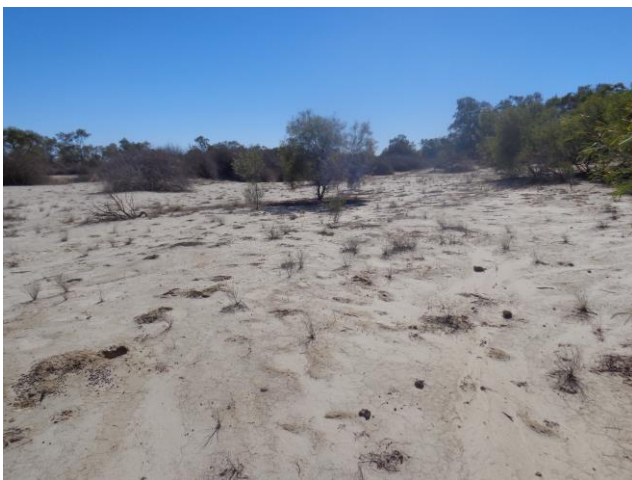
**Open areas on sandy dune swales**

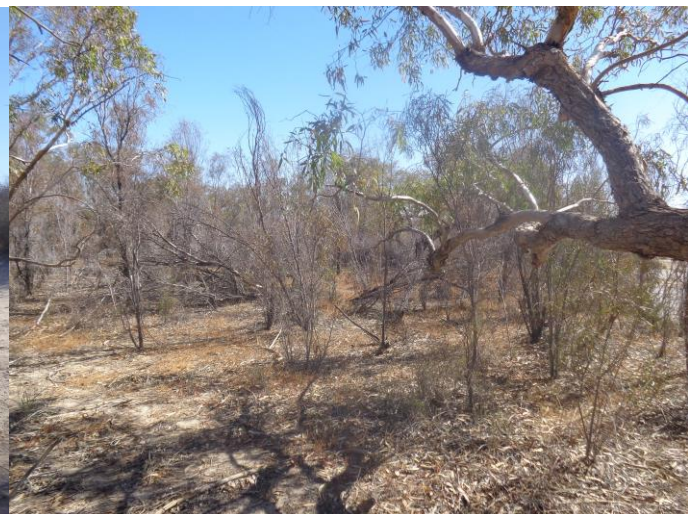
**Riparian vegetation cover**

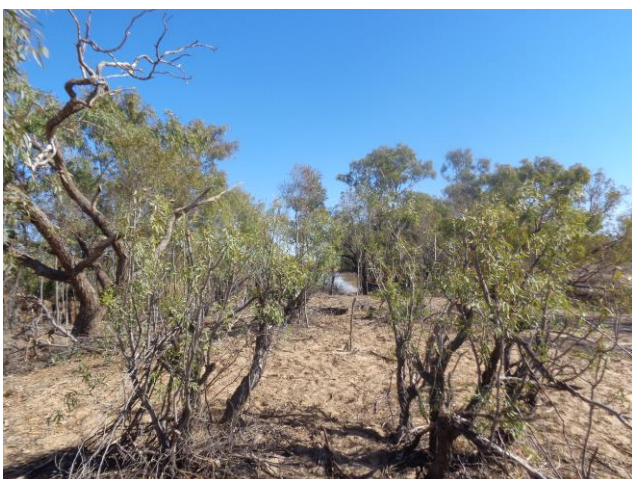
**Heavily grazed understorey and reduced groundcover layer**

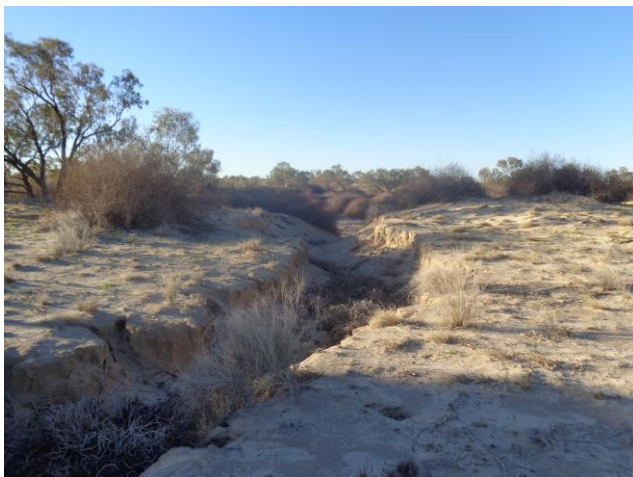
**Erosion gully forming 2015**

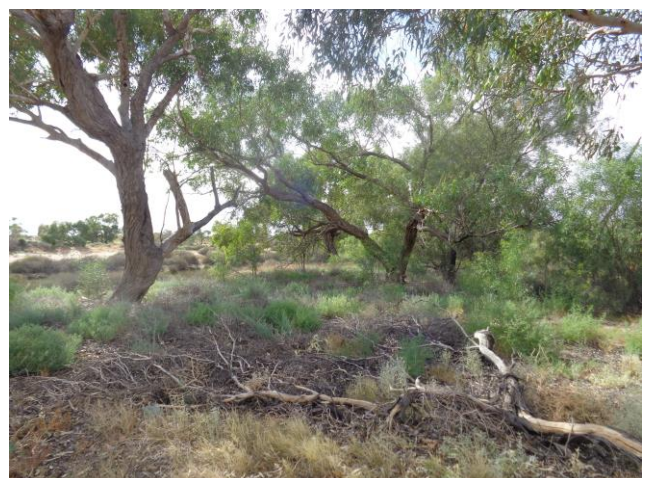
**Good debris and leaf litter cover**
